STAR ONLINE PUBLICATION

Case Number: S2108000266

Symptom/Vehicle Issue: Surround View Camera 360 View Left Side Top Rear Image Goes Black

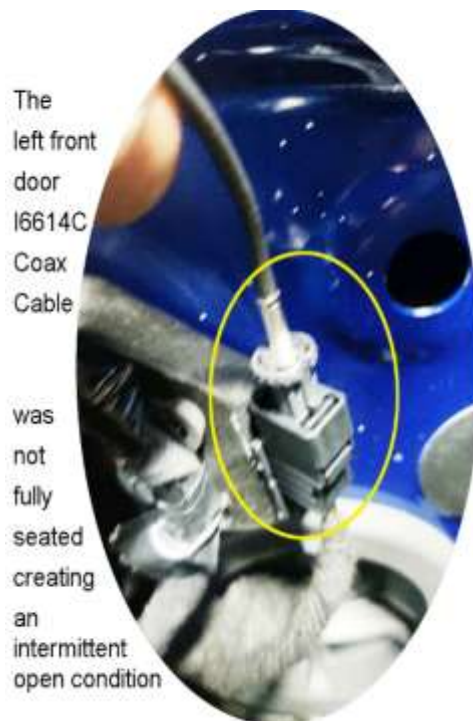
Fig 1

Customer Concern/Technician Observation: Owner complains after a recent door repair service that the left side camera for the 360 top rear view would intermittently cut out (Black screen). Technician observed DTC's B23C6-92 Camera Performance Incorrect Operation, U0266 Lost Communication With Left Camera set as stored or active.

Repair Procedure: Inspect the door harness and connectors for the left side camera coaxial i6624C behind the door panel or XY451A at the left side kick panel door connection. Secure the connector(s) as needed, no parts required Fig 1, 2.
