Case Number: S2108000269

Symptom/Vehicle Issue: Air Bag Lamp On, DTC B2761-11 B Pillar Side Impact Sensor Circuit

STAR ONLINE PUBLICATION

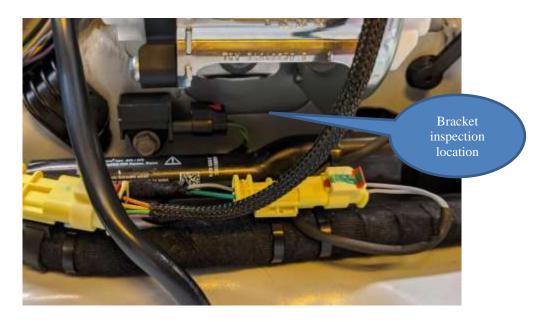
Fig 1

Customer Concern/Technician Observation: Owner complains that the air bag warning lamp is on. Technician observed the ORC sets B2761-11 B Pillar Side Impact Sensor Circuit Short.

Repair Procedure: Remove the driver side door sill trim to inspect the harness for any pinching or harness damage at the sill routing to the ORC. Inspect the B-pillar seat belt retractor bracket location for any signs of chaffing or pinching of the R13 circuit. Follow the diagnostic service procedures for repairs to safety systems Fig 1, 2. See service information 10 - Restraints / Standard Procedure SUPPLEMENTAL RESTRAINT SYSTEM WIRING REPAIRS.
