STAR ONLINE PUBLICATION

Case Number: S2123000077

Symptom/Vehicle Issue: Dash Gap On Passenger Side At Mid Bolster To Center Display

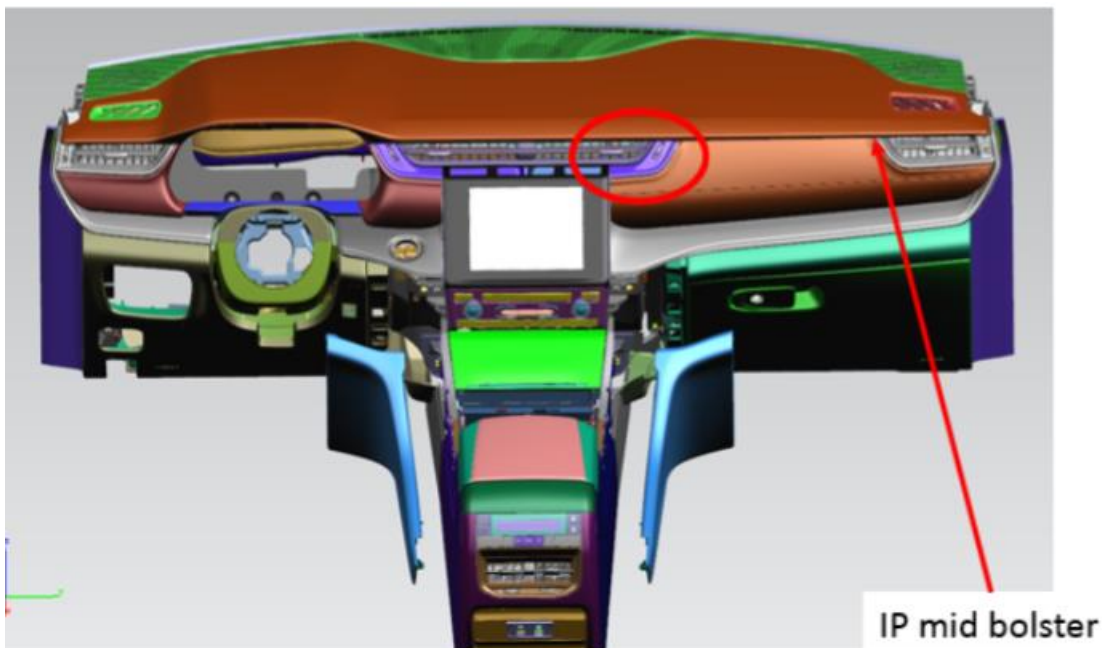
Customer Complaint/Technician Observation: Sitting in the passenger seat looking at the dash the occupant may notice a gap circled in the below image
