## STAR ONLINE PUBLICATION

**Case Number:** S2123000079

**Symptom/Vehicle Issue:** Wind Noise And Or Water Leak From Door Seal Area

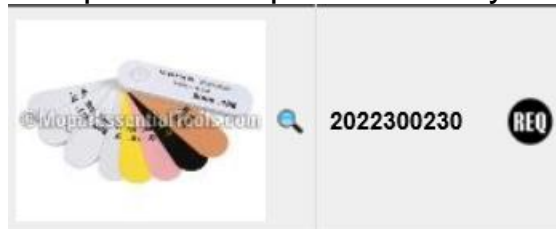
1. Prior to replacing any seals or weather strips, perform a vehicle walk around to verify door fits (gap and flush). Refer to service information 23 - Body / Body Structure / Gap and Flush / Specifications. Use of a non-marring gap gage set such as 2022300230 will protect the paint from any damage while measuring.
