STAR ONLINE PUBLICATION

Case Number: S2121000017 REV. A

Release Date: November 2021

Symptom/Vehicle Issue: Drivetrain Control Module (DTCM) Diagnostic Trouble Code (DTC) C2201-49 – FDCM/DTCM Internal Electronic Failure, set.

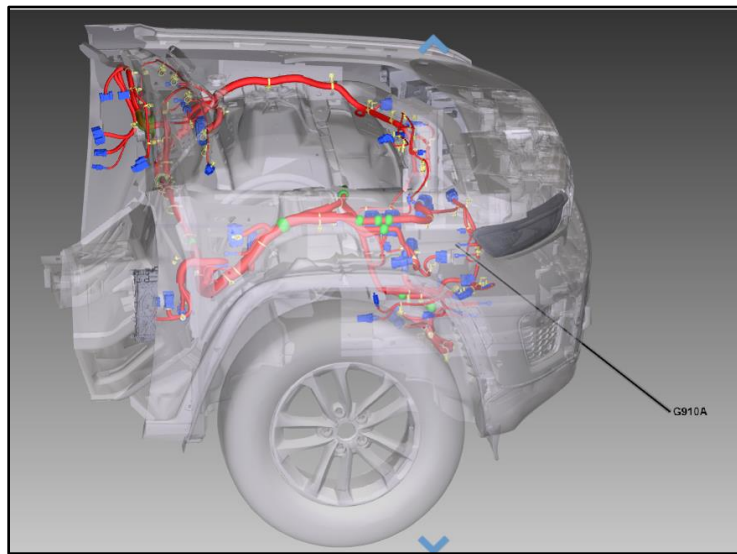
Figure 1.

Further analysis of the condition has shown that the possible cause of this DTC is due to a repeated loss of power/ground to the DTCM (such as repeated battery disconnects or loose connections) causing an incomplete shutdown of the module.

A loose ground G910A connection, which can cause this DTC, may also cause one or more of the following DTCs to set.

1. Closely inspect ground G910A for being loose, and repair as necessary. Ground G910A is located on the passenger side of the engine compartment, on the outside body rail. It can be identified by the green tape wrapped around the harness. Please see (Figure 1 & 2.). G910A can be accessed through the passenger front wheel well.
