## STAR ONLINE PUBLICATION

**Case Number:** S2123000064 Rev.A

**Symptom/Vehicle Issue:** Service FCW Message On Cluster And C1418-78 Vertical Misalignment DTC

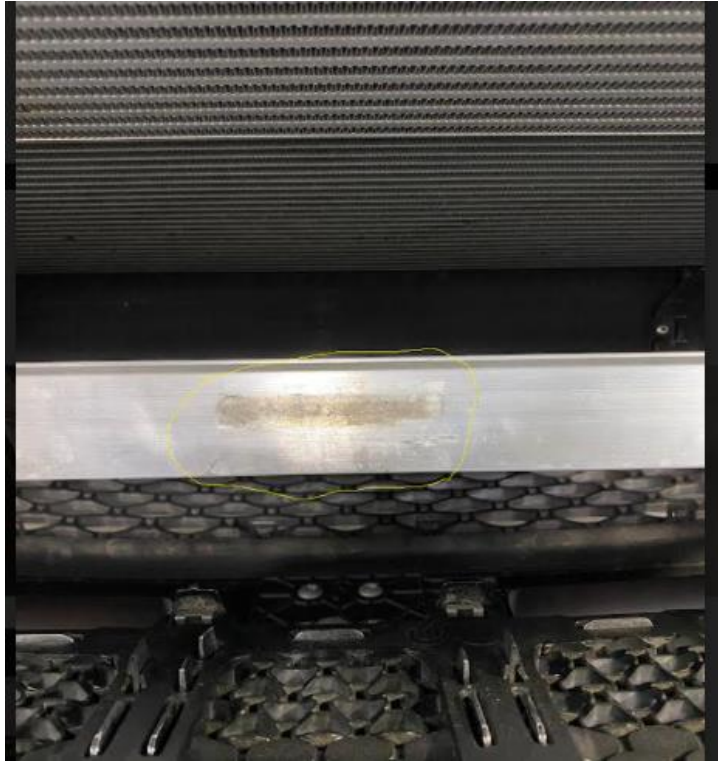
Other reports have also indicated that the ACC module is making physical contact with the aluminum bumper bar. Remove the ACC module and inspect the aluminum bumper for witness marks from contact with the ACC module. Review image below.

**ACC witness mark on Aluminum bumper**

**Repair:** The aluminum bar may be adjusted too high allowing contact with the ACC module. To resolve, begin by removing the front fascia from the vehicle. Then loosen the aluminum bumper mounting bolts and slide the bumper **DOWN** as far as possible. There are small studs designed to locate the bumper during assembly that will limit downward adjustment. Review image below.
