**NUMBER:** 08-115-21 REV. A

Front USB Media Ports Inoperative

This bulletin involves software update for the front USB media hubs.

2021 (WL) Jeep Grand Cherokee

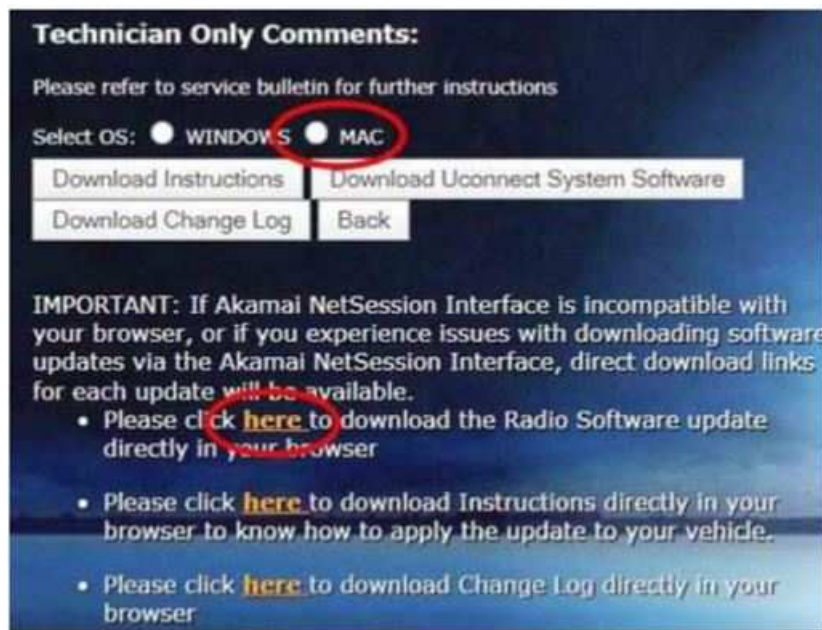
Fig. 1

3. Download the software update file to your local PC's desktop. Make sure to select the "MAC" radial button for all downloads. (Fig. 1)

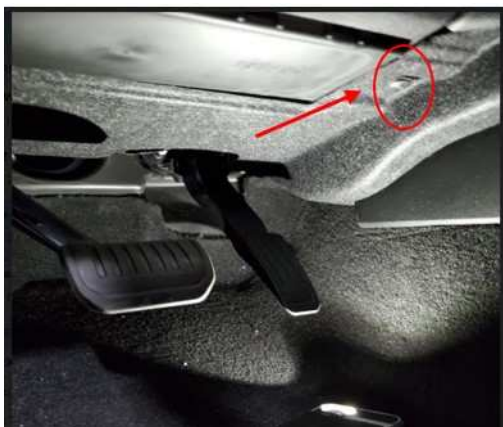
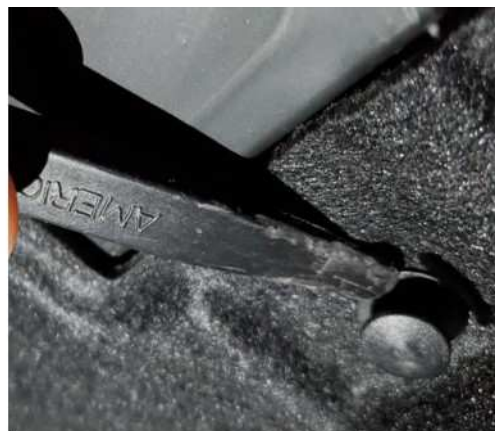
Fig. 2  
Push Pin

6. Locate the two push pins for fuse access on driver side. Using a thin trim stick pop the two push pins out to expose the fuse panel (Fig. 2) .

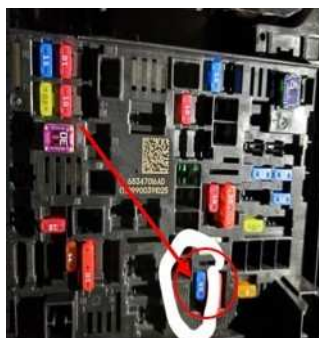
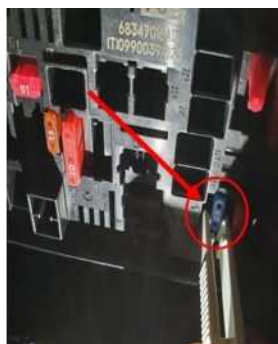
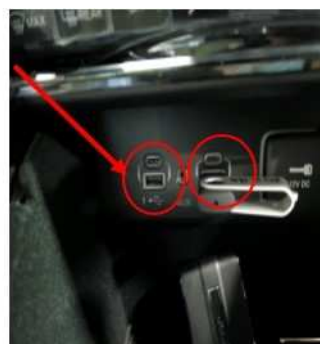
Fig. 3  
Fuse 63A Location

7. Locate fuse (63A) which is a blue 15 Amp fuse. Using a fuse puller tool, pull out the fuse as shown. After five seconds, re-insert the fuse. When the fuse is pulled, media hub lights will turn off (Fig. 3) .

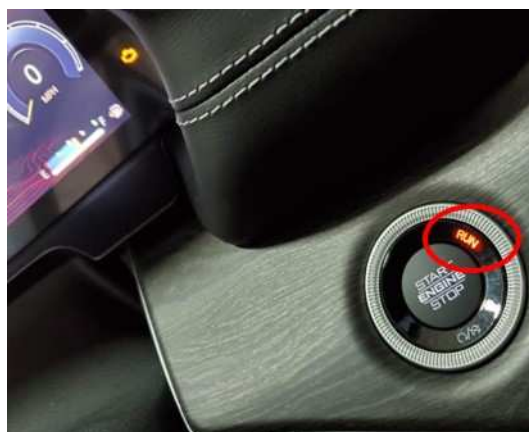
Fig. 4  
Run Position

8. Re-assemble the two push pins to the fuse access cover (Fig. 2) .
9. Cycle engine to RUN - DO NOT start the engine (Fig. 4) .

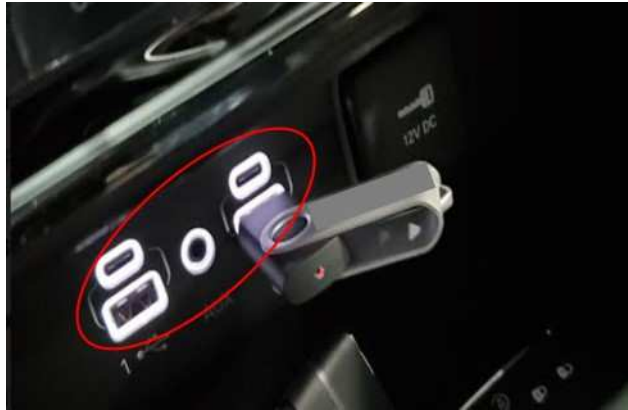
Fig. 5  
USB Flash Drive

10. Look at the media hub with the USB flash drive plugged in, when the update is completed the media hub lights blink on and off five times (Fig. 5) .

11. Once the Media Hub blinked five times then remove the USB flash drive (Fig. 5) .
12. Insert USB flash drive into a computer and open the USB flash drive then open the upgrade log file. The two lines should read “**complete**” if the update was successful (Fig. 6) .
