**NUMBER:** 08-102-21 REV. A

**DATE:** November 6, 2021

UAS and UCS Radio Enhancements

2018 - 2021	(LA)	Dodge Challenger
2018 - 2021	(LD)	Dodge Charger
2018 - 2021	(LX)	Chrysler 300

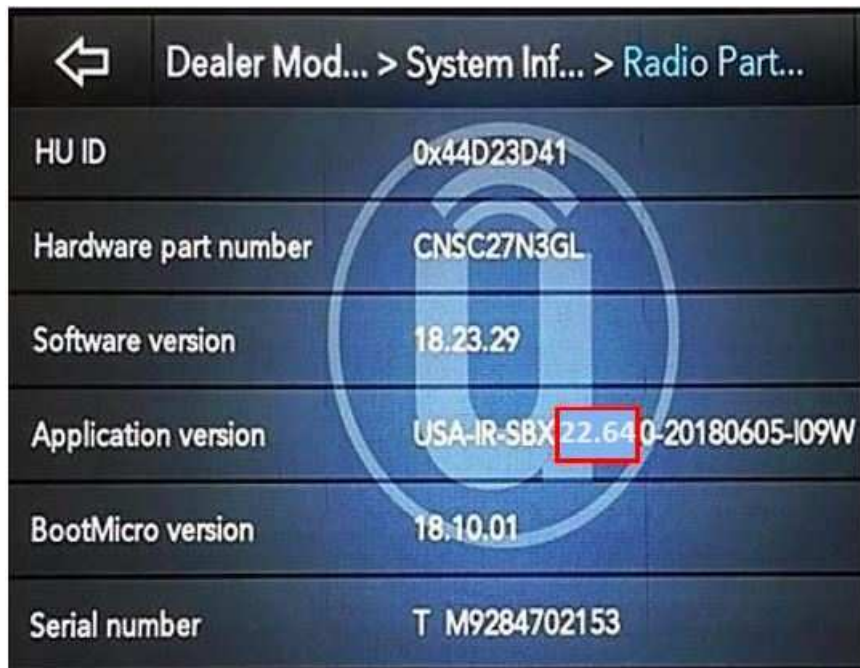
Fig. 1

1. Verify the radio software version. Radio must be in Dealer Mode to verify by following these steps:
  - a. Press and hold both lower corners of the display screen, until the Dealer Mode screen appears (approximately seven seconds). Release screen.
  - b. Select "Radio Part Information". The software version will be listed next to "Application Version" (Fig. 1) .

Radio Software Level Screen

2. What is the radio software level (Application Version) at?
  - 39.5 or higher >>> The radio software is already up to date. Normal diagnostics should be performed.
  - At or above 22.64 and under 39.5 >>> Proceed to [Step 1](#) of the Repair Procedure.

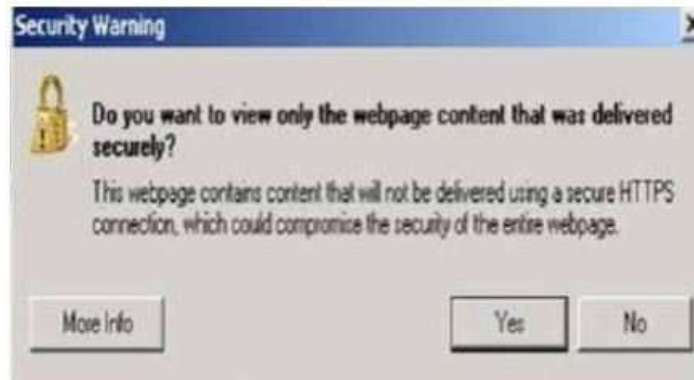
**Fig. 2**  
**Pop-Up Security Message**

3. Go to DealerCONNECT>Service>Uconnect Command Center>Uconnect>More Information >Dealer software downloads to download the files.
4. If a security message appears “Do you want to view only the web page content that was delivered securely?” ([Fig. 2](#)) . Press “No” to continue.

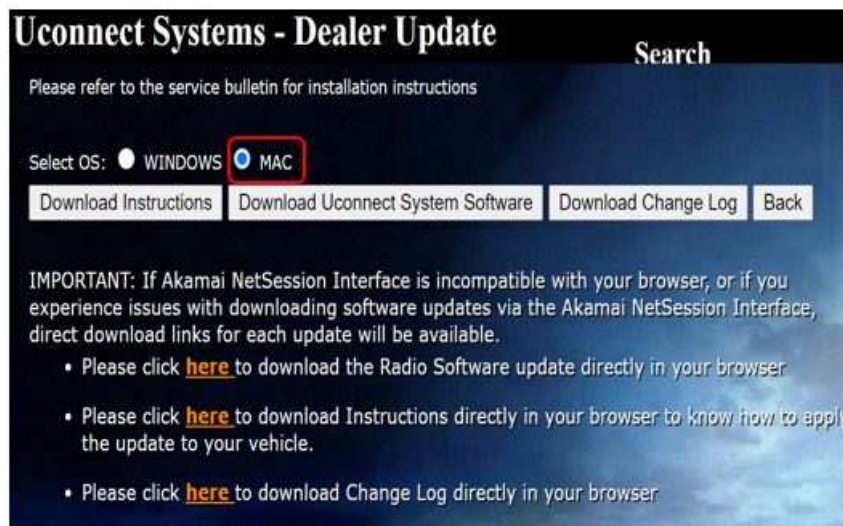
Fig. 3  
MAC Download Steps

6. Download the software update file to your local PC's desktop. Make sure to select the "MAC" radial button for all downloads (Fig. 3) .

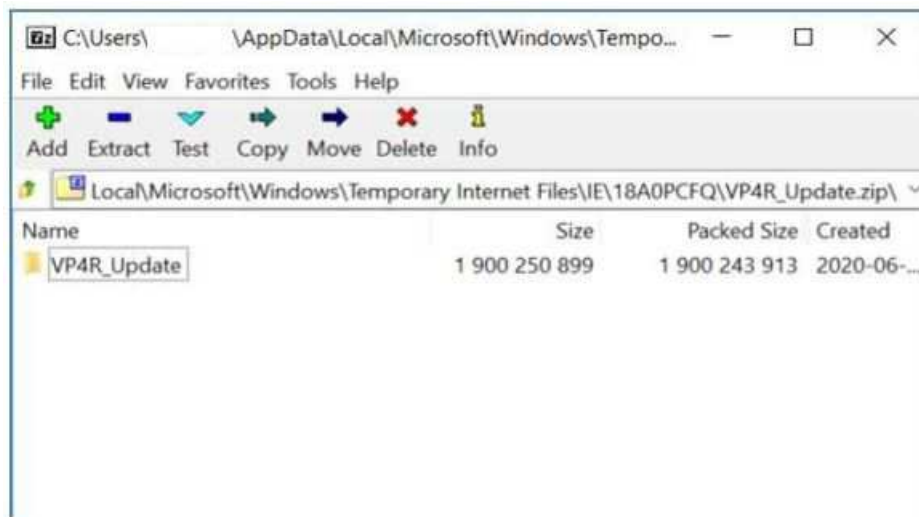
Fig. 4  
Files/Folders In The USB Flash Drive

8. Unzip the file to the root folder of the USB flash drive. File should not be within a zip folder. Your USB file should look like (Fig. 4) when you open it.

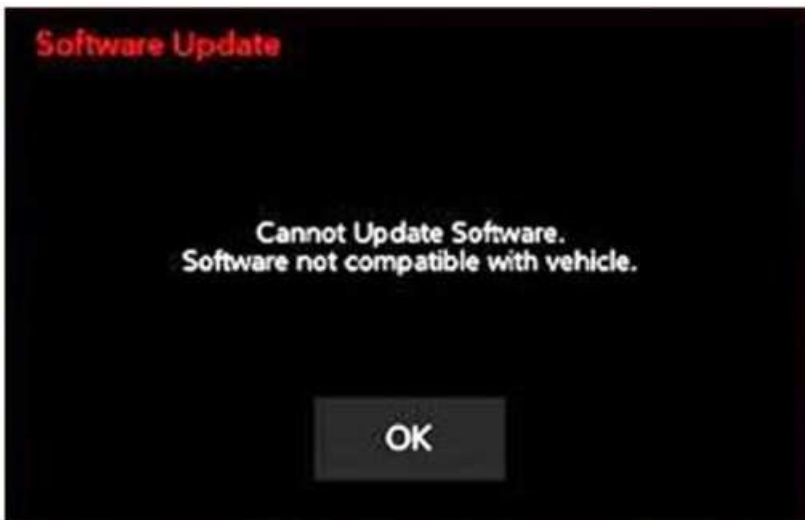
Fig. 5  
Software Not Compatible Screen

11. If the screen in (Fig. 5) is displayed, the USB flash drive was not set up correctly. Use a top name brand USB flash drive, like Kingston, create a new USB flash drive and start the update again.

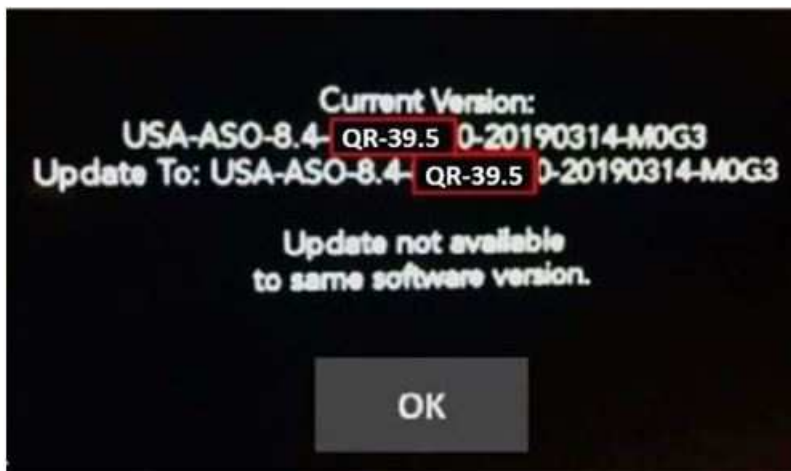
Fig. 6  
Screen Displayed When Radio Software Level Is Up To Date

12. If the radio software is already up to date, the screen in (Fig. 6) will be displayed. Press "OK" and remove the USB flash drive.

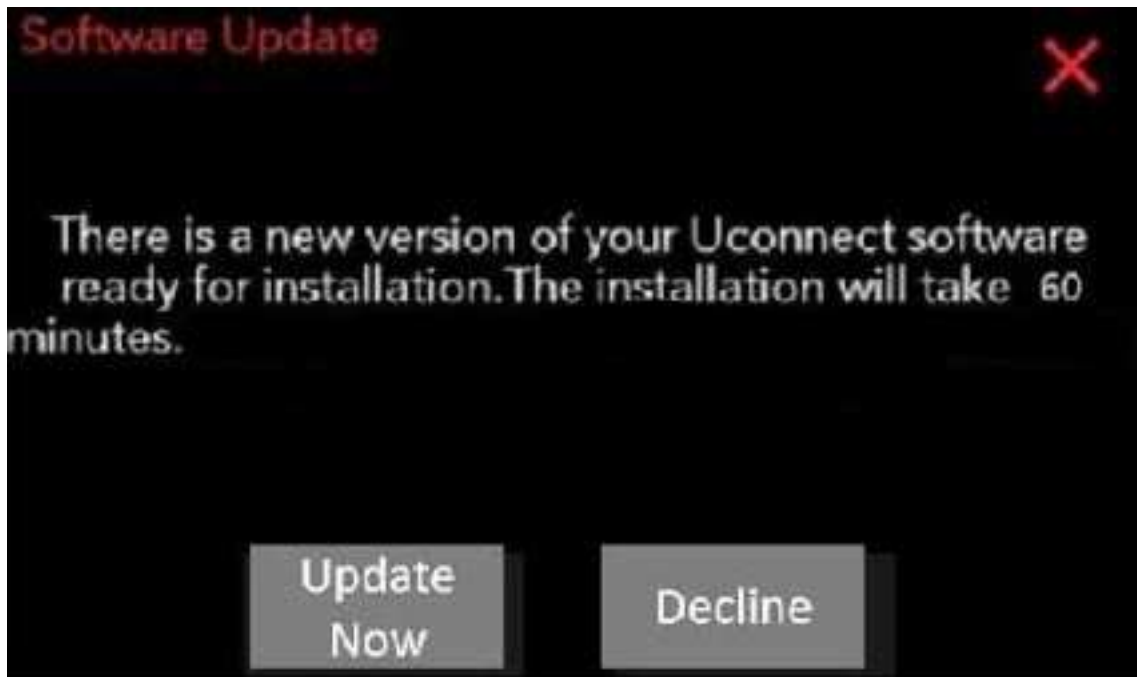
Fig. 7  
Software Update Is Available

13. Once the system has verified there is an available update, press the “Update Now” button. Make sure the vehicle is in park, **DO NOT** cycle the ignition off (Fig. 7) .

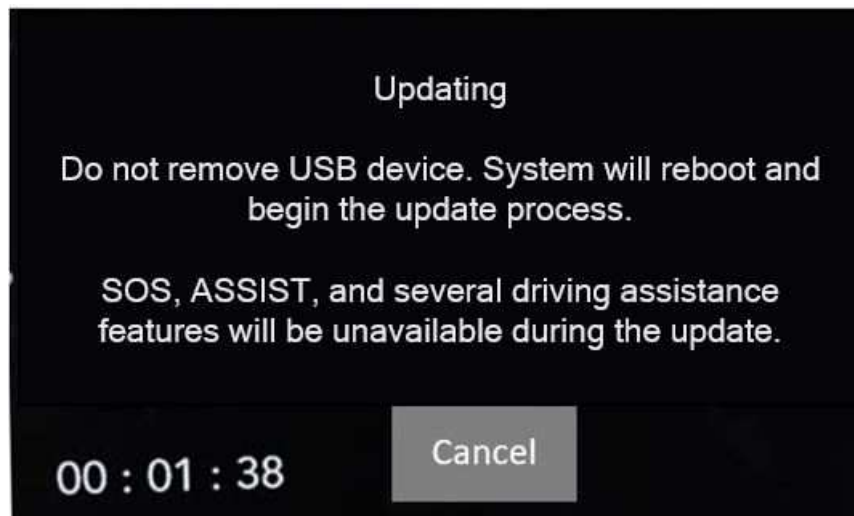
Fig. 8  
Updating Screen

14. When the radio starts updating, the screen in (Fig. 8) will be displayed.

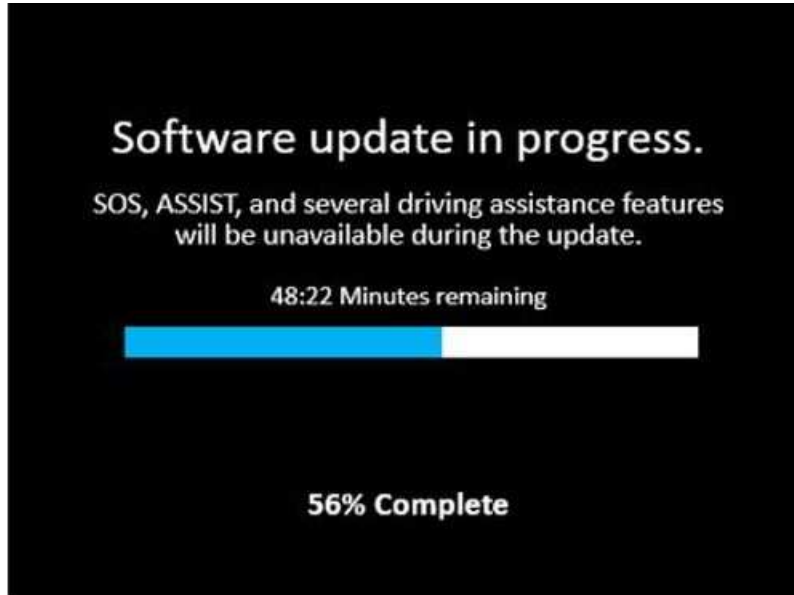
**NOTE: The completion indicator may not reach 100%, even though the software update has been completed. Once the software update has finished, the radio and display screen will turn off.**

Fig. 9  
Software Update In Progress

15. The radio will reboot and the update will begin. The update should only take 25 minutes, the timer on the screen any display the incorrect time remaining, (Fig. 9) .

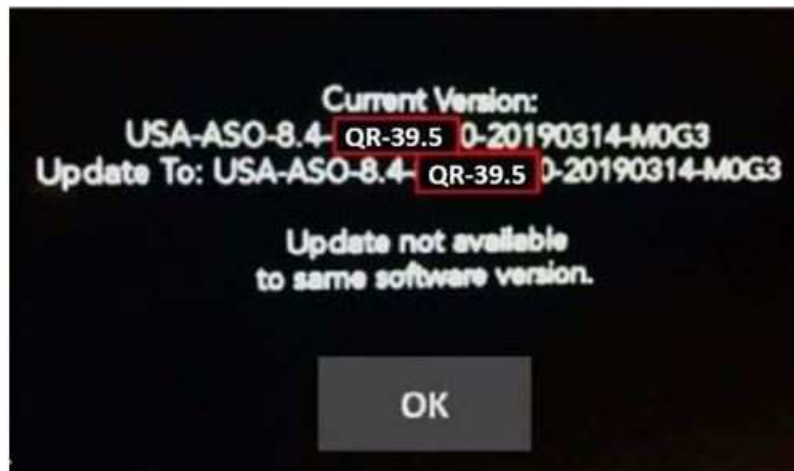
Fig. 10  
Radio Software Has Been Updated

16. After the update has completed, the radio will shut down. With the USB flash drive still inserted in the USB port, cycle the ignition back to the run position. If the radio software was updated correctly the “Current Version:” and the “Update To:” software levels in (Fig. 10) will display the identical software level. Press “OK” and remove the USB flash drive.
