NUMBER: 18-034-21 REV. A

GROUP: 18 - Vehicle Performance

DATE: November 10, 2021

P203E and P203F Additional Diagnostic Information

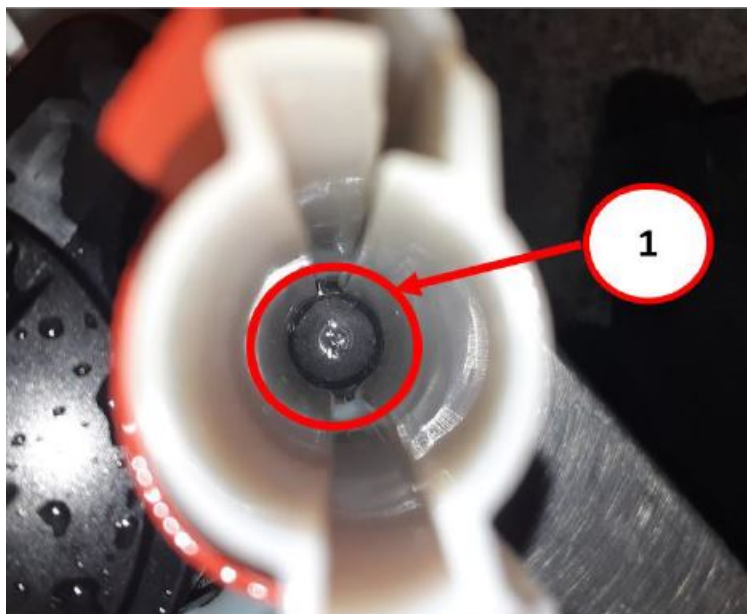
Fig. 1
DEF Pump Assembly

Another cause of P203E and P203F is residual ice in the DEF tank. Once ambient temperatures reach approximately 12°F (-11°C), the DEF fluid in the tank will freeze. The P203E diagnostic will not run if the DEF tank, and ambient temperatures stay below 39°F (4°C). However, as the ambient temperature warms up, and the tank begins to thaw, the DEF tank may not be completely thawed by the time the P203E DTC enabling criteria are met. If there is a residual layer of ice in the tank, the ice will cause the “no echo” condition setting P203E. Vehicles are especially susceptible to having residual ice in the tank, in areas where there is a large swing in temperatures (from extreme cold to warm), in a short period of time. Additionally, if ice is covering the sensor (Fig. 1) when the temperatures are too cold to run the P203E monitor, it could lead to P203F. Even if there is sufficient fluid level in the tank.

To correct this scenario, the DEF tank must be fully thawed out. Allow the vehicle to sit in a heated shop or garage overnight to thaw. If necessary, remove the DEF pump to drain the fluid, and remove all residual ice. Take care when removing the DEF pump to avoid damage to the pump, and heater mat. Once all the ice has been removed or thawed, follow the **P203E Drive Cycle** below.

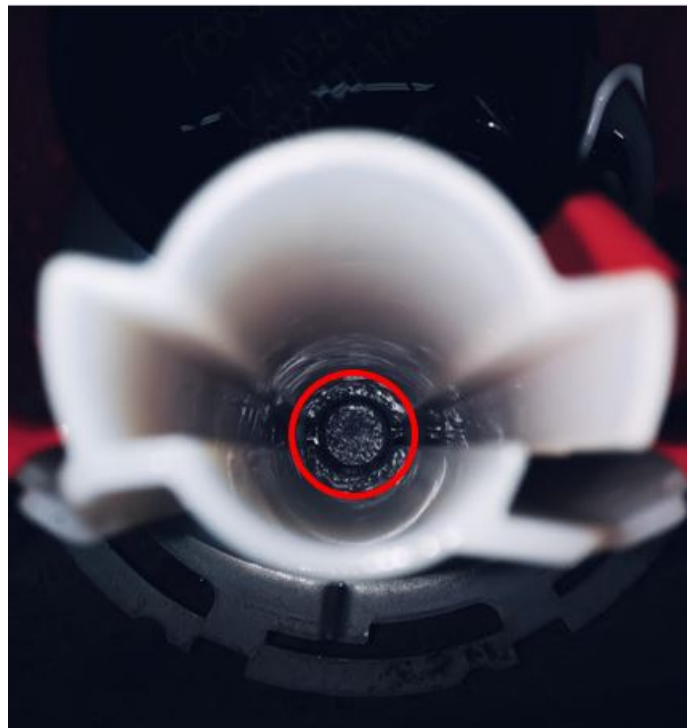
Fig. 2

Another cause of P203E and P203F is the DEF level sensor being covered in a layer or DEF crystals, or ice (Fig. 2) . Vehicles that are in extreme cold for long periods of time can start to have a buildup of DEF crystals on the bottom of the tank. When DEF tanks are completely frozen for long periods of time, evaporation will start to occur. This evaporation of the ice will leave DEF crystallization.

DEF Crystallization Buildup In Level Sensor Focus Tube

NOTE: Do NOT clean DEF system components using regular tap water. The mineral content in tap water can cause issues with the system. Only use fresh DEF fluid, or warm, distilled water to clean crystallization from the DEF components.

Unless the DEF fluid shows signs of contamination, crystallization that has formed in the tank, and on the pump components can be cleaned without having to replace any parts. Flush the tank, and clean the pump components using fresh DEF, or warm distilled water. In some instances, it may be necessary to remove the DEF tank, and agitate the fluid by shaking the tank. Thoroughly drain the DEF or distilled water used to clean the crystallization, and add fresh DEF. If P203E was set, follow the **P203E Drive Cycle** below.
