NUMBER: 08-172-21 REV. A

GROUP: 08 - Electrical

Radio Enhancements

This bulletin involves inspecting the software level and updating the software if needed. The software will be updated from S21.8 or S21B.5 to S21C.6.

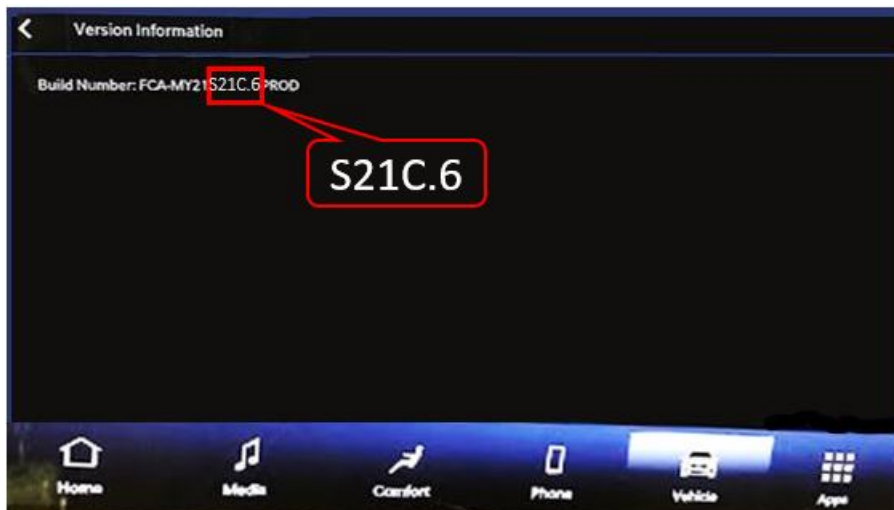
Fig. 1
Radio Software Level Screen

1. Verify the radio software version, by following these steps:
 - a. On the radio display screen go into "Vehicle Settings".
 - b. Select "System Information". The software level will be listed next to "Radio Version " (Fig. 1) .

2. Is the radio software level S21C.6 ?
 - YES >>> This bulletin has been completed. Use inspection LOP (18-60-02-V1) to close this active RRT.
 - NO >>> Proceed to [Step 1](#) of the Repair Procedure

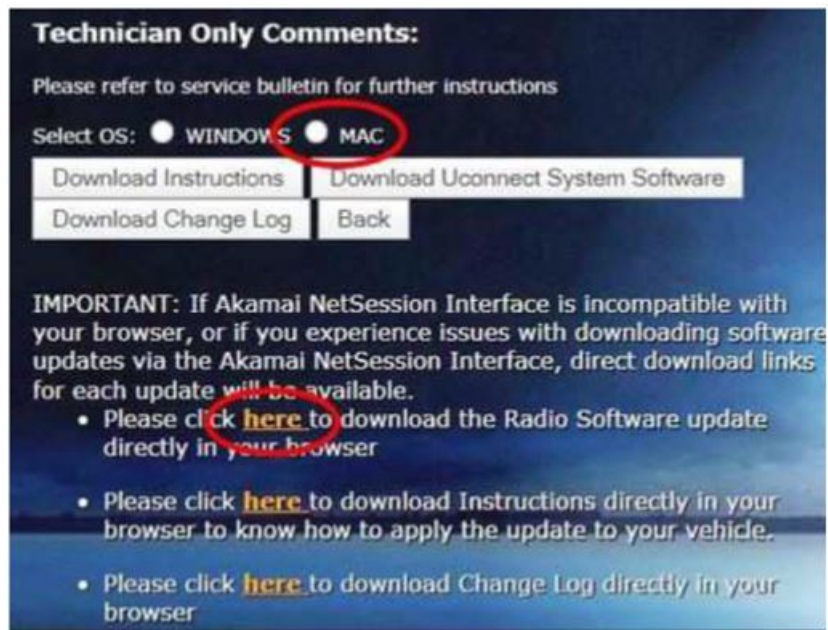
Fig. 3

MAC Download Steps

5. Download the software update file to your local PC's desktop. Make sure to select the "MAC" radial button for all downloads (Fig. 3) .

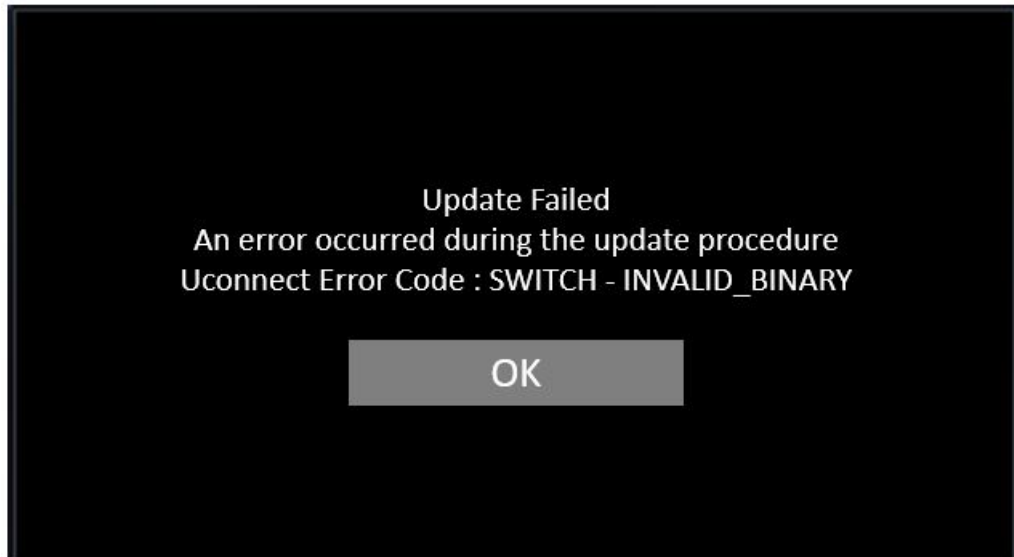
Fig. 6
Error Message

13. The radio will reboot and the update will begin. The update should only take 15 minutes.
14. **Do Not** turn off the ignition at this point. The update is still in process, wait until the radio restarts and the home screen is displayed. This should take around five minutes
15. Sometimes the radio will display an error pop up “ Invalid_Binary_Switch “ after successful radio update. Please ignore this error message and press “OK” to continue (Fig. 6) .
