NUMBER: 23-038-21

Loose 6.2L Supercharged Emblem Adhesion to The Hood Bezel

2021 (DT) RAM 1500 Pickup

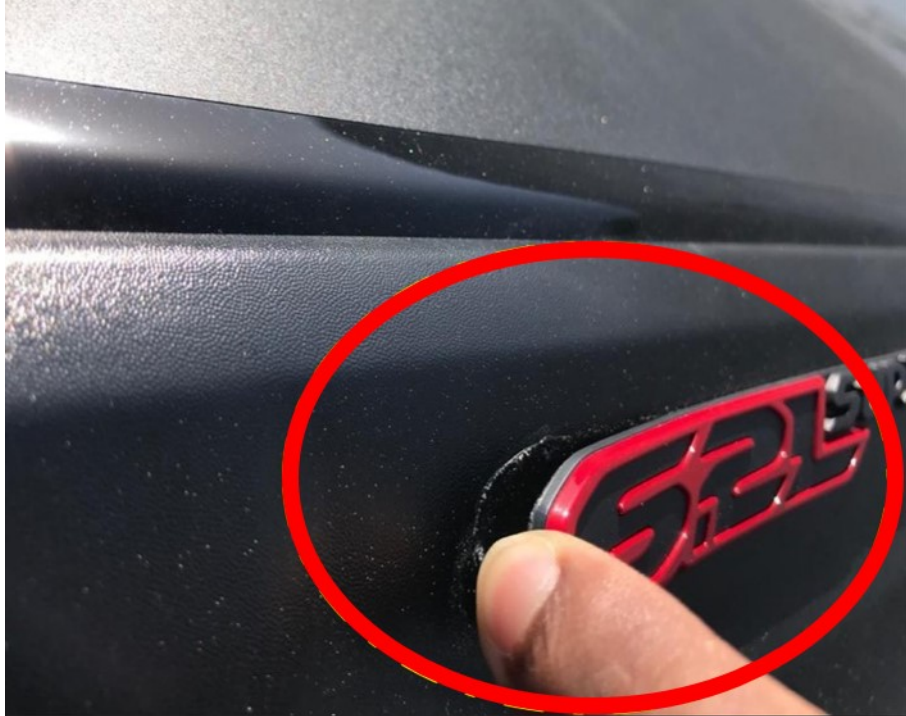
Fig. 1
Loose Emblem

The 6.2L Supercharged emblem(s) may separate from the hood bezel due to insufficient adhesive bond strength.

1. If one or both emblems show signs of visible separation at the bezel, the emblem(s) will need to be replaced (Fig. 1) .
2. Was any separation found on either of the emblems?
 - YES>>> Replace both emblem(s) if they show signs of separation (Fig. 1) . Proceed to Step 3.
 - NO>>> Both emblems were visually inspected and no separation was found. This bulletin has been completed. Use Inspection LOP (23-03-08-9P) to close the active RRT.
