NUMBER: 02-006-21

GROUP: 02 - Front Suspension

Front Shock Oil Weepage

2021 - 2022 (DT) RAM 1500 Pickup

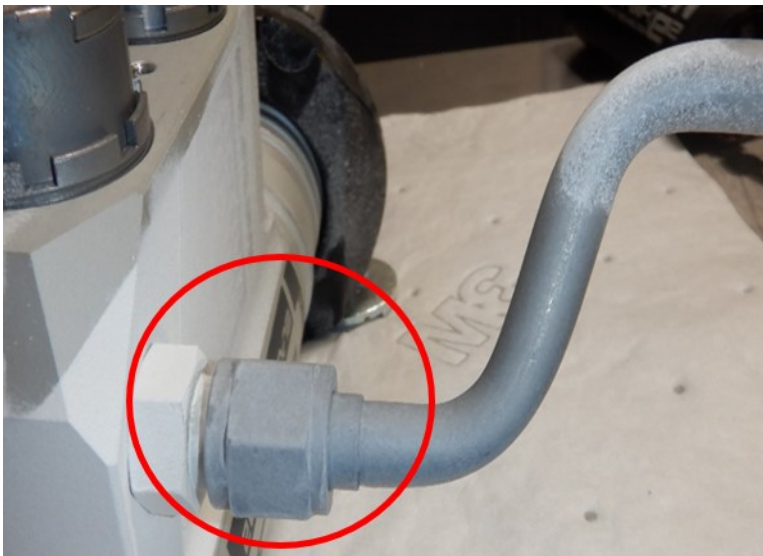
**Fig. 2****S-Fitting**

- Oil from the shock fitting is seen on or around the shock fitting area, this may not leak or be seen on the ground where the vehicle is parked.

3. Tighten the S-fittings on both front shocks to 60 N·m (44 ft. lbs) (Fig. 2) .
