NUMBER: 08-003-21 REV. A

Improved Steering Feel

2018 - 2020	(JL)	Jeep Wrangler
2020	(JT)	Jeep Gladiator

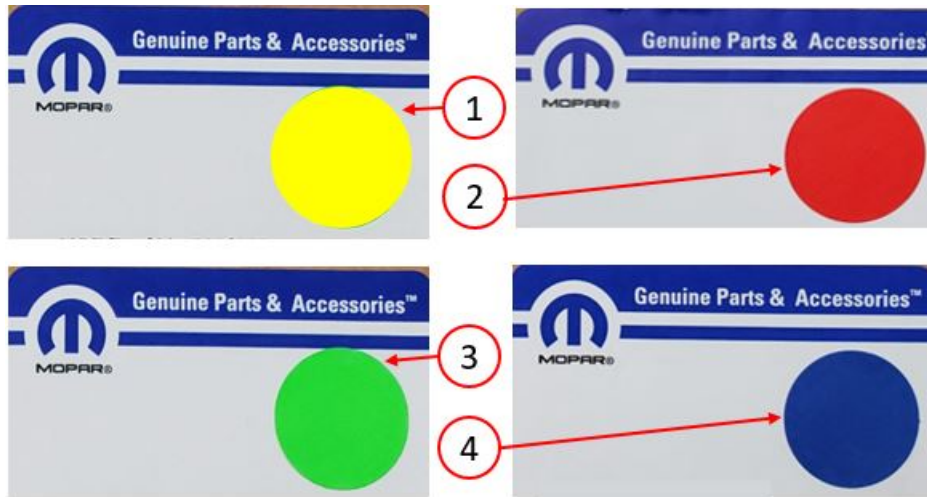
Fig. 1

The Steering Gear Parts Label Has A Color Dot On It To Help Confirm The Correct Steering Gear Was Ordered

- 1 - Yellow Dot, 68507576AA (JT Left Hand Drive (LHD))
- 2 - Red Dot, 68507569AA (JL 4 Door LHD, **W/O EXJ 3.0 Diesel**)
- 3 - Green Dot, 68507574AA (JL 4 Door LHD, **With EXJ 3.0 Diesel**)
- 4 - Blue Dot, 68507571AA (JL 2 Door LHD)
