# Technical Service Bulletin

| <b>Technical Service Bulletin:</b> TSB210225 | <b>Released Date:</b> 15-Oct-2021 |
| <b>Rocker Lever Cover Interference Causing Injector Circuit Fault Codes: 322, 332, and 325</b> | |

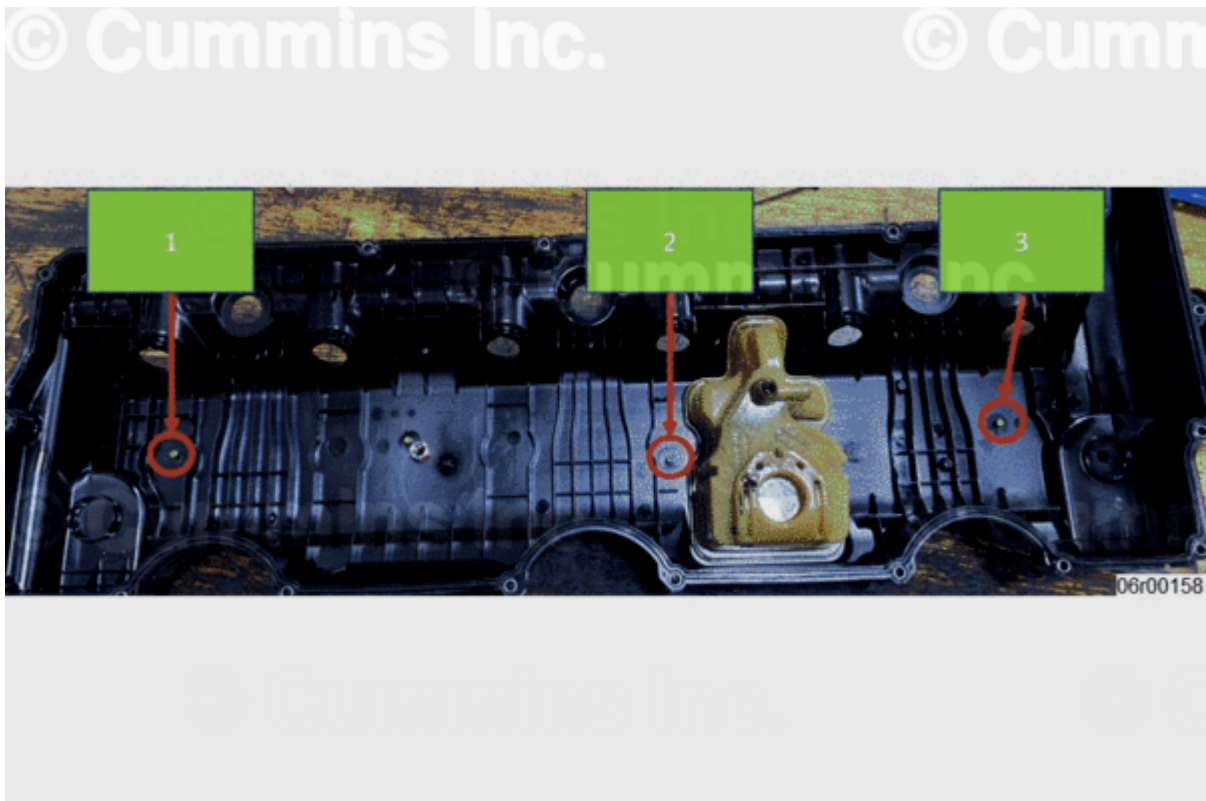
- Inside the rocker lever cover there is a potential for “nubs” made of excess flash from the injection molding process that can interfere with the injectors or injector wiring harness. This interference can lead to injector fault codes. See Figure 1 below for the location of the nubs.

Figure 1, Interference Locations 1, 2, and 3

1. Is near cylinder 1
2. Is near cylinder 4
3. Is near cylinder 6

- If the rocker lever cover is coming in contact with an injector or the injector wiring harness, remove all the nubs on the rocker lever cover.
- Preferred method of removal is cutting the nubs off as flush to the surface of the rocker lever cover as possible with end cutters and to avoid creating any kind of small debris that could get into the overhead system.
- If debris is generated from the removal process, verify that the rocker lever cover is thoroughly cleaned before installing on the engine.

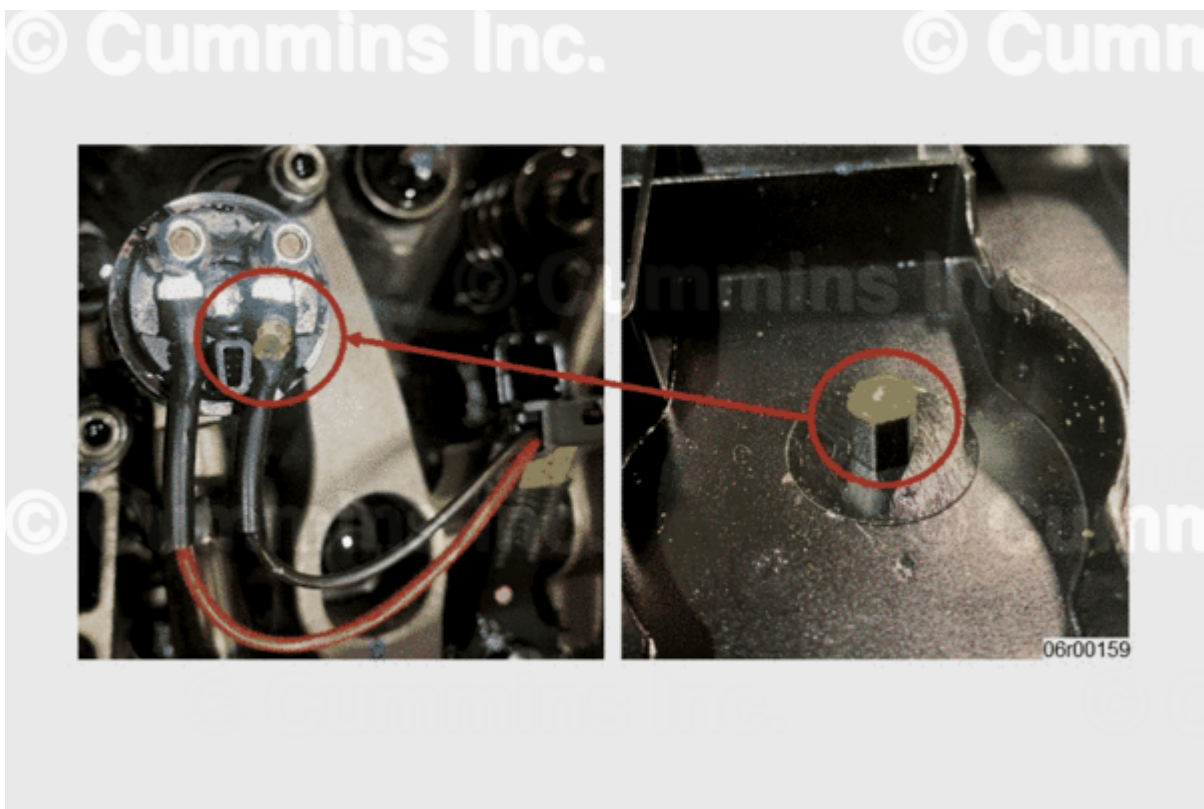
Figure 2, Evidence of Paint on Injector Wire Caused by Interference with Nub on Rocker Lever Cover.

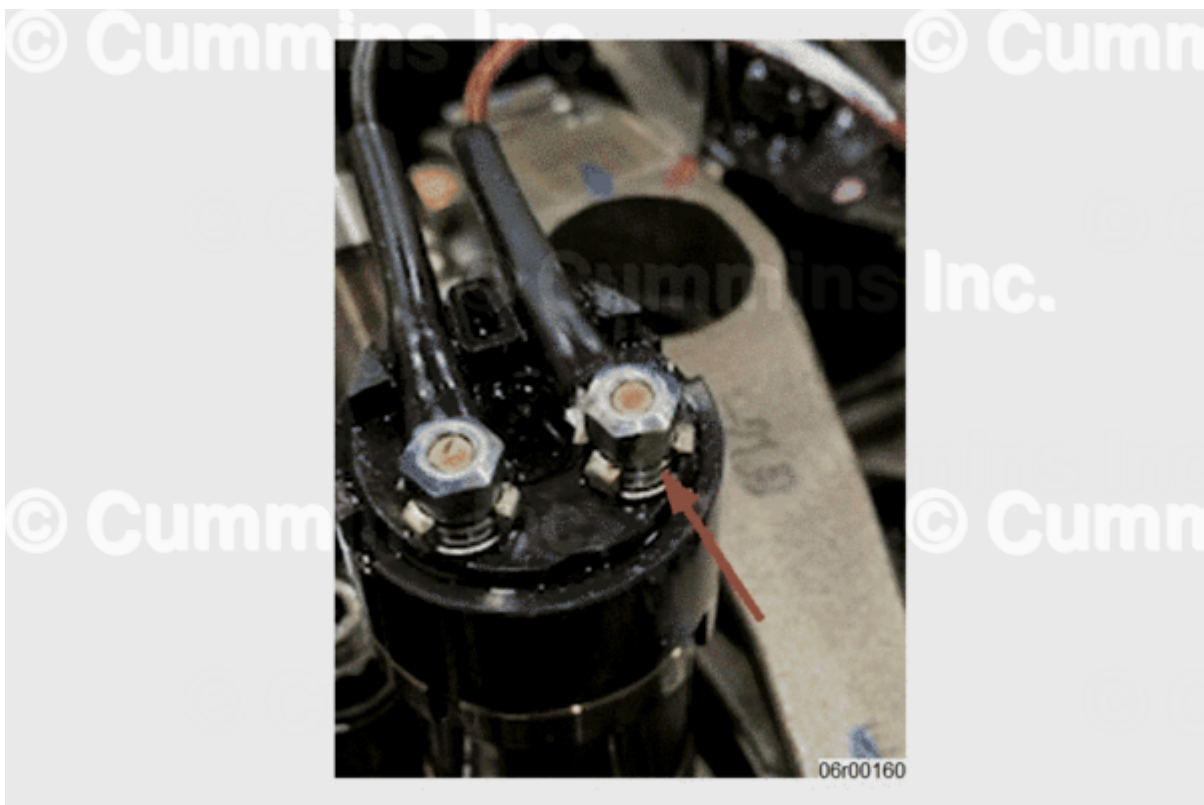
Figure 3, Evidence of Paint on Injector Nut Caused by Interference with Nub on Rocker Lever Cover.
