Technical Service Bulletin: TSB210032	Released Date: 08-Nov-2021
Intake Air Heater Stuck Relay and Intake Air Heater Damage: Fault Code 383

- ISB6.7 CM2350 B101
- B6.7 CM2350 B121B
- B6.7 CM2450 B155B

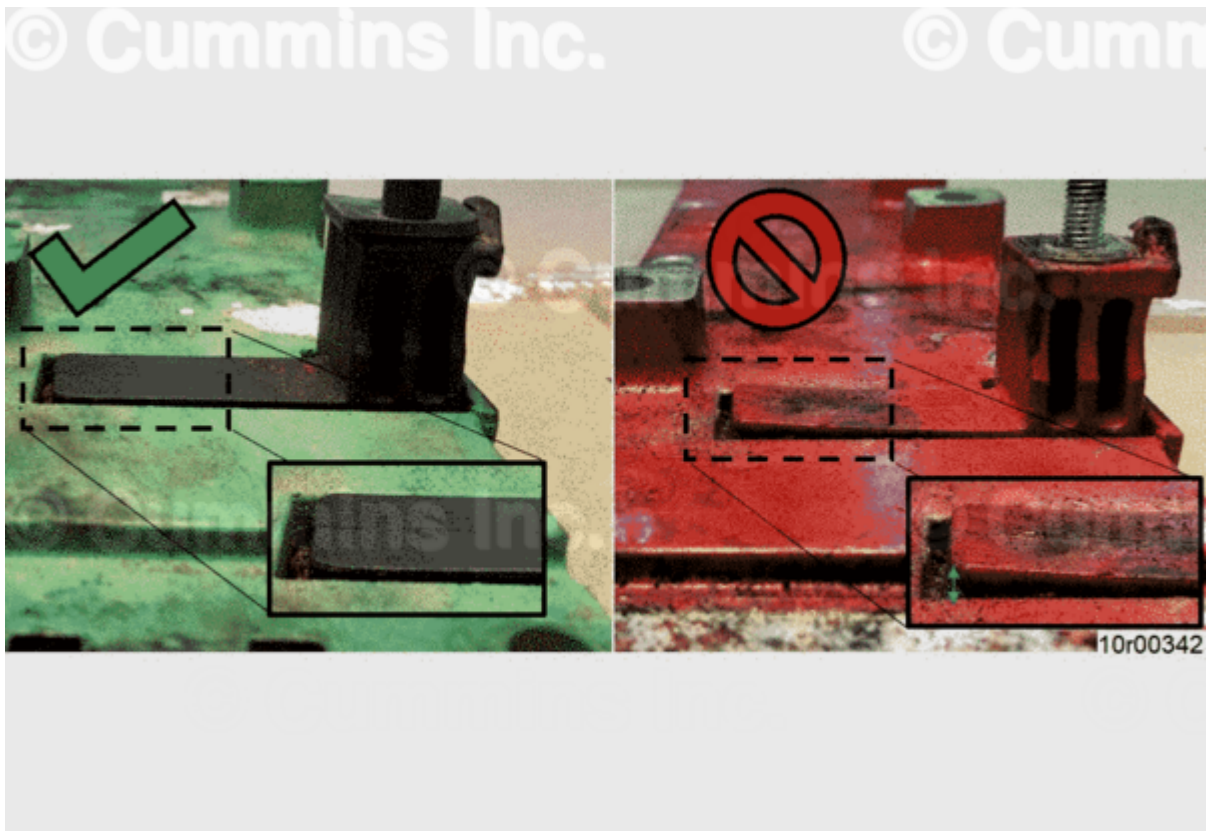
- Intake air heater relay stuck closed leading to extended on-time of the heater. Units experiencing Fault Code 383 may have experienced extended on-time of the intake air heater with no air flow entering the system caused by a stuck relay, causing the air heater to overheat. The isolated power connection bar may expand and lift from the top surface of the intake manifold cover due to extended on-time (Figure 1). The isolated power connection bar may also become loose. The issue may progress and exhibit electrical arcing damage to the intake air heater internal joints (Figure 2), with potential for arcing to cause debris to drop into the intake system.

Figure 1, Example View of Power Bar Deformation from Top Surface of Intake Manifold Cover.

- Intake air heater damage that exhibits power connection bar deformation or movement of the terminal back and forth is due to intake air heater relay failure and is **not** covered under Cummins ® warranty. Repair locations are to contact the OEM for further repair direction.
- For Navistar® and IC Bus applications reference iKnow article IK1201457.
- Inspect intake ports for debris from grid heater arcing damage. See corresponding Service Manual. Reference Procedure 010-023 in Section 10.
- If misfire fault code is active, inspect the cylinder for damage.

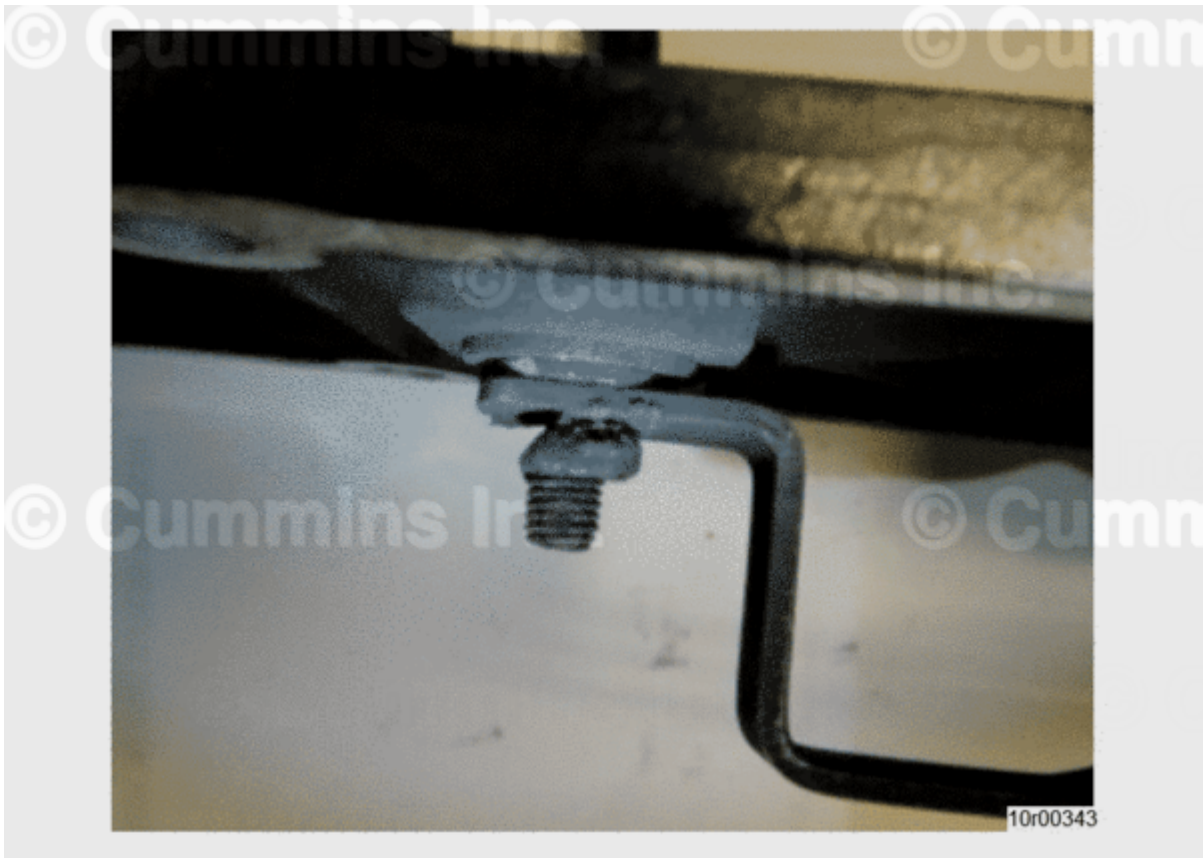
Figure 2, Example of Arcing Damage on Internal Joints of Intake Air Heater.

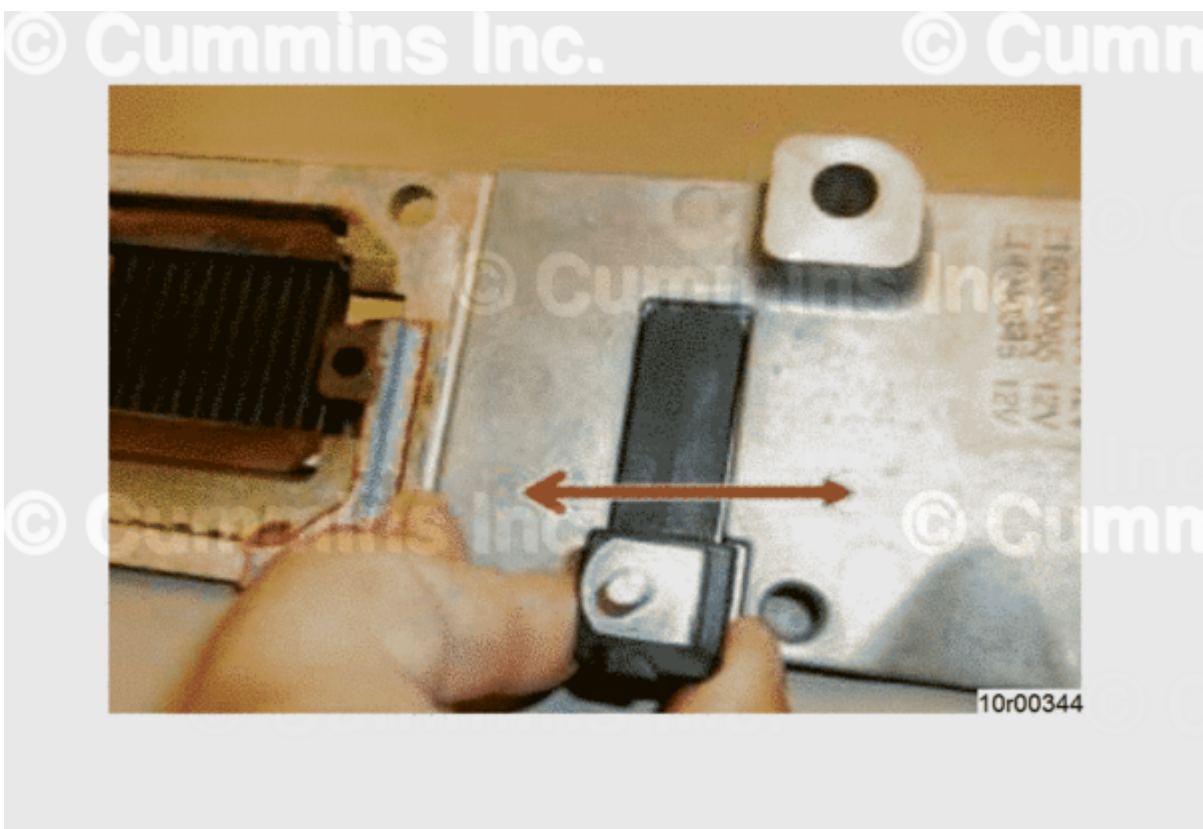
Figure 3, Any Movement of The Terminal Back and Forth As Shown is Unacceptable.
