| <b>Technical Service Bulletin:</b> TSB210239 | <b>Released Date:</b> 11-Nov-2021 |
| <b>External Coolant Leak from Base Coolant Fitting: DTNA Chassis</b> | |

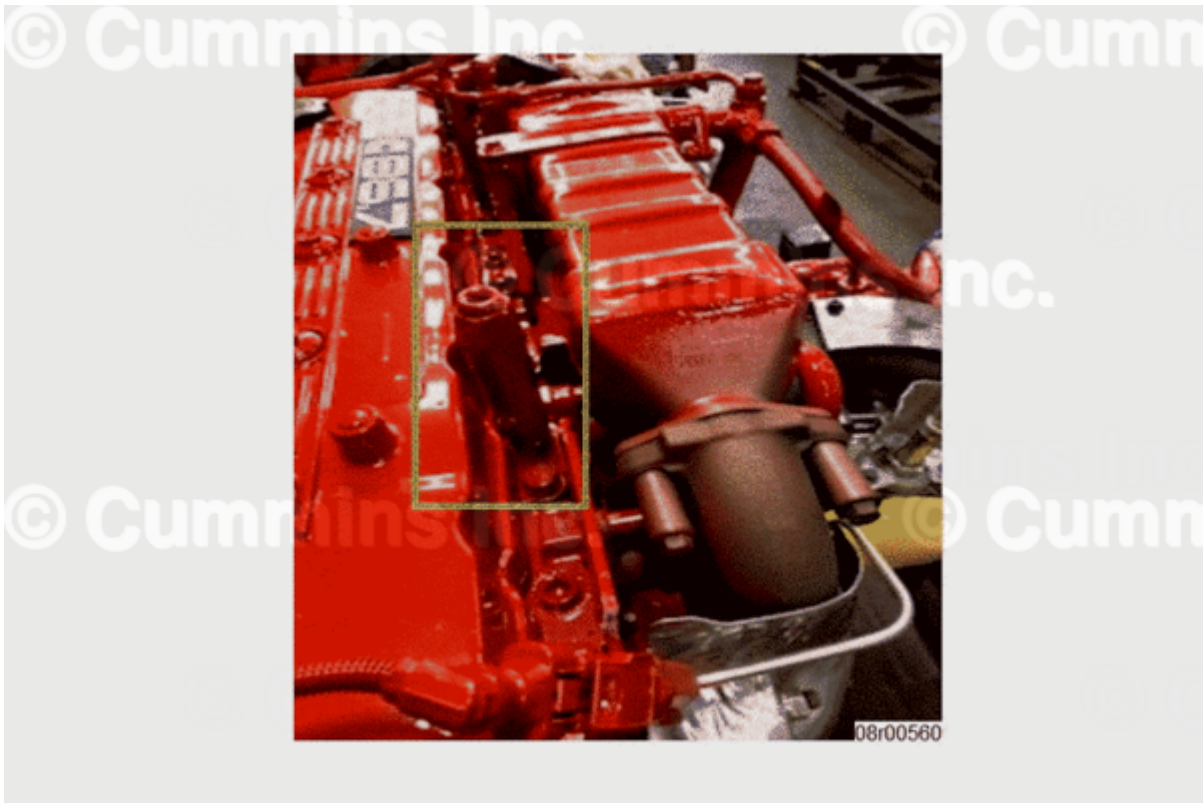
- Confirm source of coolant leak is at base coolant fitting, Part Number 5264222, at connection to cylinder head.
- Confirm engine build date is prior to 6 August 2021.

Figure 1, Base Coolant Fitting, Part Number 5264222.

- Apply thread sealant to base coolant fitting, Part Number 5264222, and re-torque. See corresponding Service Manual. Reference Procedure 017-007 in Section 17.
- This issue is unique to DTNA chassis. All claims for the issue outlined in this document are to be filed through DTNA.

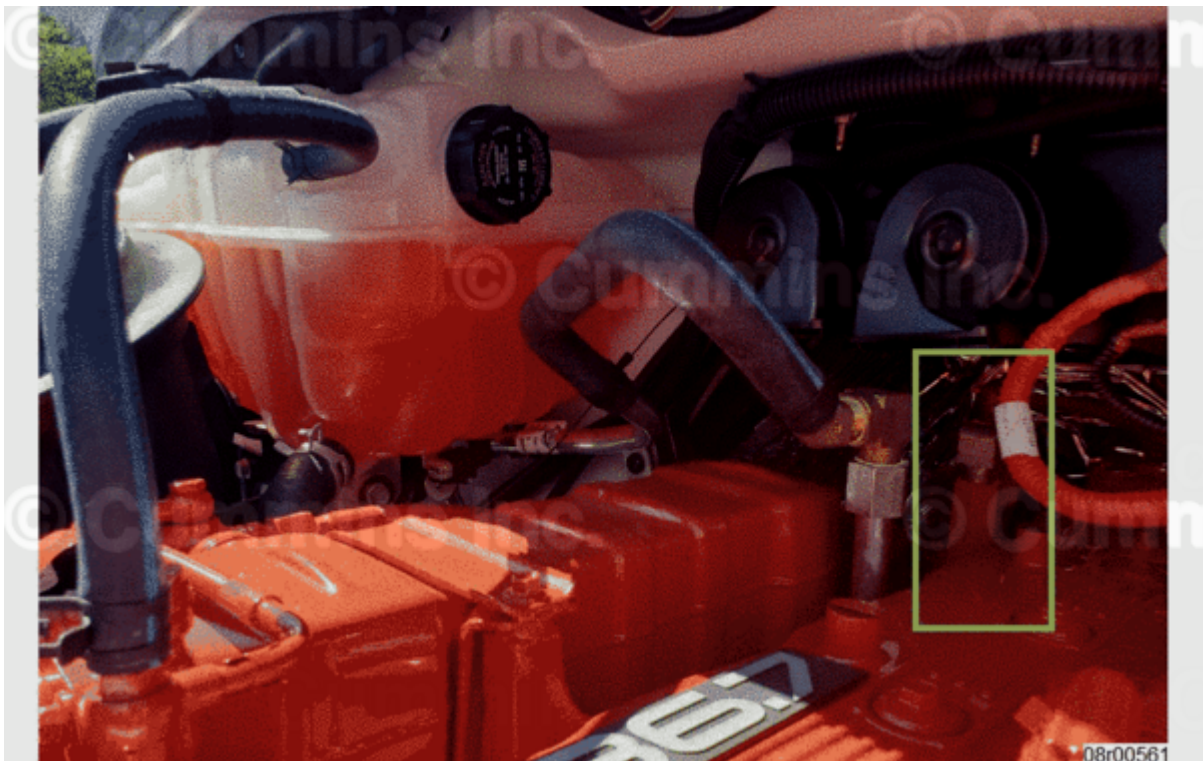
Figure 2, Base Coolant Fitting, Part Number 5264222.
