# Preliminary Information

## PIP5826A MIL illuminated with DTC P0521

### Models

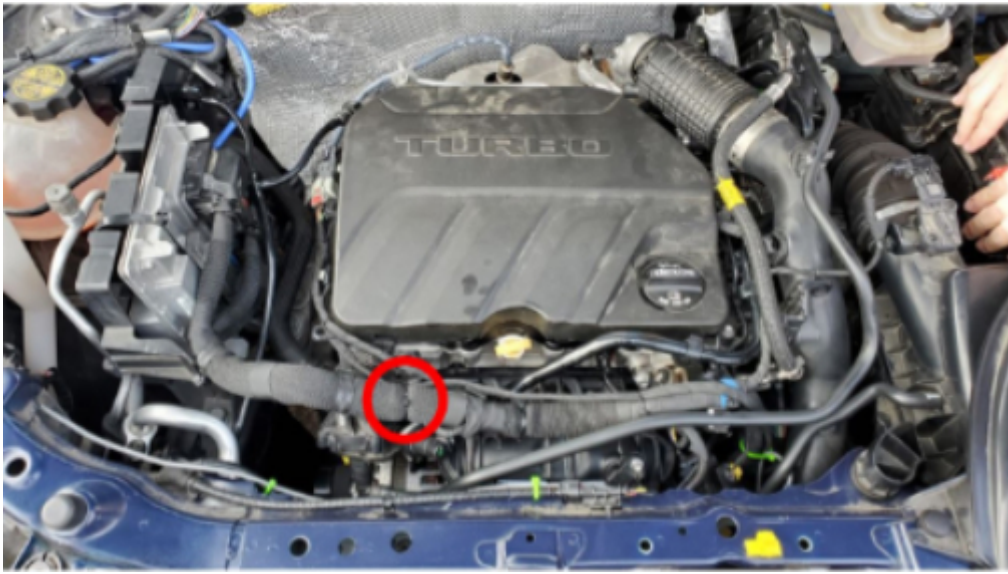
Once you have duplicated the engine oil pressure showing above 0.0 PSI, open the hood and slightly bend the harness back and forth at the circled location shown below while monitoring for a pressure change.

A change in the engine oil pressure sensor reading either up or down in PSI, isolates the issue to the Special Splice in this location of the main engine wiring harness.

A high resistance splice in the main engine wiring harness above the EVAP Purge Pump, may cause the P0521 to set.

There is an additional three wire special splice that has been added to the Low Reference circuit 548 BK/GN.

This three wire special splice is located in the main branch of the engine wiring harness above the EVAP Purge Pump Assembly as shown above.

Open the engine wiring harness in the location circled above to access the three wire special splice for Low Reference circuit 548 BK/GN.

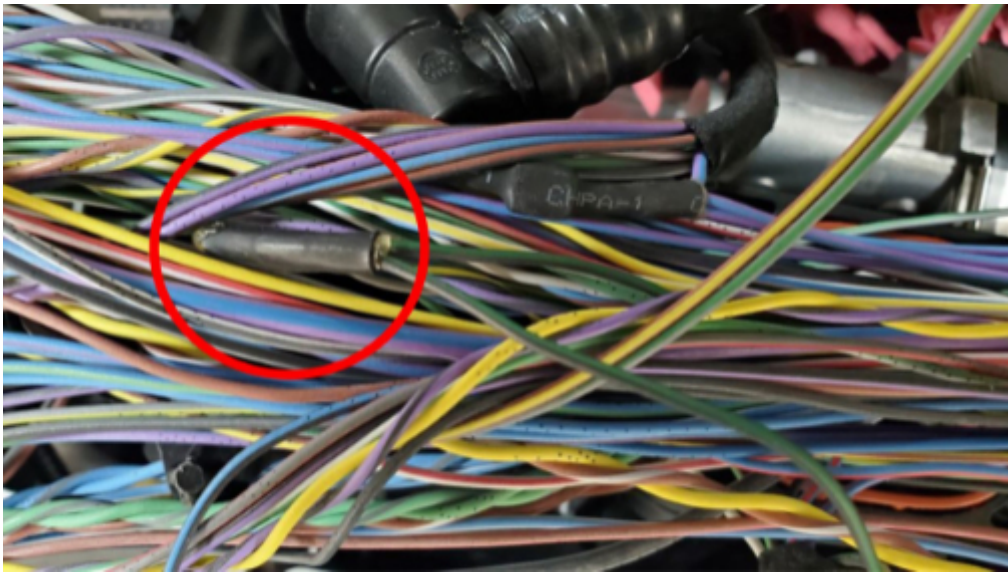
Remove the Heat Shrink and splice clip to expose all three legs of the special splice.

Inspect each leg for broken wire strands and correct any issues.

Slide the appropriate size heat shrink tube up one branch of the circuit.

Install a new splice clip, solder the three legs, and cover with the heat shrink.
