# Preliminary Information

## PIP5812C Diagnostic Tip: Potential For Oil/Moisture Condensate Freezing Up in Turbocharger Wastegate Regulator Solenoid Valve (TCV)

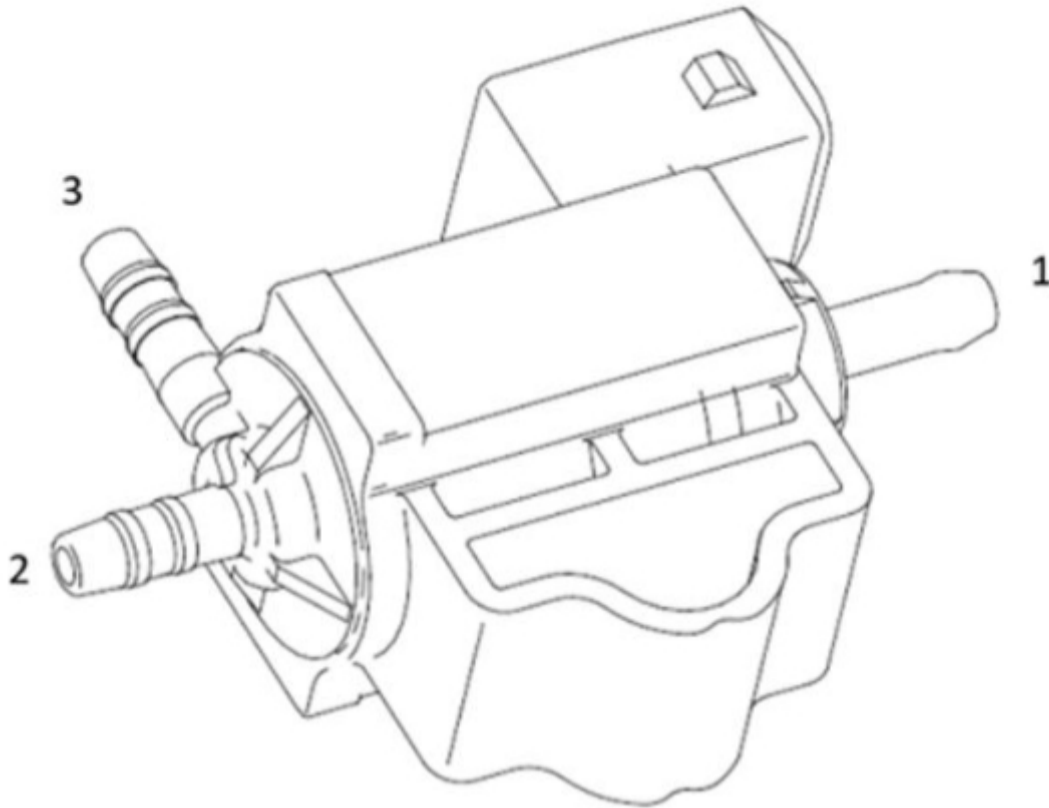
<b>Involved Region or Country:</b>	<b>North America, Argentina, Brazil, Colombia, Ecuador, Paraguay, Uruguay, Israel, Palestine, Middle East, Israel, Chile, Peru, China, Thailand, Australia, New Zealand, Egypt, Africa</b>
<b>Condition:</b>	<b>Possible DTC P0234 P0299 that can occur during cold weather driving.</b>
<b>Cause:</b>	<b>Oil/moisture condensate freezing up in Turbocharger Wastegate Regulator Solenoid Valve (TCV).</b>

**Note: Check port #2 to assure the spring gets lifted off the seat. This will be determined by the compressed air not dead-heading when applied to port #2. When applying air to this port a small amount of air should be observed at port #3 and even less air will be noticed at port #1. If this does not happen, the TCV plunger may have hardened deposits from hot operating conditions which will impede TCV plunger movement and the Turbocharger Wastegate Regulator Solenoid Valve should be replaced.**

1. **Remove Turbocharger Wastegate Regulator Solenoid Valve**
2. **Drain Turbocharger Wastegate Regulator Solenoid Valve (TCV) by turning valve upside down.**
3. **Using clean shop air regulated to 15-20 PSI (103kPa), blow through all three ports (1, 2 &3) for 5 seconds each. Repeat twice.**

**4. Reinstall Turbocharger Wastegate Solenoid Valve (TCV) using the latest service information and clear all DTC's using GDS and evaluate.**
