Preliminary Information

PIP5762B 3.0L LM2 Diesel With Possible Oil Consumption, With or Without DTC P06DD

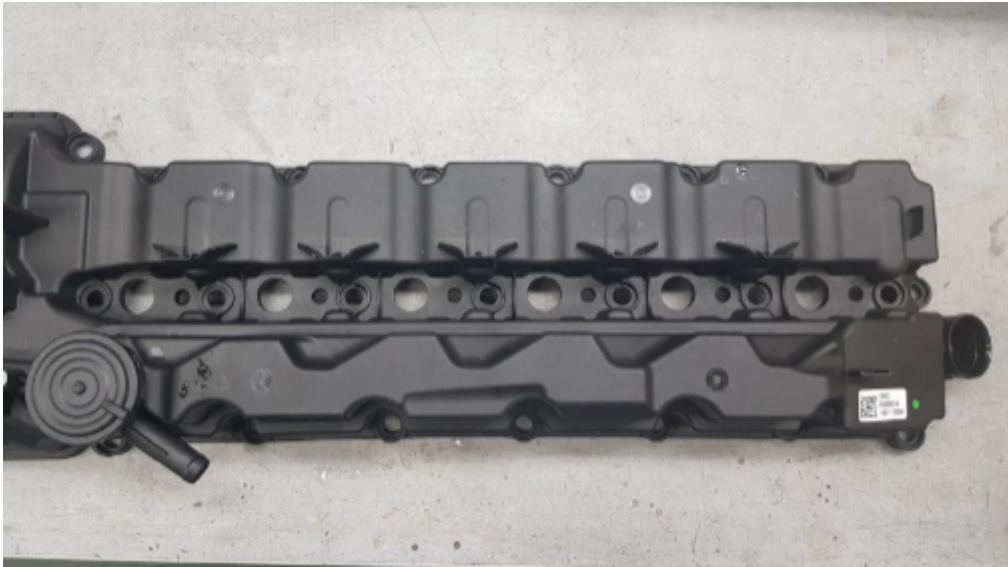
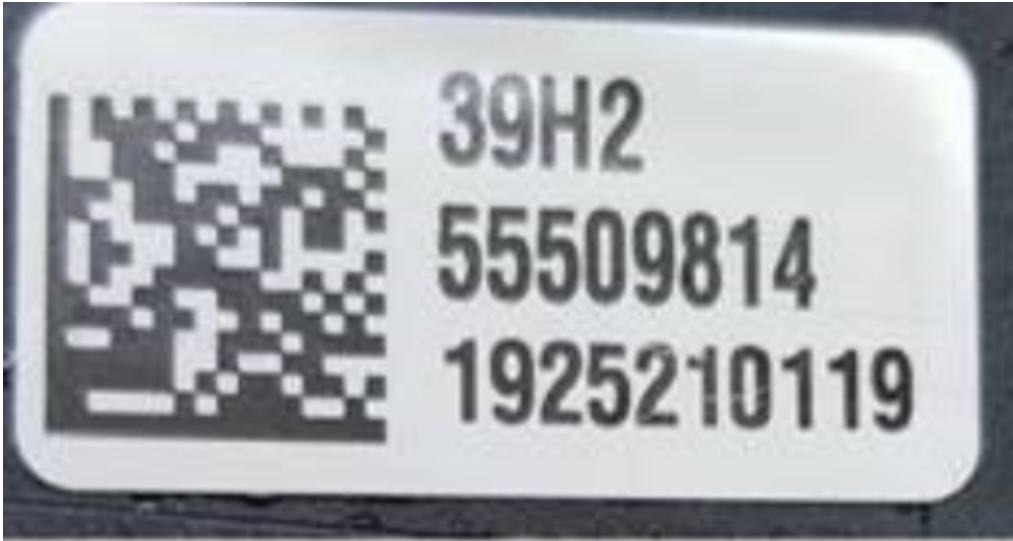
Involved Region or Country	North America
Condition	A customer may have a concern with oil consumption. The technician may find DTC P06DD set.
Cause	Camshaft housing (cover) may have a baffle plate weld that is not adequate.

Inspect the cam cover label for Julian dates and daily progressive number starting from 39H219 249 1 0098 through 39H219 253 1 0037.

If the serial number is from 39H219 [249](#) 1 [0098](#) through 39H219 [253](#) 1 [0037](#) and the customer's concern is oil consumption:

- 1) Replace the camshaft housing cover.
- 2) Replace the #2 glow plug.
