Preliminary Information

PIT5868 Poor Heater Performance On Drivers Side

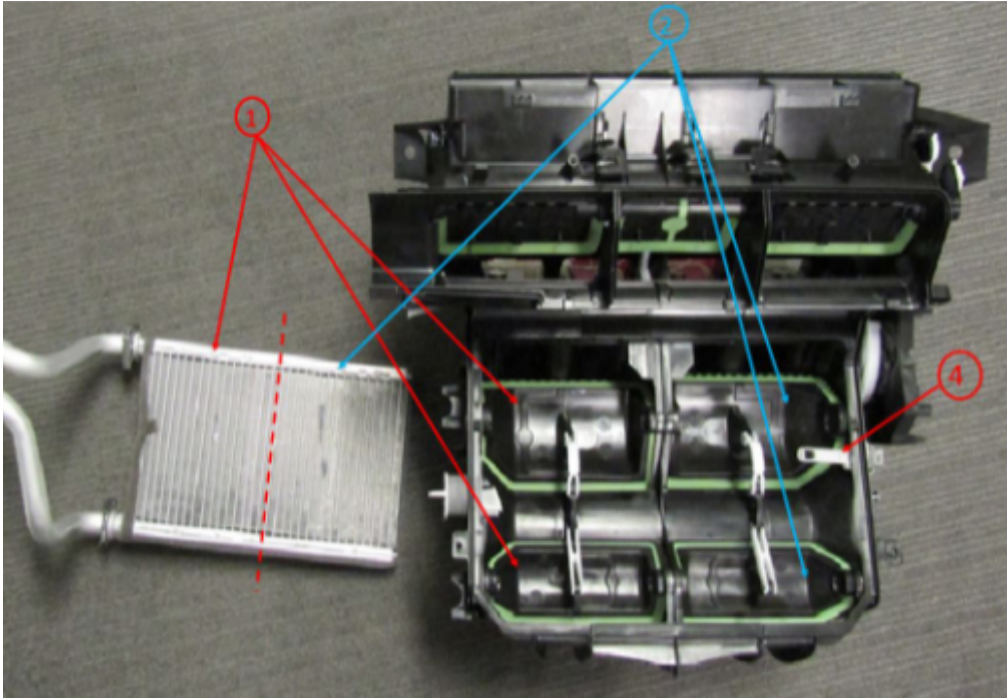
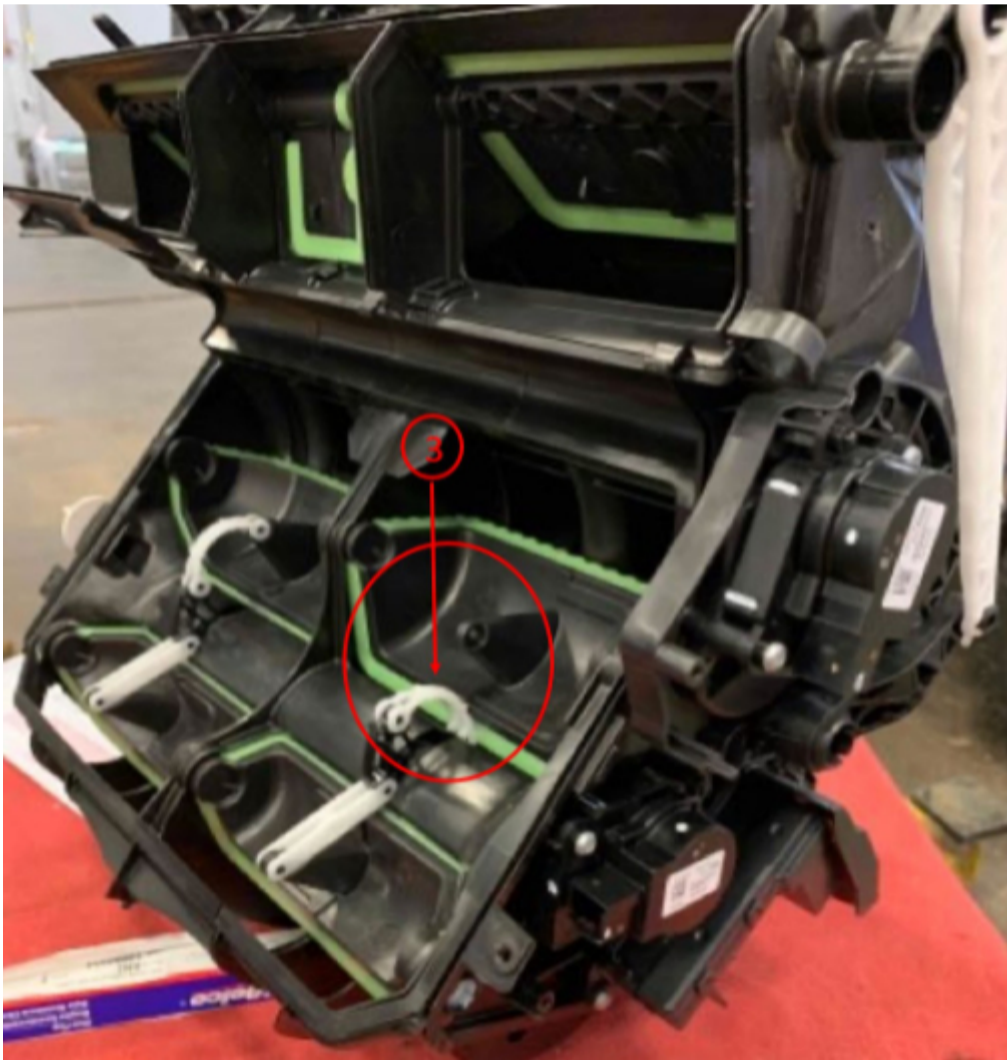
Involved Region or Country	North America
Condition	Some customers may comment on lower heater performance from the driver side HVAC vents when compared to the passenger side. In some cases, the driver side center dash vent will have the lowest temperature.
Cause	<p>The cause of this condition could be one of the following:</p> <p>Cause 1: The heater core may have become plugged. When the heater core begins to plug, it affects the driver side center vent first.</p> <p>Cause 2: Both single and dual zone HVAC cases utilize two temperature doors per side (a total of four doors), shown below. In the photo below, call-out 1 shows the passenger side temperature doors and heater core. Call-out 2 show the driver side temperature doors and heater core. Call-out 4 shows the evaporator air temperature sensor location in relation to the driver side temperature door which will be helpful later in this document. Inside the HVAC case, there are four white links which connect each of the four temperature doors. In some cases, one of these white links can become disconnected inside the HVAC case, as shown below (3).</p>
