Preliminary Information

PIT5866A Multiple Radio Inoperable Issues – IOK Radio

Models

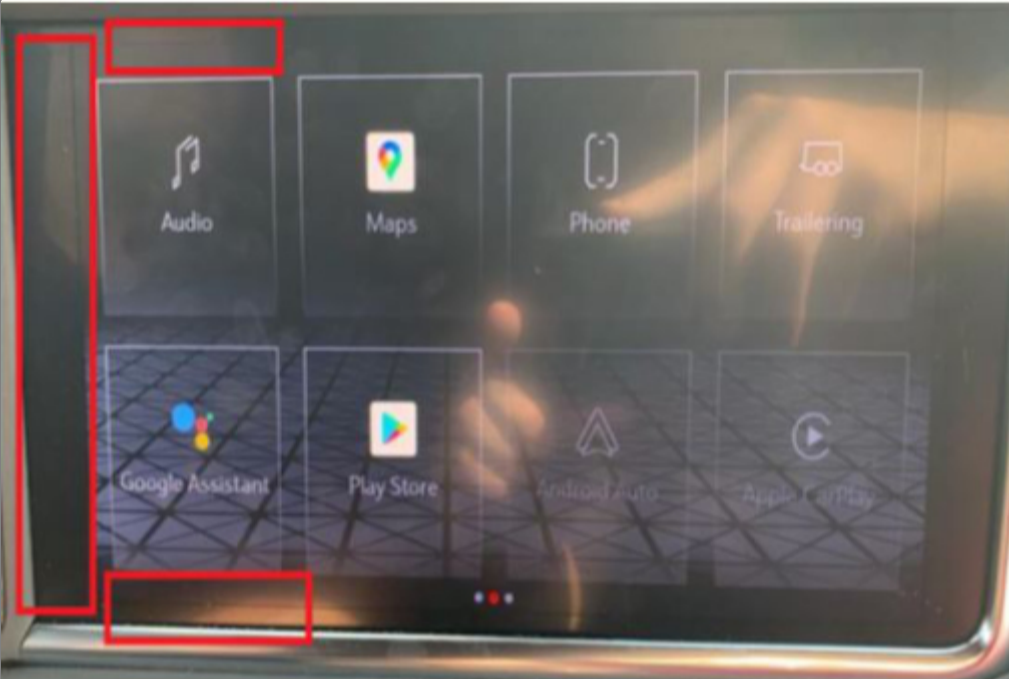
EX. Defect

1. **That the home screen bar is missing on the left side of the display.**

Cause	Condition is occurring in W160.4 software and reason is unknown at this time. Engineering is aware of the issue and is working on a fix.
--------------	---

While engineering is working on a permanent solution, dealers should not replace the radio. Dealers are to consult with T AC on issue and request the Data Wipe package file from the OneDrive site.
