BULLETIN NUMBER:  
**IB14-J-002B**

## **OIL IN THE INTAKE – TURBOCHARGER INSPECTION**

- 2011MY – Current Isuzu N-Series Diesel Vehicles  
Equipped with Diesel Particulate Filter (DPF)
- 2018 – 2021 Isuzu F-Series

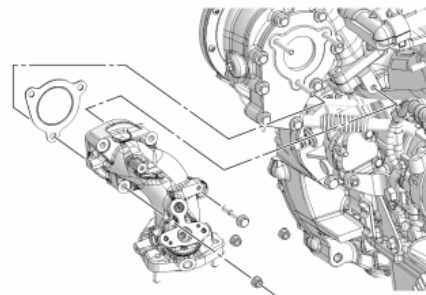
LNWC18SH021501

Remove the air hose, the turbocharger inlet pipe and the exhaust adapter from the compressor. Using an inspection light, inspect the compressor and turbine wheels for evidence of foreign object damage. If one or both of the wheels are damaged, a foreign object(s) has probably entered through the intake or exhaust system. Be sure to identify the origin of the foreign object, as foreign objects tend to enter the system as a result of human error or deteriorated engine/intake systems. Repair the source of the foreign object’s entry and replace the turbocharger assembly. If **NO** damage is found, inspect the radial and axial shaft play.

1. Air Hose
2. Turbocharger Inlet Pipe

Exhaust Adapter
