**East Manufacturing Corporation**

**TECHNICAL BULLETIN 21-02**

Composilite EXF Lift Axle Hanger Inspection

SUBJECT: Lift Axle Weld Cracks

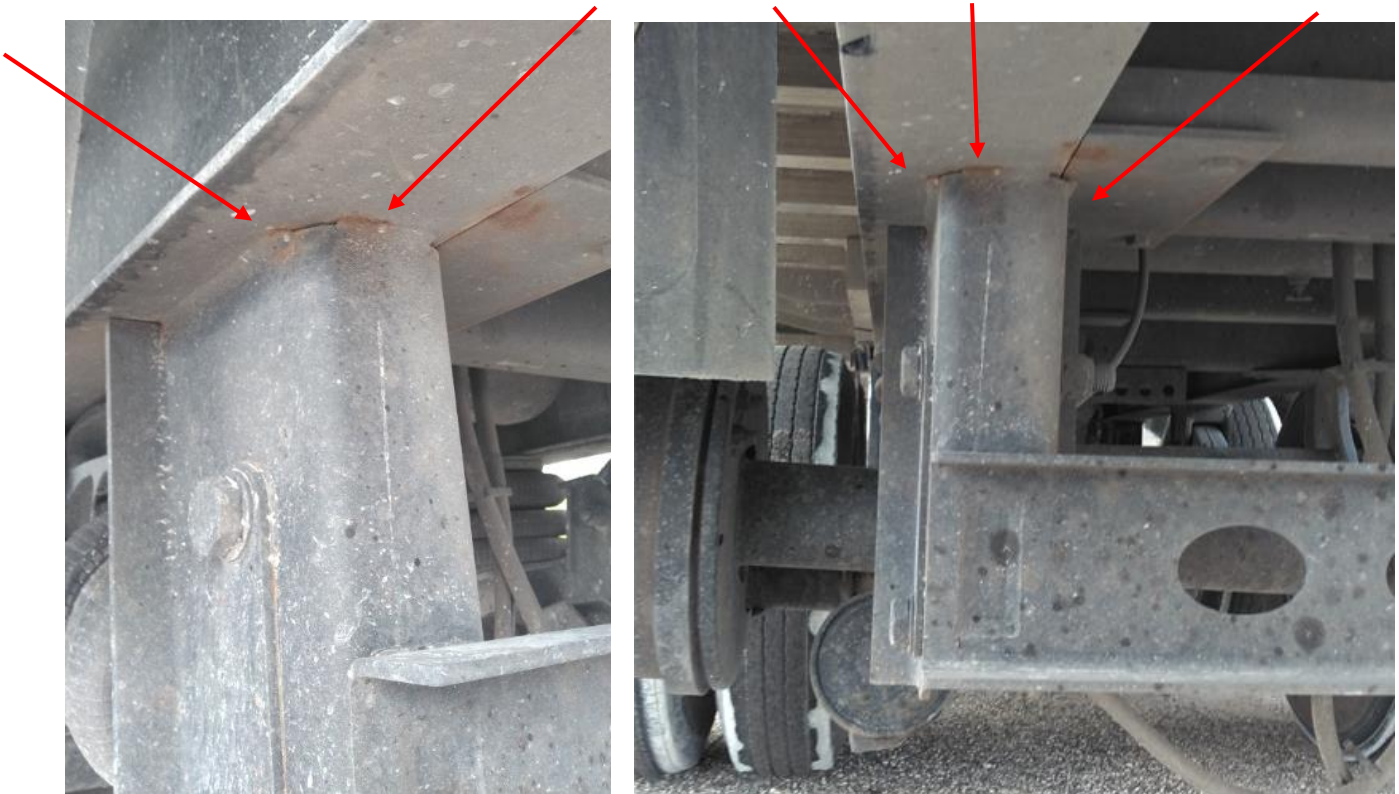
It is possible for the welds to crack around the front side of the lift axle suspension hangers where they are welded to the bottom of the frame flange and mounting plate. If the weld cracks are not caught during **normal monthly inspections** and maintenance, the cracks can propagate into a larger problem and premature wear.
