## Service Bulletin 590

### Issue 1 - 10.2021

#### Subject: Re-torque Engine Cover Bolts

| Bulletin Number | Models Affected | VIN Range | | Markets Affected |
|---|---|---|---|---|
| 590 | Speed Triple 1200 RS | From AD2117 | AW0999 | All |

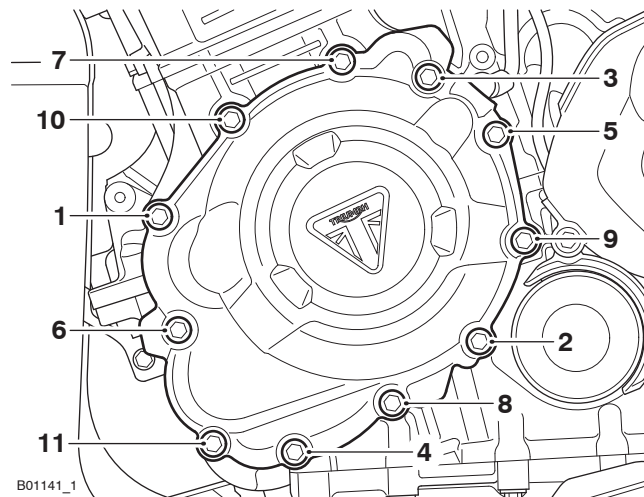
Alternator Cover Tightening Sequence

Internal investigations have identified the alternator, clutch, crank & balancer cover fixings must be re-torqued as described in the procedure below.

1. Tighten fixings one to eleven in the sequence shown to **10 Nm**.
2. Re-tighten fixings one and two to **10 Nm**.

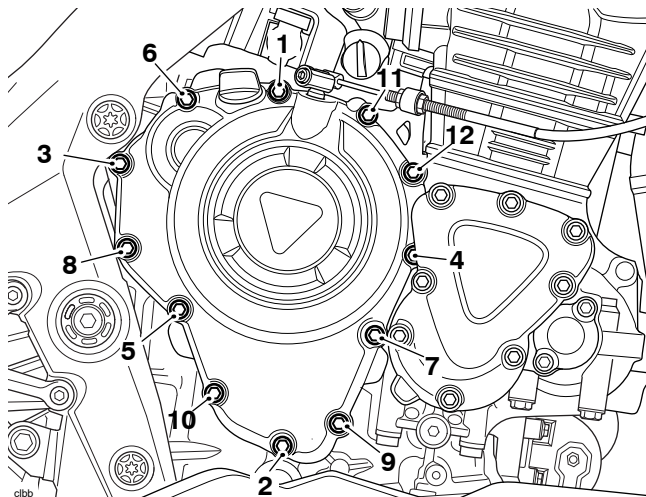
Clutch Cover Fixings Tightening Sequence

Do not tighten fixing 4 during the tightening procedure.

Attempting to tighten fixing 4 will damage the clutch cover and crankshaft end cover and/or fixing.

1. Tighten fixings one to three in the sequence shown to **10 Nm**.
2. Tighten fixings five to twelve in the sequence shown to **10 Nm**.
3. Re-tighten fixings one and two to **10 Nm**.
