# **TECHNICAL INSTRUCTIONS**

## **LIMITED SERVICE CAMPAIGN 21TD03**

**CERTAIN 2016 – 2019 Model Year Double Cab Tacoma**

**CENTER HIGH-MOUNTED STOP LAMP – WATER LEAK**

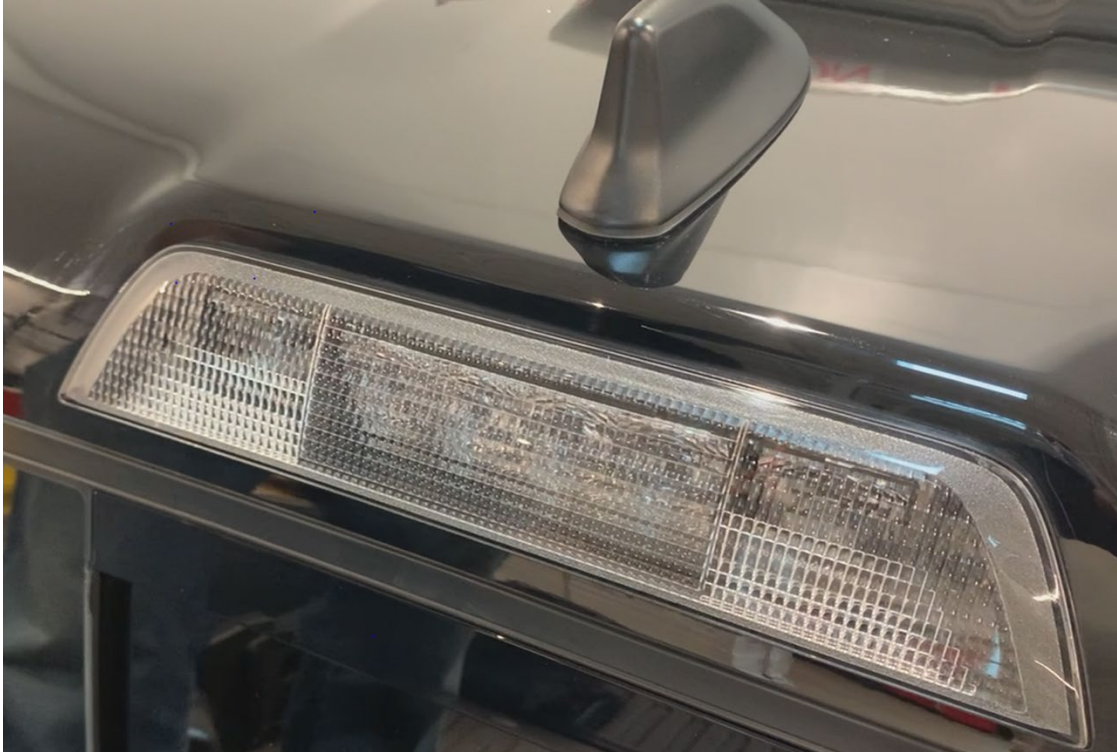
The Center High-Mounted Stop Lamp on the involved vehicles has a seal between the lamp and the vehicle body which can deteriorate over time. If the seal deteriorates sufficiently, water from outside the vehicle could leak into the vehicle cabin through the seal.

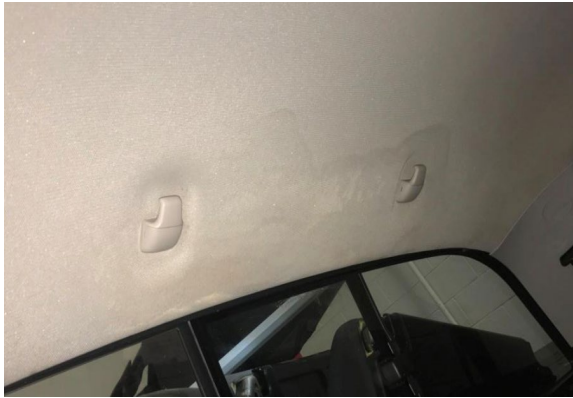
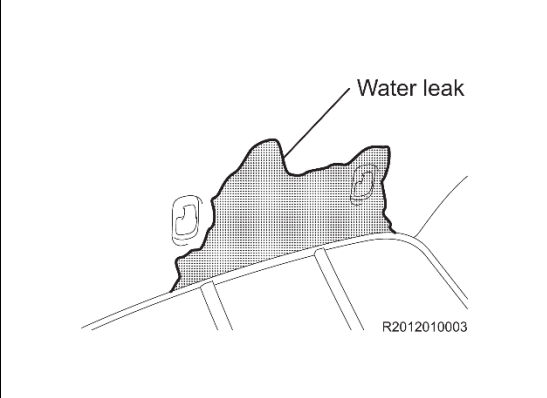
- a. Visually inspect the rear section (above the rear window) for evidence of water intrusion stains on the headliner. Water stains will usually be noticeable for discoloration of the visual surface.

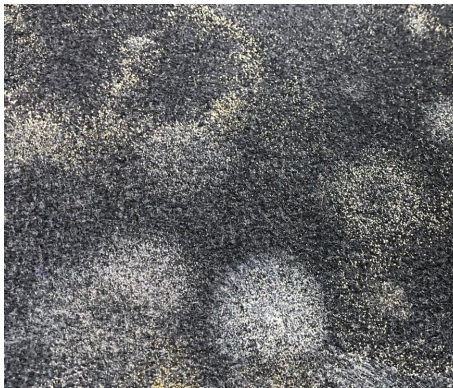
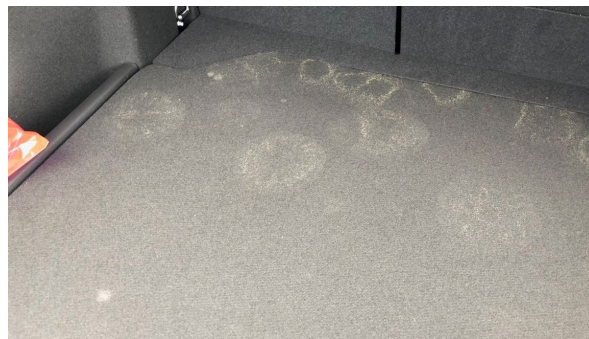
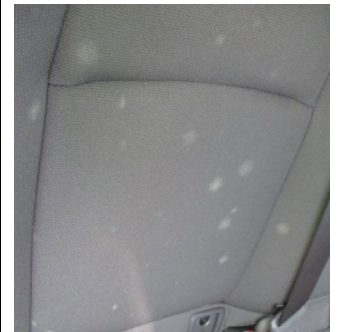
#### **Examples of Organic Growth**

**Example of Organic Growth on the Tacoma Floorboard**
