**SIB 64 06 21**

DIFFERENT AIR TEMP FROM LEFT TO RIGHT OUT OF THE VENT

This Service Information Bulletin (Revision 1) replaces SI B64 06 21 **dated July 2021**.

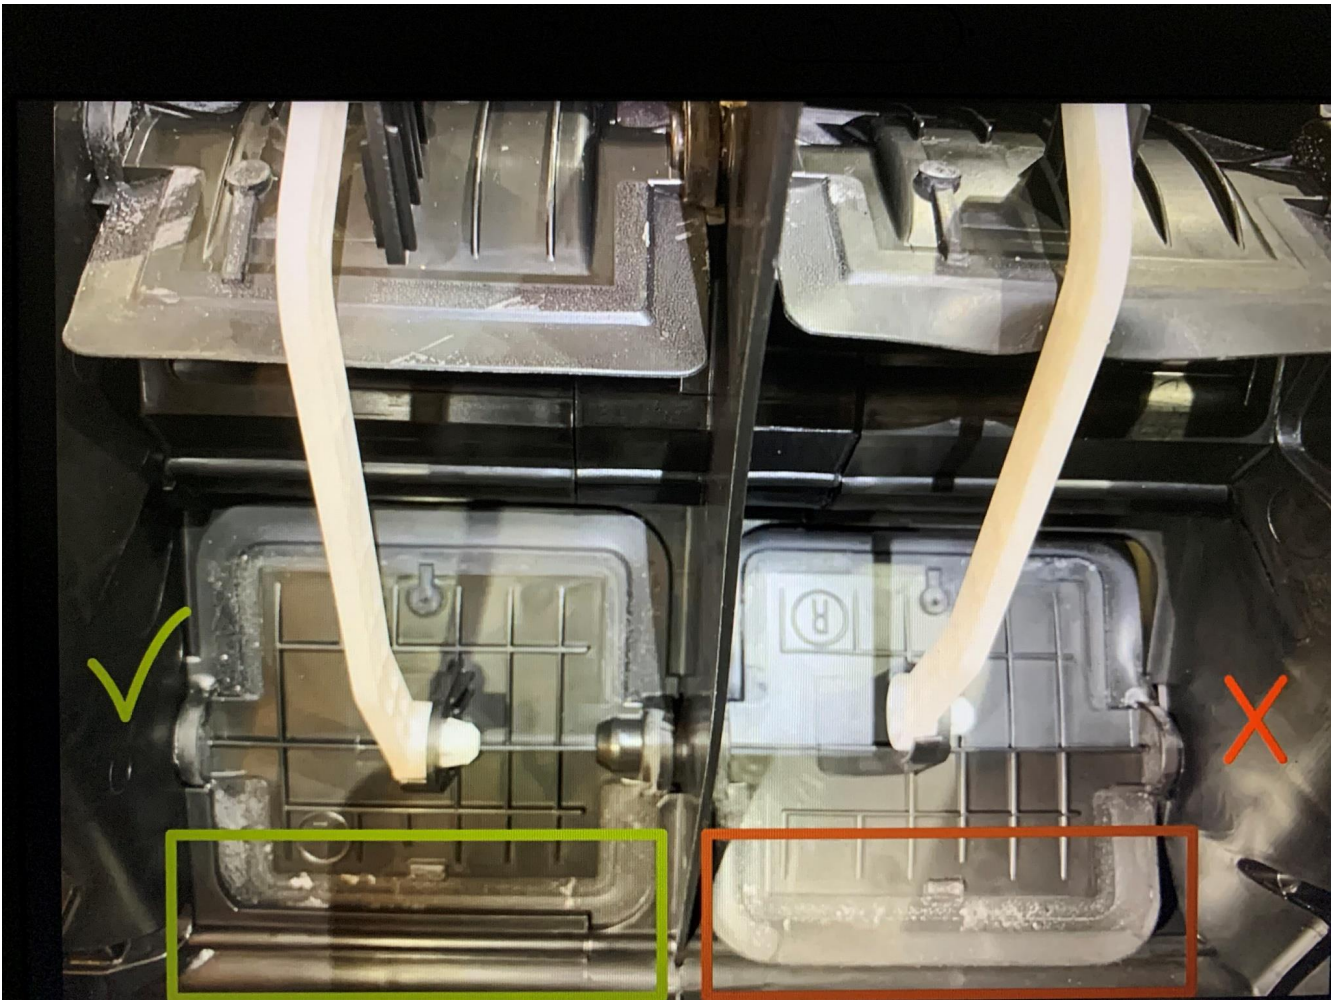
Due to the constant pressure on the end stop of the mixed air flap, it may become deformed and in some cases break off.

As a result, one of the air flap units may no longer move correctly

Test operation of the mixed air flap. Repair as needed.
