SIM 64 02 21

## DIFFERENT AIR TEMP FROM LEFT TO RIGHT OUT OF THE VENT

## MODEL

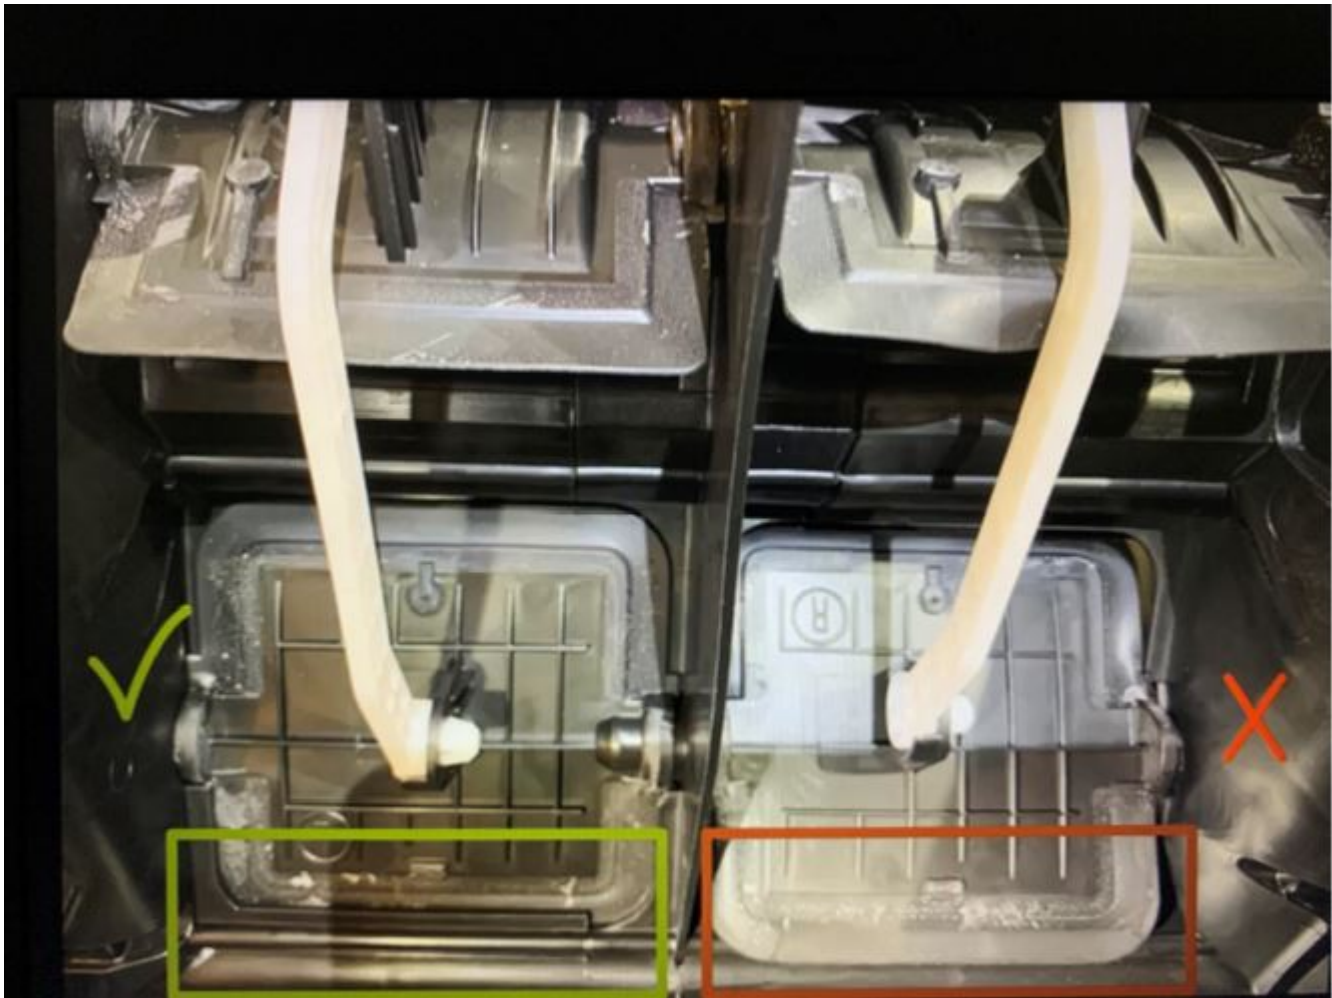
Due to the constant pressure on the end stop of the mixed air flap, it may become deformed and in some cases break off.

As a result, one of the air flap units may no longer move correctly

Test operation of the mixed air flap. Repair as needed.

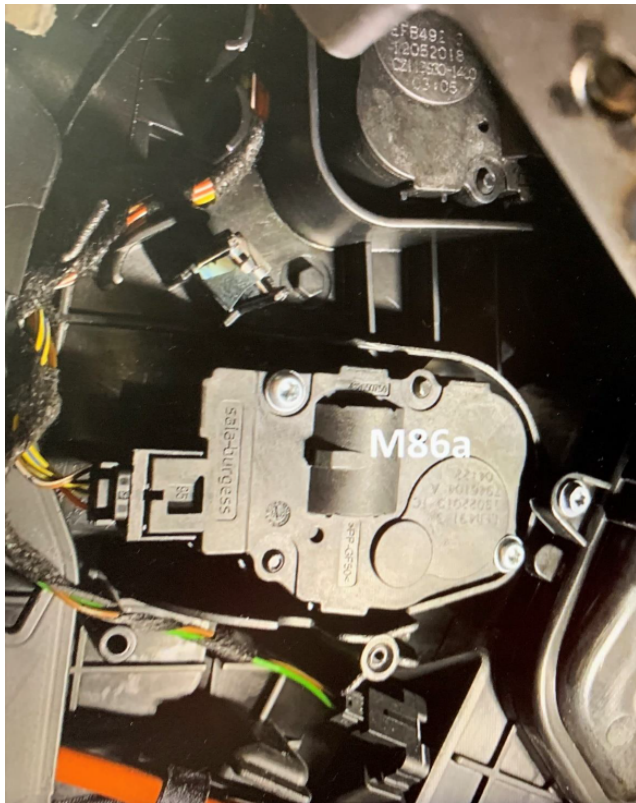
Note: The motor is numbered differently on different models.

Follow repair instructions Replacing controller drive of air mixing flap, front right to access the stepper motor.
