**SIB 61 04 06**

SERVICE ACTION: Instrument cluster wiring harness chafing - 61 004 06 (054)

Service Information Bulletin

Subject: Instrument wiring harness chafed through or pinched

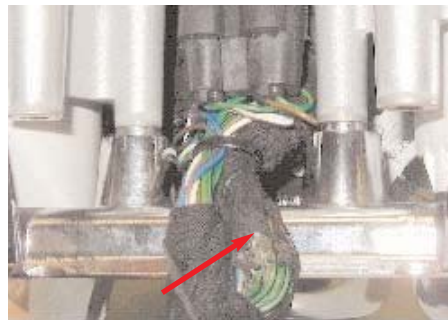
Details: There is a possibility of the wiring harness leading to the instrument cluster showing signs of chafing. In extreme cases this can result in a short-circuit. Individual cables in the instrument cluster can also become be pinched. See photos below.

1) The cable chafes against the holder of the instrument carrier. The cable tie is missing, or was incorrectly positioned by the supplier behind the insulating hose or the insulating tape.

1. Harness chafed through

The next time the motorcycle brought into the workshop, check the wiring harness of the instrument cluster for chafing and pinched wires. Install an edge protector, part number 51 46 7 019 965, and secure the wiring harness firmly to the instrument cluster by means of a cable tie (see photo above).

If the instrument cluster wiring harness is found to be damaged from chafing against the carrier, then replace the instrument cluster wiring harness.

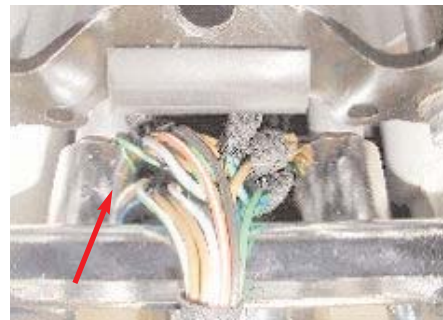
2) The instrument cluster was incorrectly assembled by the supplier, with the result that individual cables were pinched on installation.

2. Pinched wire

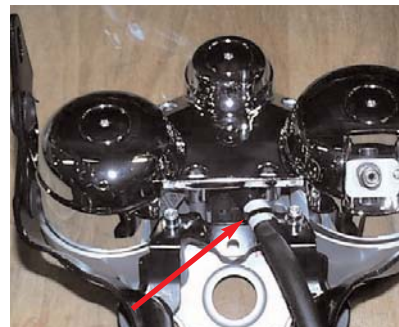
Production solution showing marking of the insulating hose.

Production Solution: An edge protector was fitted to the frame of the instrument carrier as a provisional measure. The series solution entails correcting the position of the cable tie (supplier's scope of work). The tie has to be positioned in such a way that the insulating hose of the wiring harness extends a safe distance (approx. 30-40 mm/1.18-1.57 in) past the edge of the bracket of the instrument carrier (see photo on next page). To facilitate correct installation, the insulating hose was marked accordingly in series production.

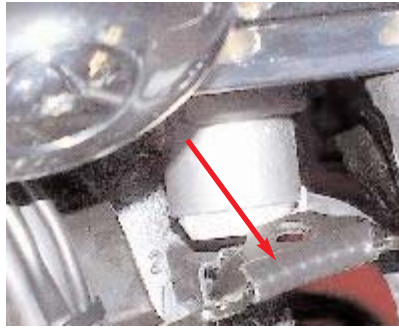
Edge protector installed

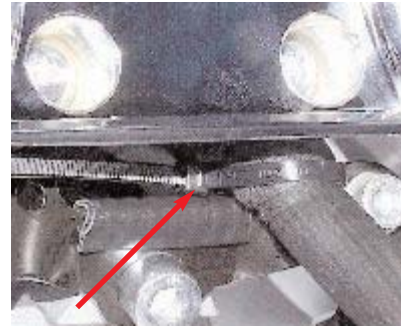
Note position of cable tie
