Headlamp condensation - broken guide pin

REF NO: TJ 35662.2.0	ISSUING DEPARTMENT: Technical Service	CAR MARKET: United States and Canada	
PARTNER: 3 US 7510 Volvo Car USA		ISSUE DATE: 2021-10-18	STATUS DATE: 2021-10-21
FUNC GROUP: 3521	FUNC DESC: Headlamp, complete	Page 1 of 5

TJ Instruction VCC-519478-1

Title	Cover bumper front	Page	1 (3)
Action	Product fix	Operation number:	86103-2 99922-2

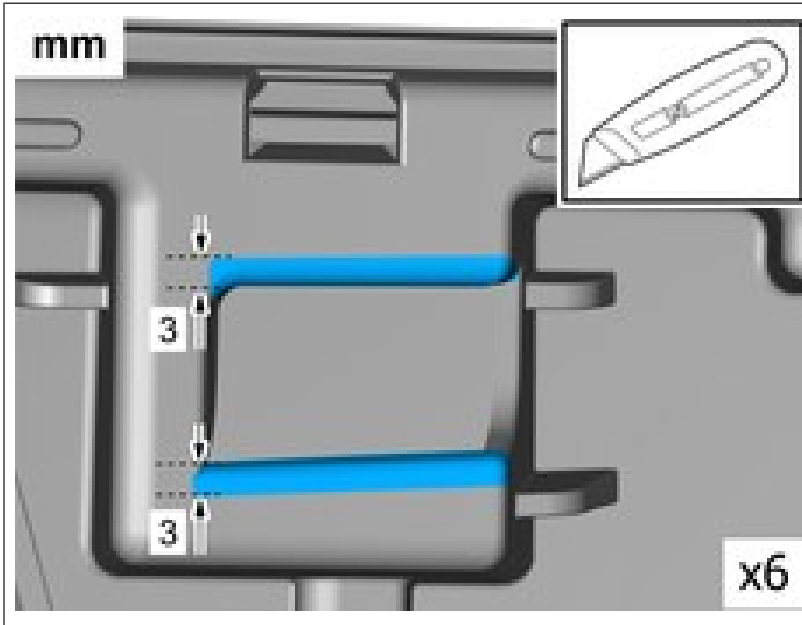
Remove the marked parts.

Caution! Cut carefully to avoid unintentional damage or personal injury.

Note! Use a sharp knife.
