Technical Service Bulletin

27 48V Vehicle electrical system warning, DTC P0CA700 and/or U046900 stored in the starter/generator control module/ECM

27 21 40 2058831/3 December 6, 2021. Supersedes Technical Service Bulletin Group 27 number 21-37 dated April 1, 2021 for reasons listed below.

Model(s)	Year	VIN Range	Vehicle-Specific Equipment
A6, S6, A7, S7, A8, and S8	2018 - 2021	All	48V MHEV

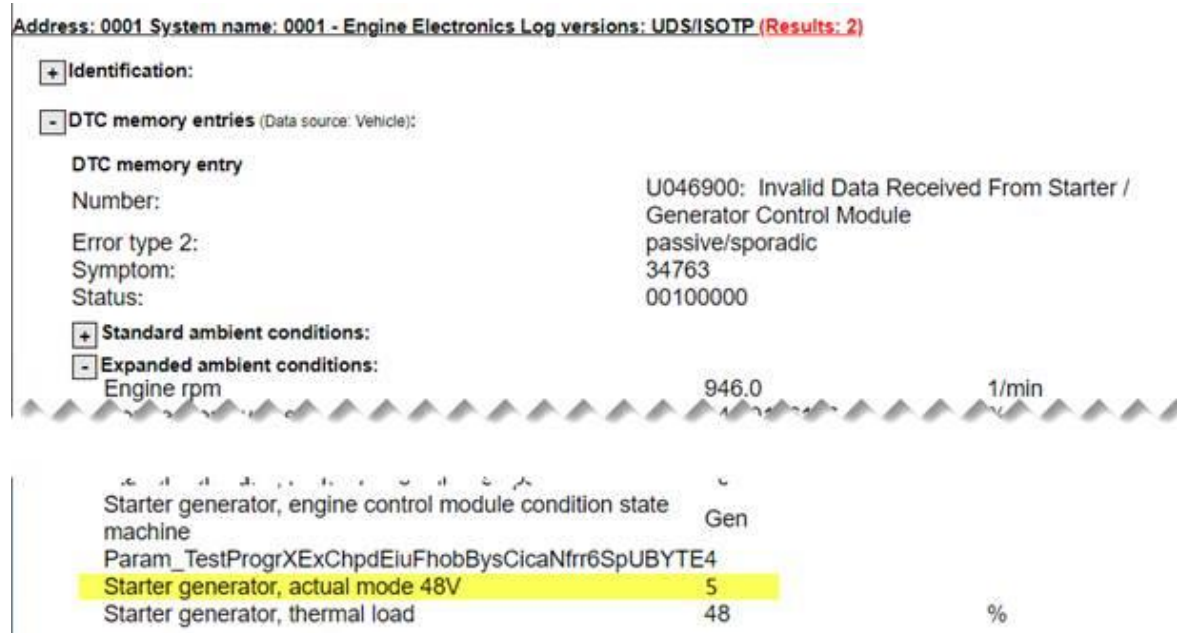
- **DTC U046900** (invalid data received from starter/generator control module).

The software needs to be updated in the starter/generator control module, C29 (address word 00CC).

Figure 1. DTC U046900 with Expanded ambient condition “Starter generator, actual mode 48V” value of 5 in the engine control module (ECM), J623 (address word 0001).

1. If DTC U046900 is found in the ECM, J623 (address word 0001), check the expanded ambient conditions of this DTC for the value of “Starter generator, actual mode 48V.”
2. If the expanded ambient conditions value for “Starter generator, actual mode 48V” is 5 (Figure 1) for DTC U046900, then replace the starter generator.
