Technical Service Bulletin

66 Grinding noise heard with steering wheel turned to full lock

66 21 80 2062700/2 December 8, 2021. Supersedes Technical Service Bulletin Group 66 number 21-70 dated March 25, 2021 for reasons listed below.

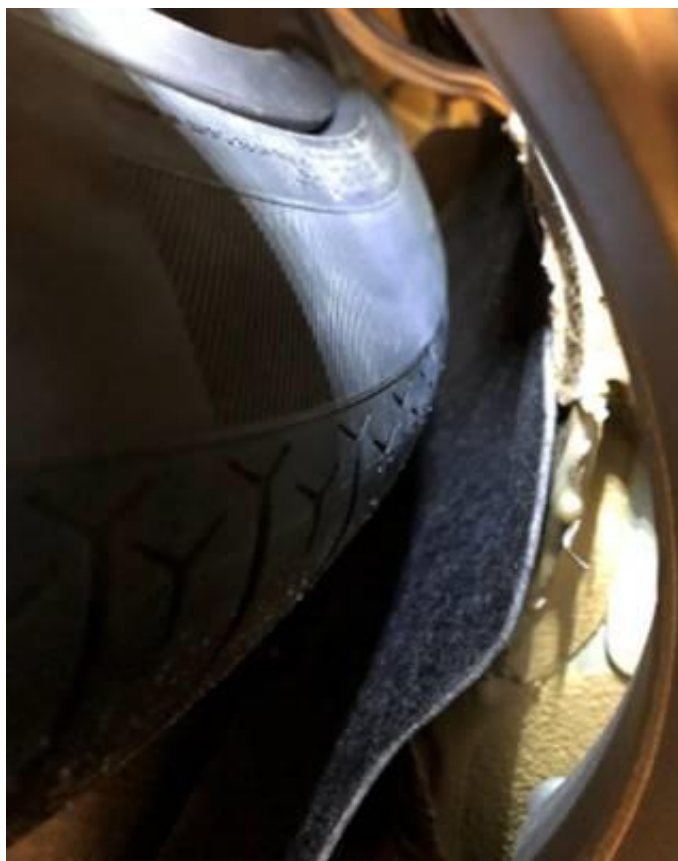
The front wheel housing liner backing can weaken and 'sag' into the path of a rotating front tire when the wheels are turned to full lock. The noise disappears when the steering angle is straightened (Figures 1 - 2).

Figure 1. Front tire making contact with the wheel housing liner.

If this symptom is duplicated and one or both front wheel housing liners are found to interfere with the tire causing the noise replace both the right and left front wheel housing liners with part numbers:

- 4KE 821 171 C Left front wheel housing liner.
- 4KE 821 172 C Right front wheel housing liner.

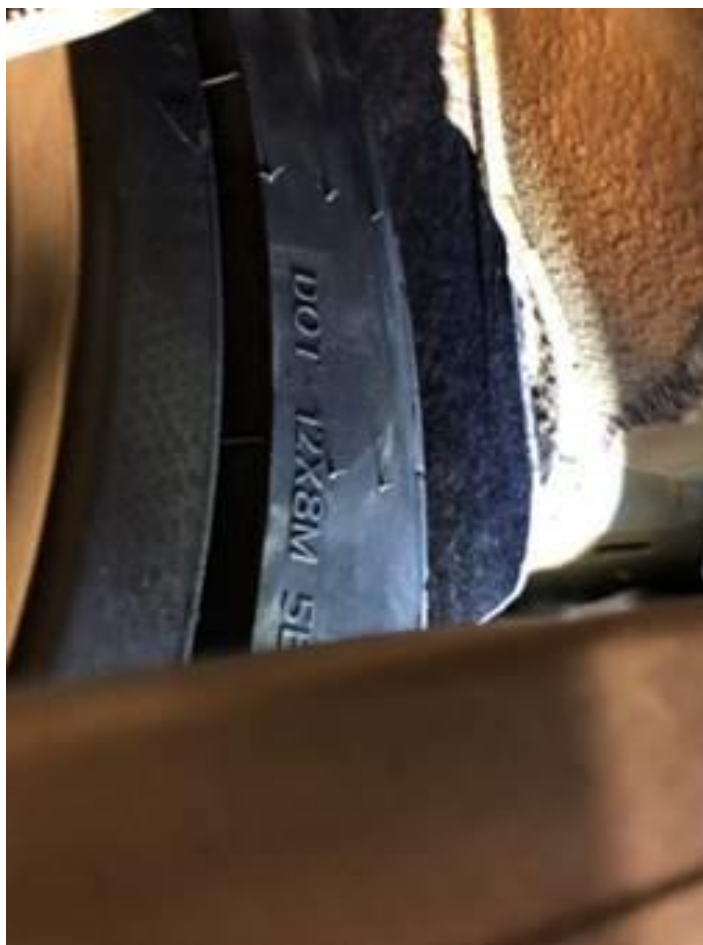
Figure 2. Front tire making contact with the wheel housing liner.
