RECREATIONAL VEHICLE SERVICE CAMPAIGN

Service Advisory: 21-415

SERVICE ADVISORY # 21-415

Arcadia A/C Ducts & Wiring

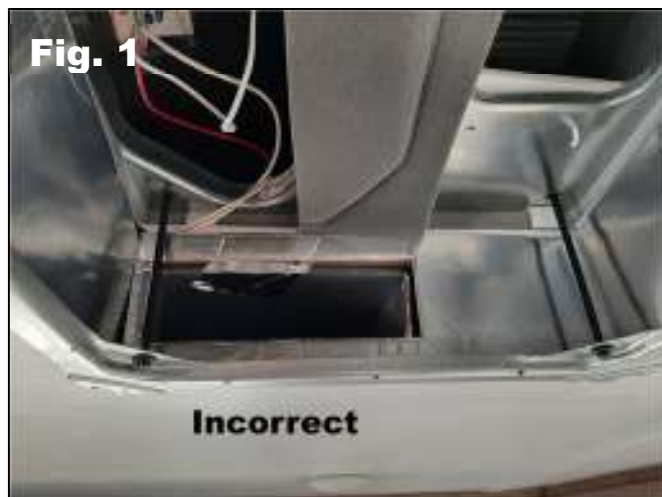
It has been determined that some Arcadia units have A/C ducts that are improperly installed into the return air portion of the opening for the rear A/C, and the rear A/C thermostats were not wired properly. The following procedure describes how to resolve the issue.

Remove the return air filter and inspect the return air to see if the ceiling ducting was installed into the return air side of the A/C. See Figure 1, picture shown without plastic duct connector.

If the ducting is installed correctly proceed to repair instructions for thermostat wiring. If ducting is installed into the return portion of the 14"x14" opening, proceed to step 4.

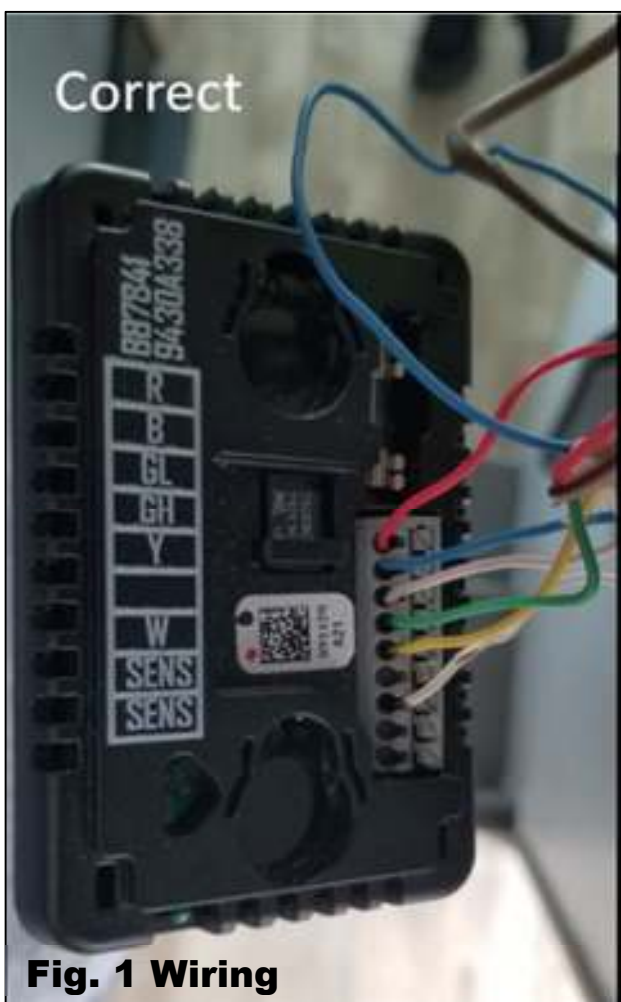
Inspect wiring at back of thermostat. See Figure 1 Wiring and Figure 2 Wiring.

Disconnect the red wire connected to "Y" position on the thermostat. Cut the red wire back to the jacketed insulation as it will not be used again.
