Highland  
RIDGE RV

## LP Tank Wiring – Fuel Sender and Solenoid

| <b>Bulletin #(s):</b> | 21-025 | <b>Make(s):</b> | Jayco & Entegra |

| <b>Incident:</b> | LP Tank is full but showing empty on Vega Touch panel | | |

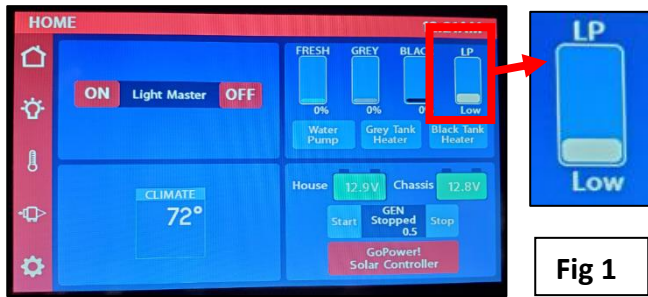
Fig 1

1. Check Firefly Home Screen to ensure LP Pressure Gauge is functioning correctly. Complete repair #1 & #2 if LP tank is full but is showing empty on the Vega Touch panel. Only complete repair #2 if the LP Pressure Gauge shows “Disc” (Figure 2).

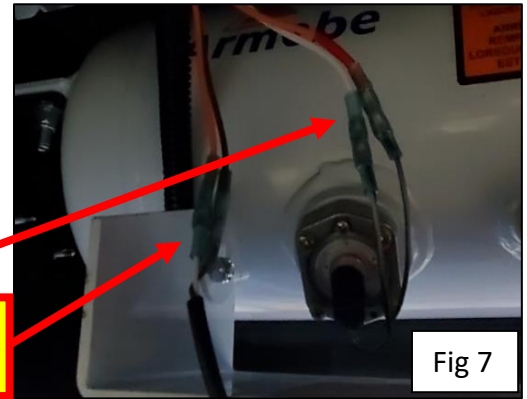
Fig 7

- A. Pull vehicle onto hoist and raise unit to a comfortable working height.
- B. Locate wire connections at LP Tank (Figure 7) and ensure they are wired:
  - i. Orange to Purple at Solenoid
  - ii. Brown to Black at Solenoid
  - iii. Orange w/Red Tape to Black at Gauge
  - iv. White to Black at Gauge

Electrical connections shown  
installed incorrectly

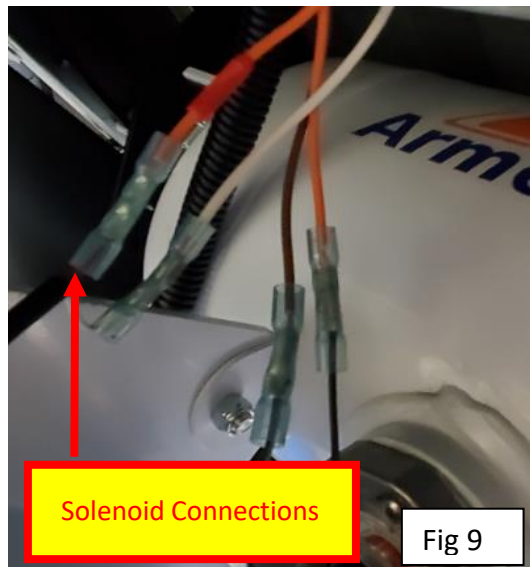
Fig 9

Solenoid Connections

- D. Re-connect wiring with 16-14GA Butt Splice Connector (Figure 9)
  - i. Orange to Black at Gauge
  - ii. Brown to Black at Gauge
  - iii. Orange w/Red Tape to Purple at Solenoid
  - iv. White to White at Solenoid
- E. Using a butane torch, heat shrink the 16-14GA Butt Splice Connector.
- F. Verify functionality by reviewing Firefly to ensure LP pressure is reading. If not, the gauge may have been damaged. If damaged, please contact your service representative for repair instructions and parts to replace.
