Service Bulletin

Bulletin No.: 17-NA-221

Subject: Poor Engine Performance in Extremely Cold Weather Conditions for LE2 Engines, Charge Air Cooler Icing - Malfunction Indicator Lamp (MIL) Illuminated, DTC P0299, P0234, P0236, P2227, P00C7 Set

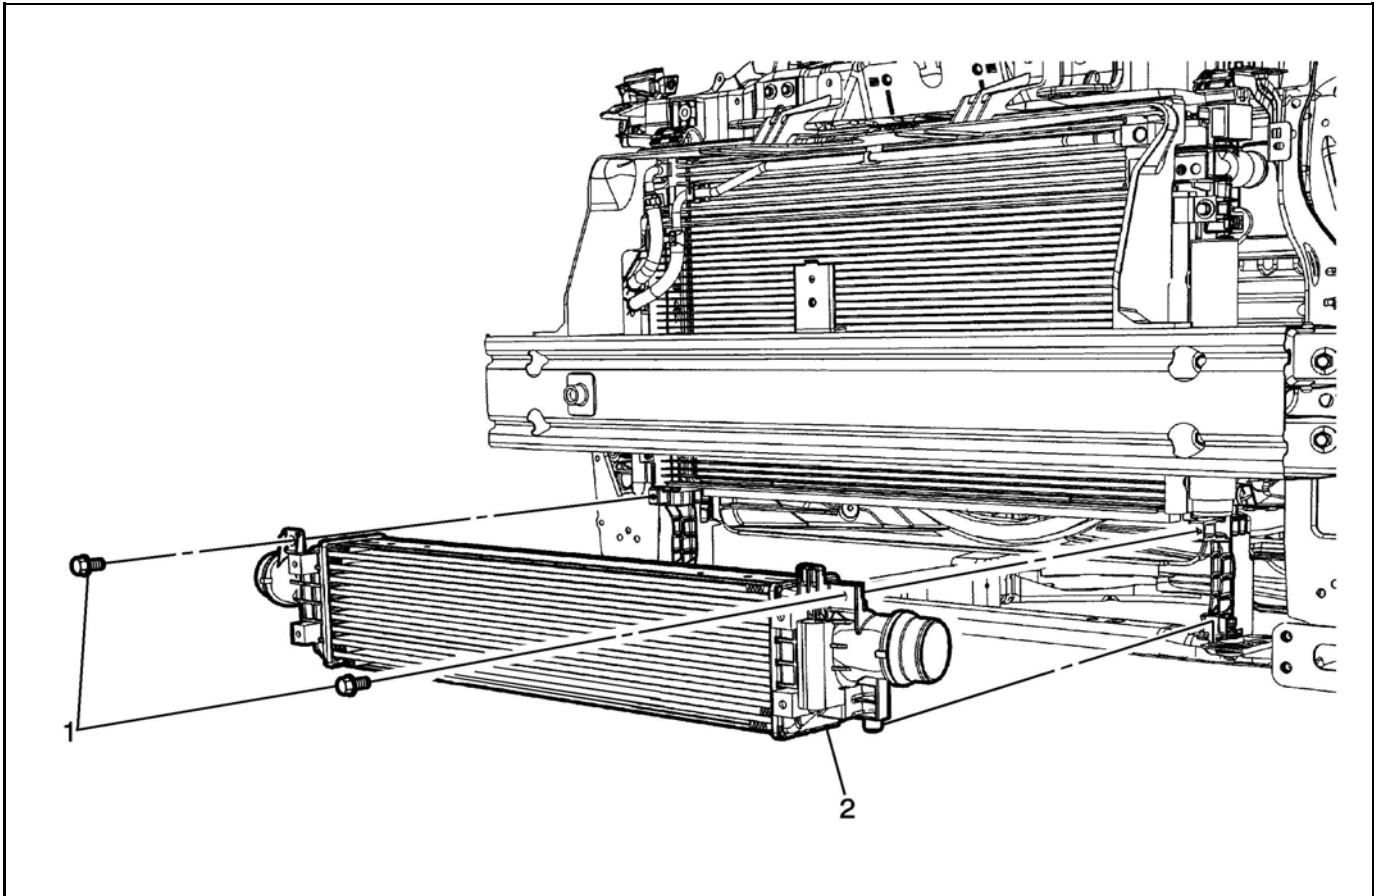
2851444

Cause	<p>This condition may be caused by ice accumulation in the charge air cooler (CAC), restricting air flow to the throttle body.</p>
Correction	<p>If any of the above conditions are present, allow time for possible ice build up in the CAC to melt by allowing the vehicle to thaw in a warm climate.</p> <p>If any of the following conditions are validated to be caused by freezing/icing, replace the CAC.</p> <p>If not previously performed, an oil change may be necessary to remove any moisture from the engine. Prior to the oil change, run the engine at idle for an extended period of time to melt any ice in the engine.</p> <p>If there is a check engine light with a P0234 or P0299 DTC during cold weather driving, refer to Turbocharger Wastegate Regulator Solenoid Valve Inspection below.</p> <ul style="list-style-type: none">– Frozen oil/water condensate contaminant in the Turbocharger Wastegate Regulator Solenoid Valve (TCV) is often concurrent with vehicle operation conditions that cause CAC freezing.

1. Install the CAC (2). Refer to *Charge Air Cooler Replacement* in SI.
