Service Bulletin

Subject: Carpet Damage, Seat Mounting Stud Wear Through, Hole in Second Row (Intermediate) Carpet

Brand:	Model:	Model Year:		VIN:		Engine:	Transmission:
		from	to	from	to		
Cadillac	Escalade Models	2011	2020				
Chevrolet	Suburban Tahoe	2011	2020			All	All
GMC	Yukon Models	2011	2020

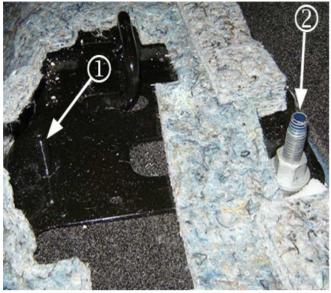
4867792

Note: There are two different size seat studs; 8 mm (1) used for long side bench to short side bench seat attachment (present on right side bucket seat), and 12 mm (2) used for seat to floor attachment.

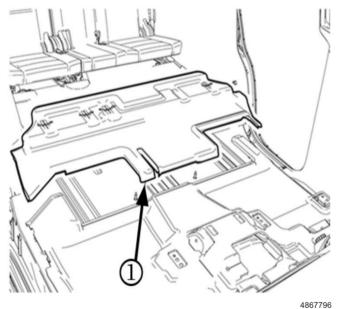
1. Inspect the intermediate carpet for wear through from seat studs and mark the affected stud locations.

2. Remove the damaged intermediate carpet (1). Refer to *Intermediate Floor Panel Carpet Replacement* in SI.
