# Service Bulletin

Bulletin No.: 19-NA-256

**Subject: Diagnostic Tips for Knocking, Rattle, Squeak and/or Squeal Type Noise from Engine – Engine Replacement Recommendations for HFV6 Gen 1 and Gen 2**

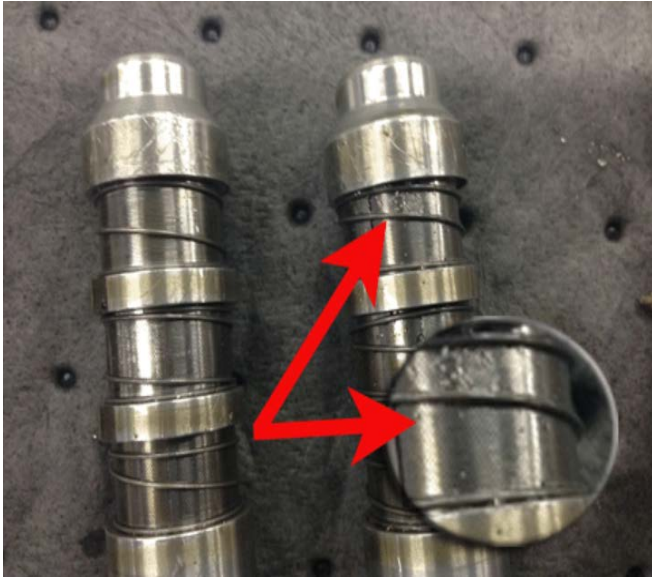
3961448

1. Inspect the oil control solenoids for metal debris. This shows the oil filter is in by-pass and unfiltered oil with bearing debris was pumped into the oil lubrication galleys, throughout the engine.

Any of the above 3 instances would be cause to replace the engine instead of repair.
