Service Bulletin

Bulletin No.: 20-NA-148

Subject: Plastic to Metal Squeak/Creak Noise Heard Coming from the Driver or Passenger Side B-Pillar Area

Brand:	Model:	Model Year:		VIN:		Engine:	Transmission:
		from	to	from	to		
Chevrolet	Traverse	2020	2021			All	All

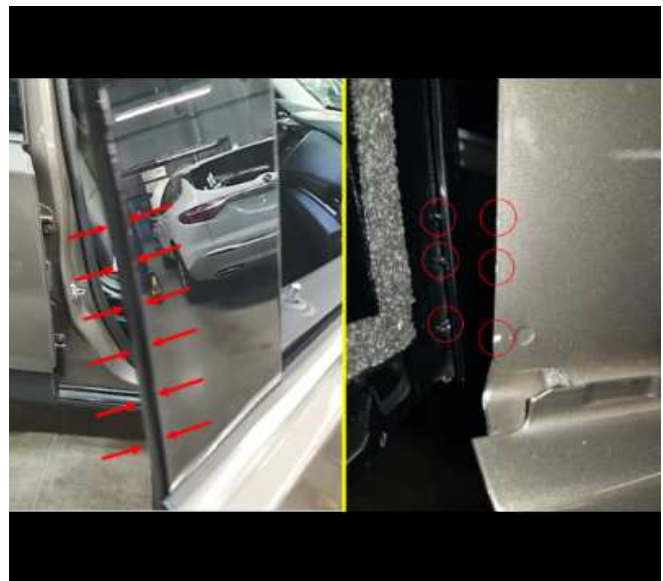
5633856

Note: The common area most effected is shown in the left graphic above, and visual wear markings that may be visible on the paint, which could assist with identifying affected areas, is shown on the right.

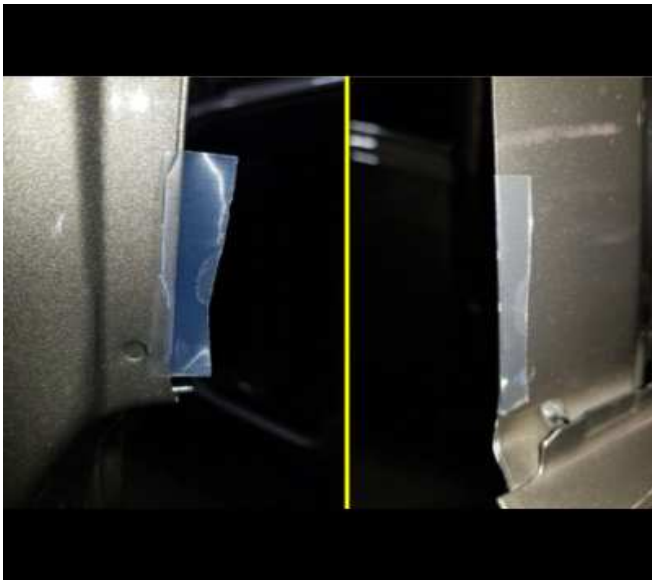
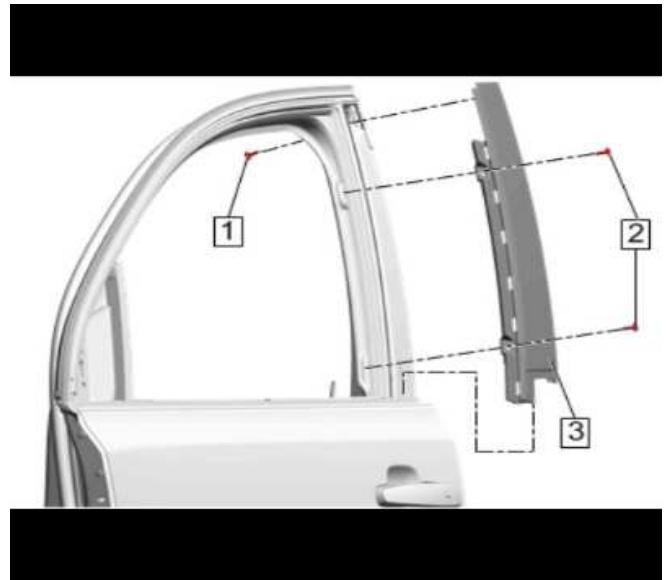
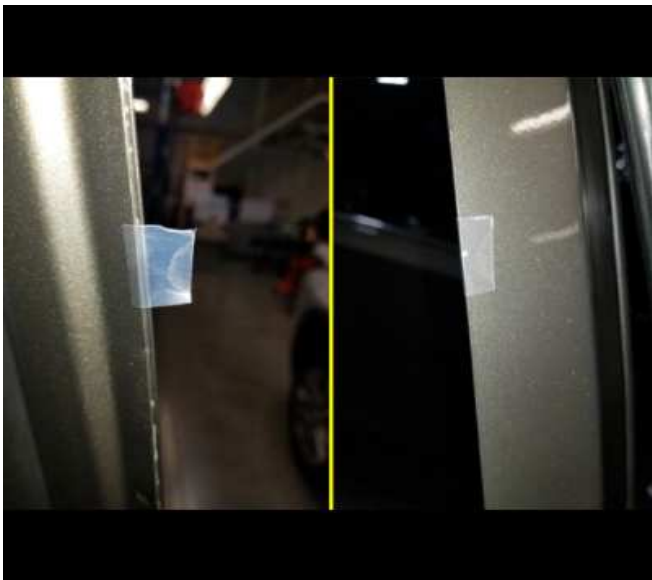
Note: Some examples of the common tape application locations are shown in the graphics above.

2. Apply strips of Kent Automotive Anti-Squeak Film Tape # KT13512, or an equivalent UHMW Polyethylene anti-squeak tape, to the affected areas on the B-Pillar of the front side door window frame where the rear applique connects.
