# Aftersales TSO – Service campaign

**MAS002829**  
(MSC 21-15)

## Service Campaign 430: M15X MY20-21 Sunroof Water Infiltration

MY20 and MY21 Maserati Sedans are involved in a Service Campaign to check for a possible water leak in the sunroof assembly.

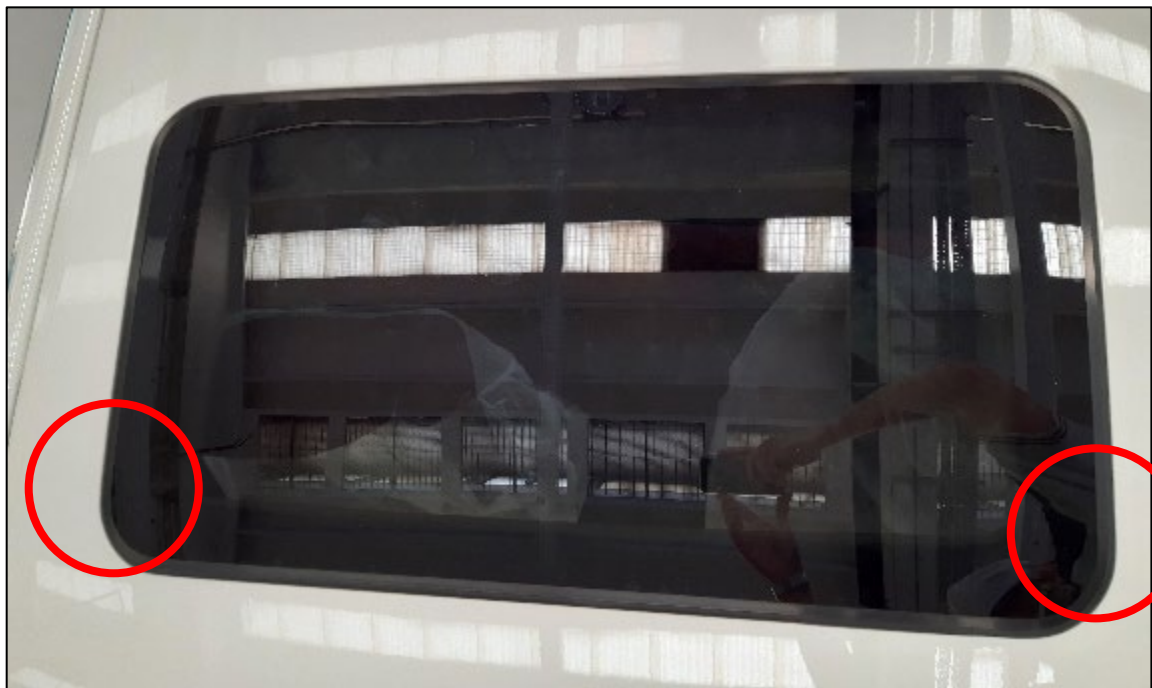
*This campaign only involves water infiltration in the circled areas above. Water infiltration in any other area of the sunroof is out of scope of this campaign and must be treated as a separate case/repair.*

This campaign is needed due to the possibility of an improperly sealed sunroof that could result in a potential water leak that drips on to the front seat from the lower ribs of the roof panel.

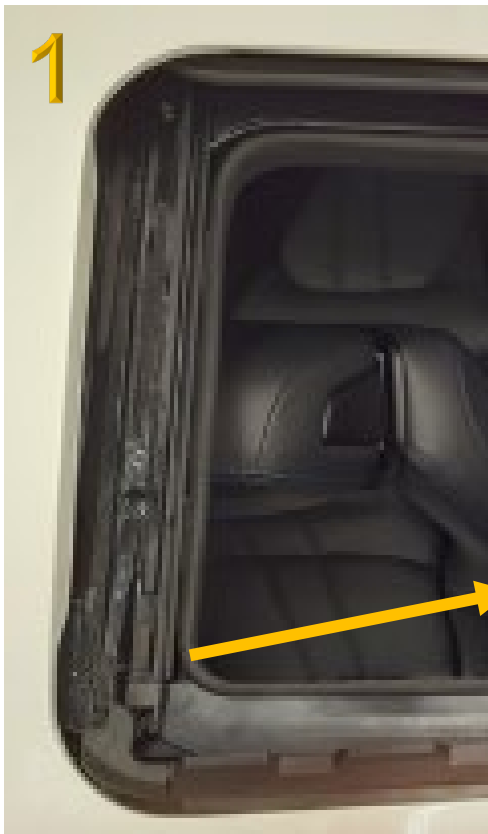
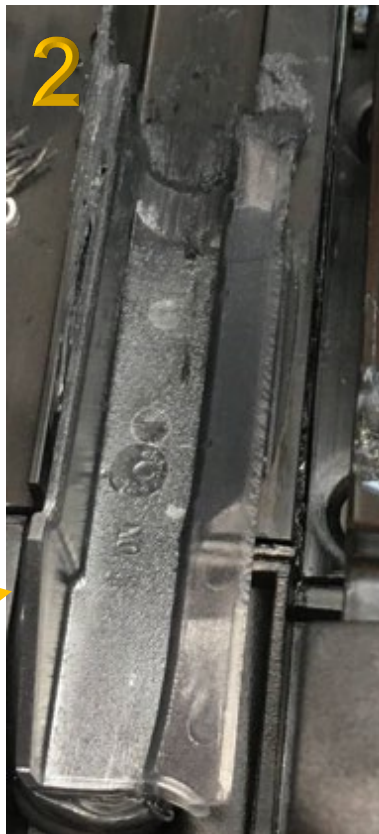
The water infiltration is localized to the areas shown in pictures 1 and 2.

An adhesive bead is applied on the plastic element assembled in the drain channel (pic 2). The adhesive bead is there to seal the interference fit between the plastic element and the frame (pic 3).

Due to a supplier issue, some sunroof assemblies could have a poor seal between the plastic element and the channel (pic3).

Water infiltration could occur in severe conditions (heavy downpours, car wash, etc.)

In cases of a poor seal, a specific procedure has been tested to seal the plastic to the frame without removing the Sunroof.

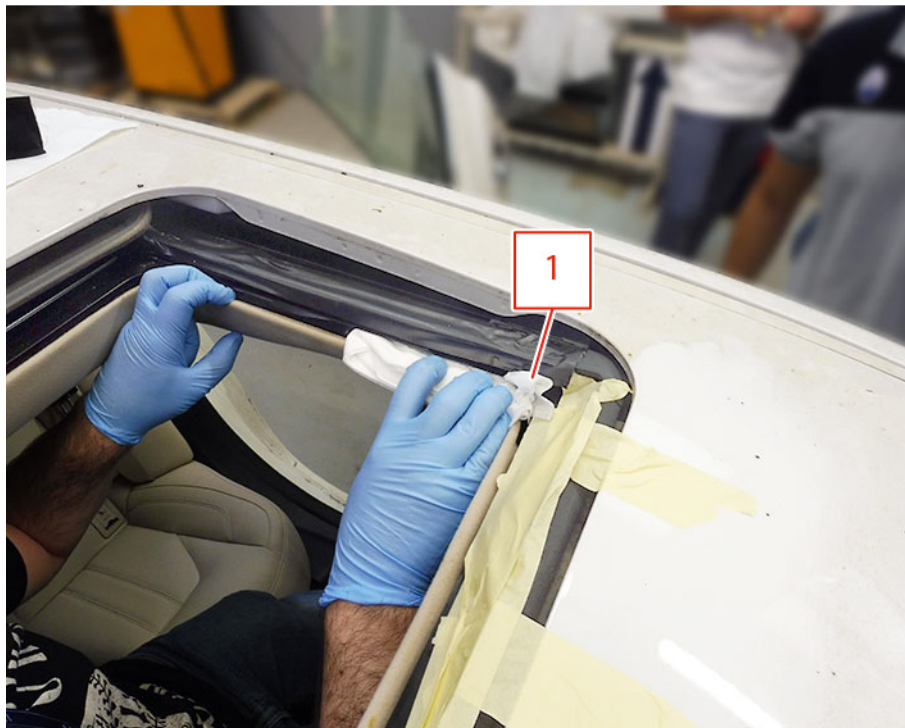
10. Check the condition of the blotting paper. If:

Blotting paper **dry** → OK. Remove the protections.

Blotting paper **wet** → NOT OK. Follow the procedures in **Reworking**.

*These procedures are used to check that there is no water infiltration. Under normal conditions, the water flowing into the draining channel should not reach the paper. Only if there is a bad sealing, the water can wet the paper.*
