SIB 64 06 13

2021-11-01

## A/C COOLING: INTERMITTENT REDUCTION OF AIR FLOW

This Service Information Bulletin (Revision 11) supersedes SI B64 06 13 **dated December 2020**.

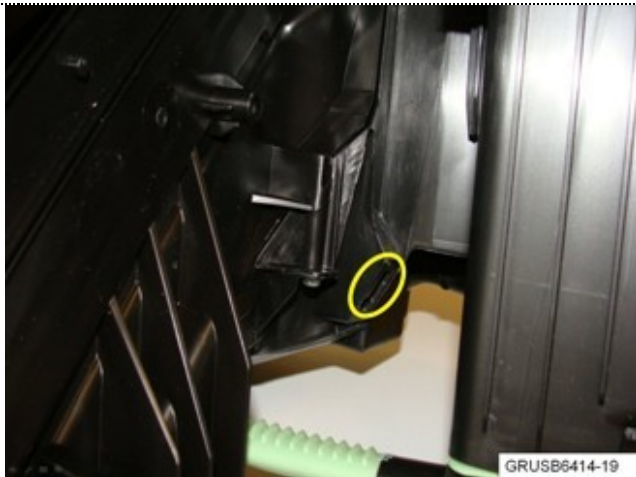
5. The close-up picture shows the exact location (circle) of the sensor opening. The following steps will be performed from the lower passenger's footwell area at the bottom of the IHKA housing.

**Note:** As a reference point, the evaporator temperature sensor is located just above the white ribbed rubber water drain hose, when viewed from below.

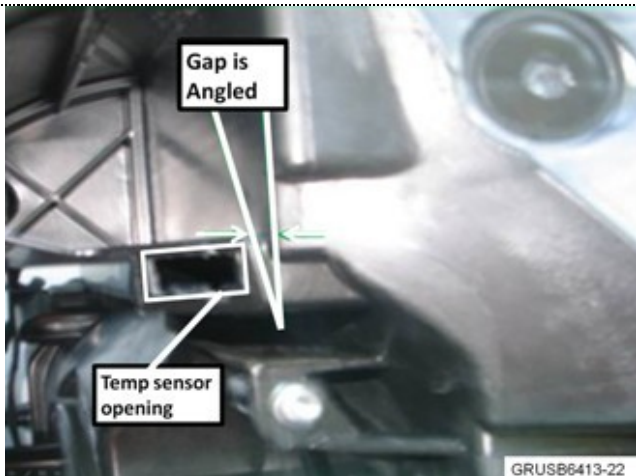
6. Locate the evaporator temperature sensor opening (sensor removed for clarity).

Check the gap between the sensor opening and the evaporator case.

If the sensor opening contact surface is slightly angled as shown, this housing is **NOT** affected by this repair procedure. In this case, proceed with normal A/C diagnostic procedures.

If no gap exists proceed to the next step.

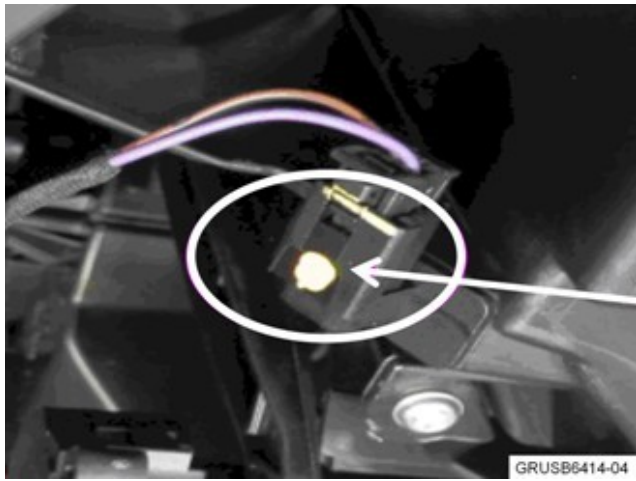
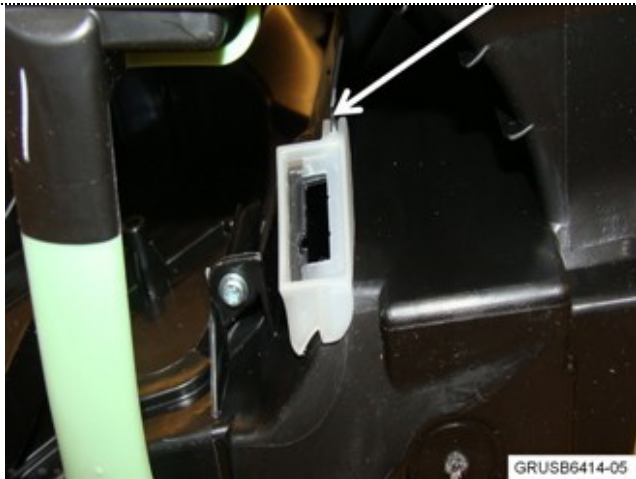
7. Check for a marking on the electrical connector.

If a mark is seen or **NO** gap exists, the IHKA housing must be modified.

**Do not replace any parts. The repair procedure includes installing a new adapter to correct the gap.**

8. Insert the new adapter firmly into the sensor opening, as shown.

**Note:** The arrow shows the slot in the adapter that is properly fitted into the raised rib of the housing.
