**SIB 65 05 18**

2021-11-29

AIR BAG LAMP ILLUMINATED. FAULT CODE 9309A0This Service Information Bulletin (Revision 5) replaces SI B65 05 18 **dated February 2020**.**What's New** (Specific text highlighted):

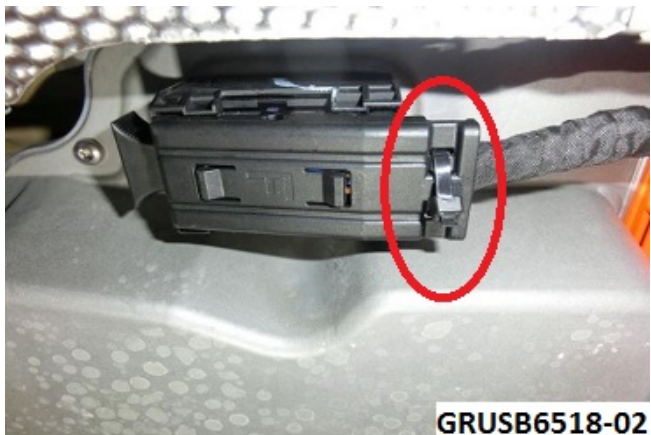
4. Perform a visual inspection of connector A190*1B on the bottom of the EME.

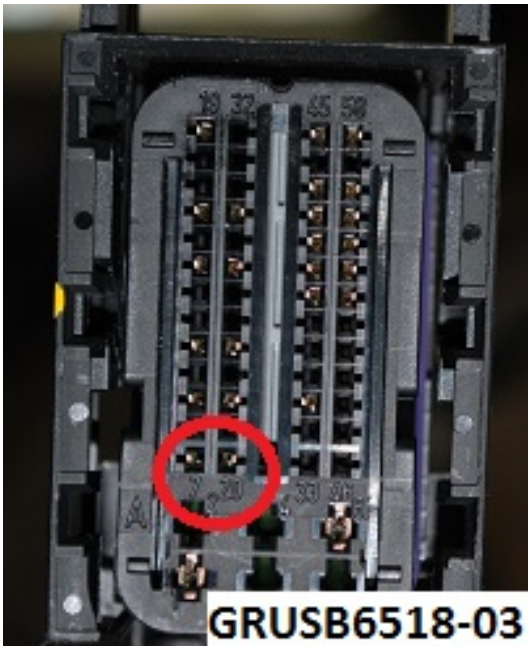
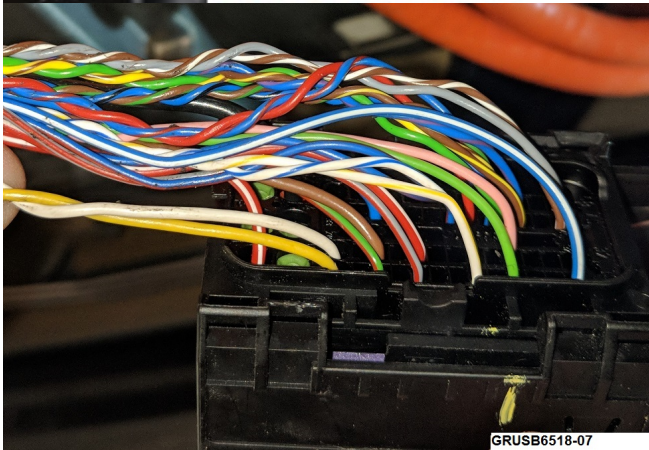
6. Examine pins 7 and 20 at the EME connector.

Notify technical support via a TSARA case if there is visual/water damage to these pins.

7. These two bottom wires (white & yellow) need to have some tension relieved on them.

- Remove the last 8" of tape from the harness at the EME connector to introduce some stress relief into this connection at the EME

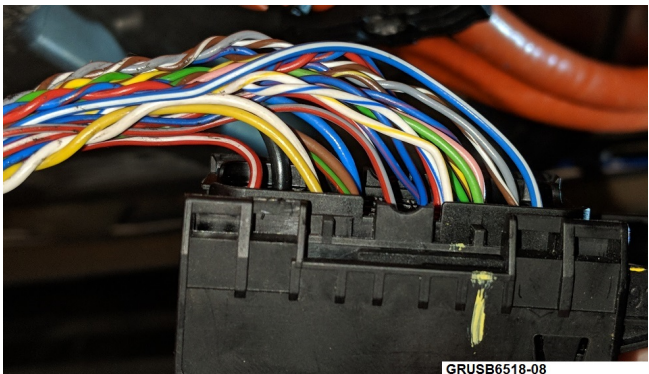
8. The wires between the zip tie location and the EME electrical connector/pins should **NOT** be under tension!

The wires now have a strain relief loop to eliminate tension on the electrical pins.

9. If you need more slack at the connector, go back to the last body tie down approx. 6" (16 cm) back from this EME connector, and pull some slack from there.

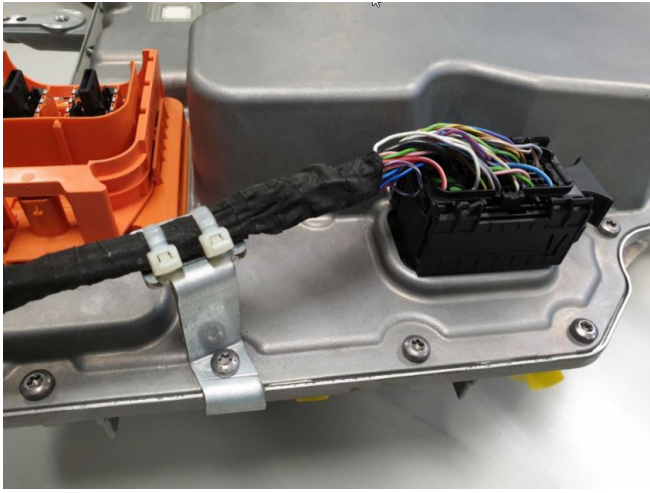
There must be some slack between the angle bracket and the EME electrical connector.

This slack functions as strain relief and prevents vibrations in the harness/underbody from being transmitted to the EME electrical connector.

the new angle bracket and secured with two new cable ties as shown here.
