SIB 41 03 21

SERVICE ACTION: CHECKING THE FRONT SIDE PANEL

E-Series	Model Description	Production Date
G20	3 Series Sedan	February 7, 2018 – November 17, 2020

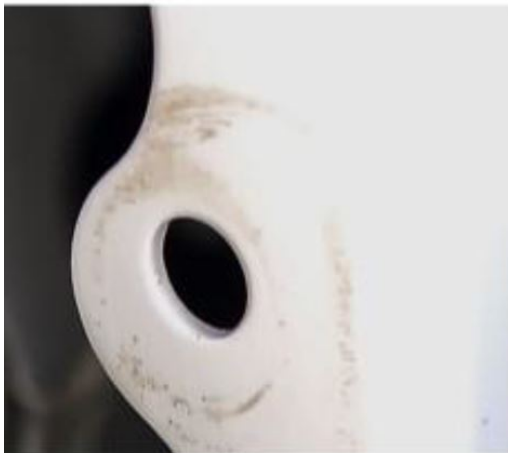
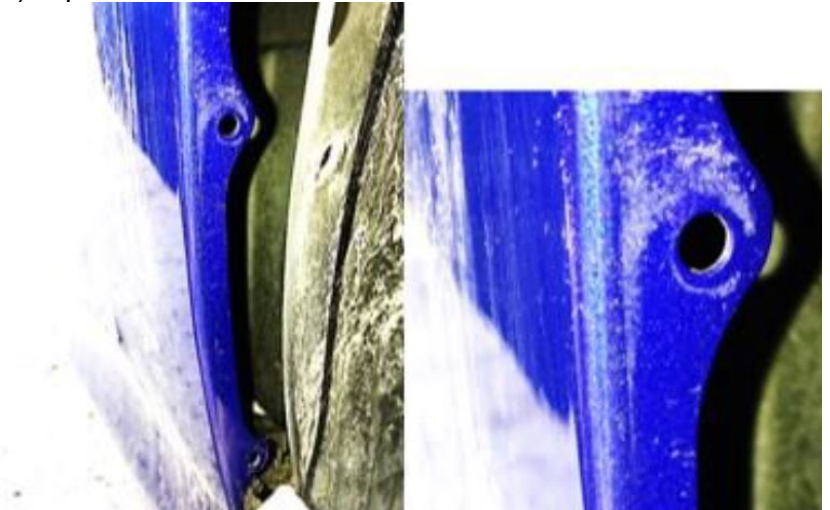
Damage version 1: Scratches in the clear coat, even over the entire area (matting of the clear coat in the area of the wheel arch liner) is permitted.

Damage version 1 (No Repair): Re-secure the fender liner using updated blind rivets. No additional repair is necessary.

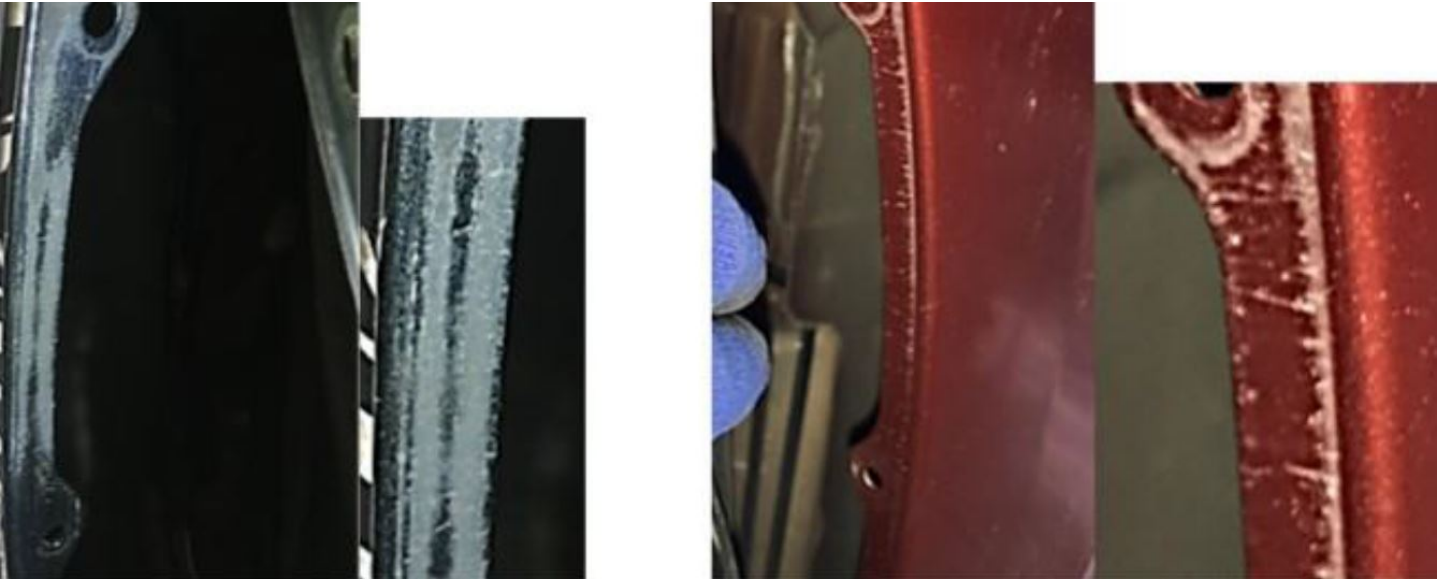
Damage version 2: Damage through the clear coat and paint. Damage must not extend all the way through to metal.

Damage version 2 (Rework): Tie back and secure the fender to keep it away from the fender. Using a clear coat touch up pen P/N 51 91 0 419 748, apply clear coat over any areas of damage. Allow the clear coat to dry completely, and re-secure the fender liner using updated blind rivets. No additional repair is necessary.

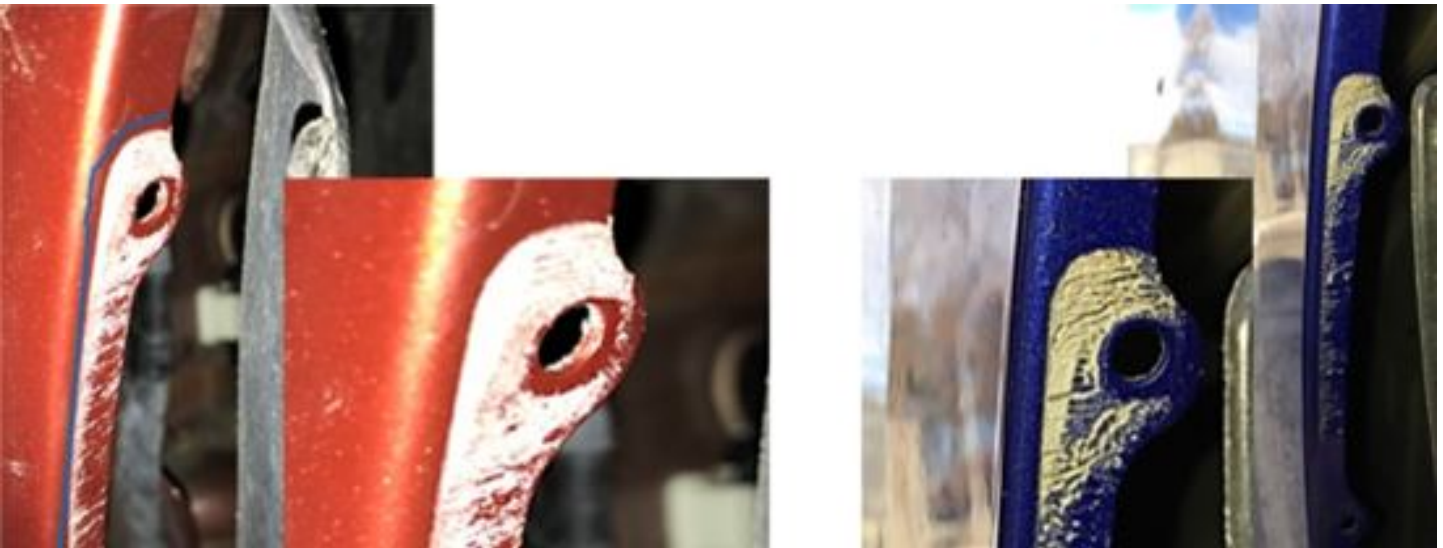
Damage version 3: Damage through the clear coat and paint down to the metal.

Damage version 3 (Repair): The small area of damage will need to be repainted by a collision repair facility. **After refinishing the damage, reinstall the fender liner and secure using updated blind rivets.** The collision repair facility can reference attachment "Attachment to B41 03 21" for additional information about how to make the repair.

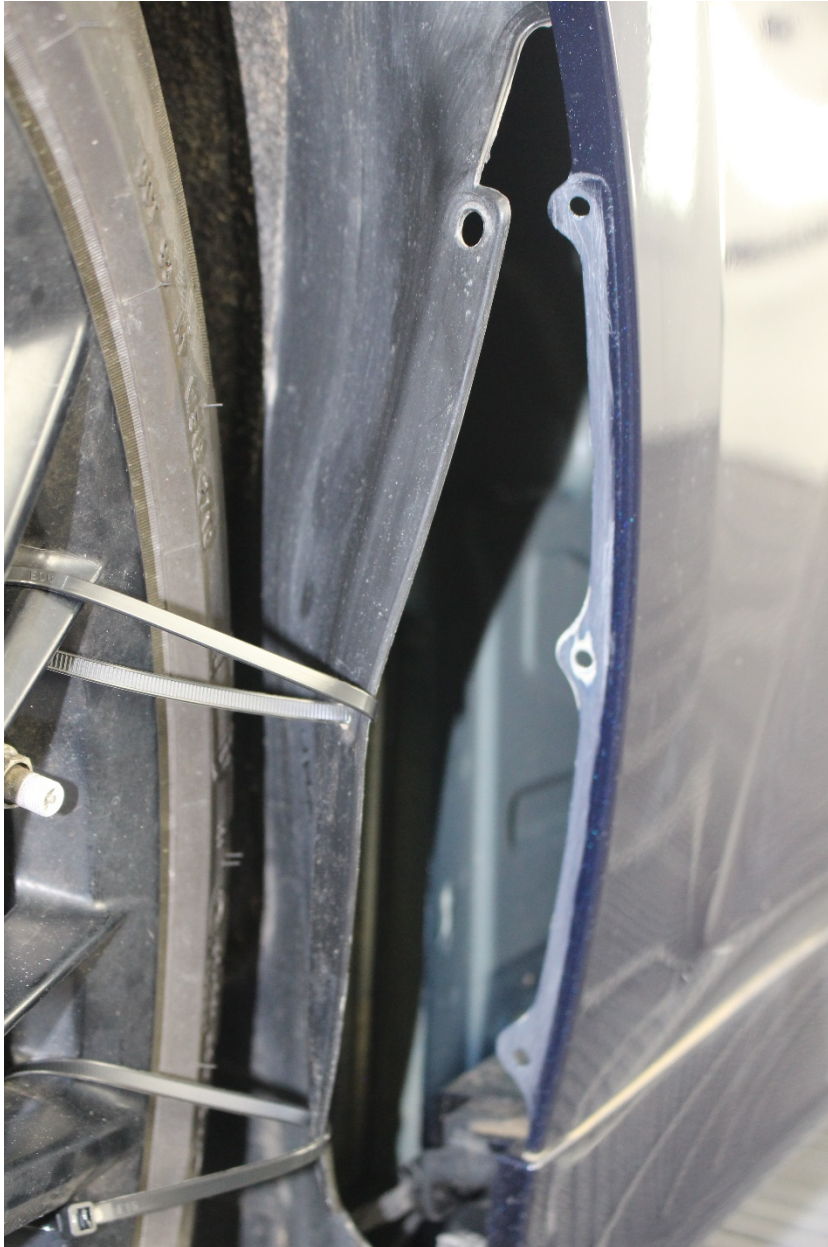
Step 4 – Once the liner is pulled back the area can be inspected for paint damage and corrosion. In this example there are a few areas with exposed metal and primer. Clean the area with Wax and Grease / Silicone Remover. (Market specific due to VOC compliance)
