SIB 51 13 21

**RAIN LIGHT SENSOR REPAIR DURING WINDSHIELD REPLACEMENT**

This Service Information Bulletin (Revision 1) replaces TRI B51 13 21 **dated June 2021**.

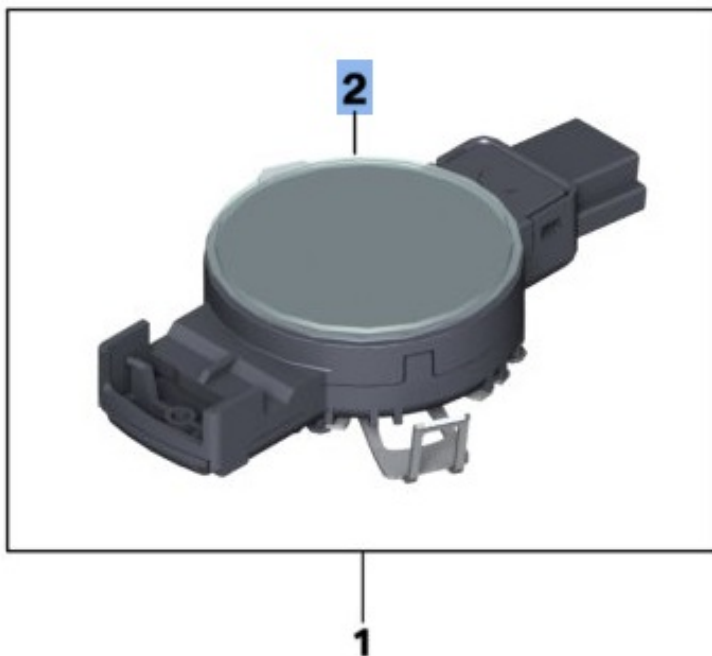
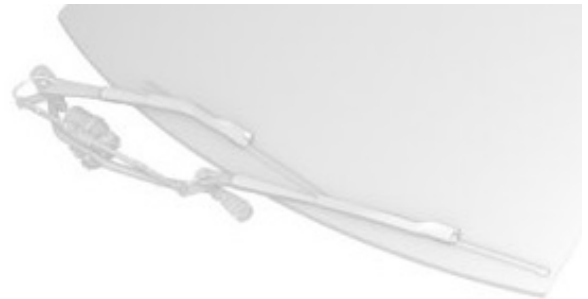
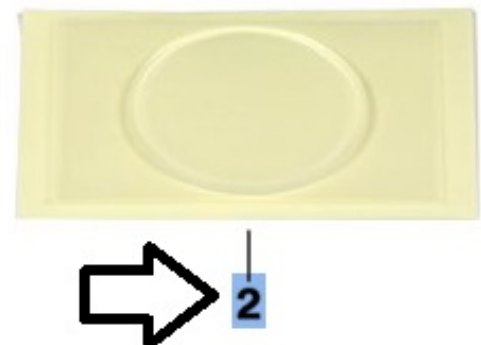
During replacement of a windshield, the rain light sensor needs to be transferred from the original to the replacement windshield. The sensor's gel pad can become damaged, leading to functional issues related to the automatic wipers.

If, even after following repair instructions, the gel pad becomes damaged, many models allow for a replacement of the gel pad **ONLY**. Damage to the gel pad does **NOT** require a complete rain light sensor replacement for vehicles which have the gel pad available independently of the rain light sensor. For applicable vehicles, the gel pad (item 2 below) can be found in ETK/AIR.

Care should be taken to follow ISTA/AIR repair instructions for careful removal of the rain light sensor without damaging the gel pad. The wait time outlined in repair instructions must be followed to allow time for the gel pad to relax for removal.

For windshields that are replaced under warranty, complete rain light sensor replacement for a damaged gel pad will no longer be accepted if the gel pad repair kit is available.
