SIB 61 06 15

2021-11-24

Washer Fluid Reservoir Rattles While Driving on Rough Roads

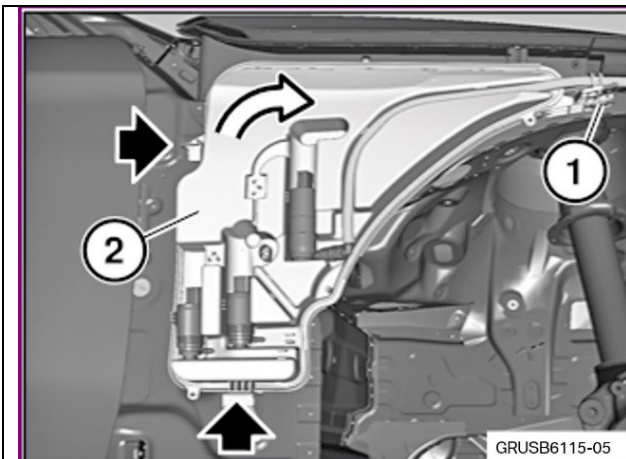
1. Remove the washer fluid reservoir as per Repair Instruction 61 71 061.
Note: Accompanying picture shown is with the passenger side fender removed for purposes of clarity.
2. Remove the screw (1).
Tightening torque = **8 Nm**.
3. Pull the washer fluid reservoir (2) out of the guides (arrow) in the direction of the arrow.
4. Unlock and disconnect all plug connections.
5. Unlock the filler hose and pull it off the fitting on the washer fluid reservoir.
Note: Capture any escaping washer fluid, if necessary.

- Note: The close-up picture shows a gap (0.40 mm) that exists between the plastic reservoir guide and the metal securing bracket.**
6. With the reservoir removed, clean the upper guide tab with a clean cloth.
