SIB 61 15 21

2021-11-29

## SERVICE ACTION: INSPECTING THE VEHICLE BATTERY INSERT

E-Series	Model Description	Production Date
G82	M3 Sedan	November 14th, 2019 to September 14th, 2021
G83	M4 Coupe

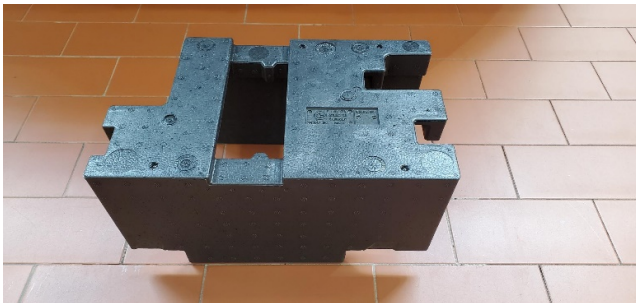
It is possible that the EPP (expanded polypropylene) insert for the lithium-ion battery was not installed in approx. 0.3% of the G82 and G83 vehicles.

The EPP insert is not a statutory requirement and serves as additional protection for the battery in the event of a rear-end crash at very high speeds.

Since there are no sharp-edged components in the battery tray or the surrounding vehicle structure, it can be assumed that the battery is sufficiently well protected in this loading case even without the EPP insert.

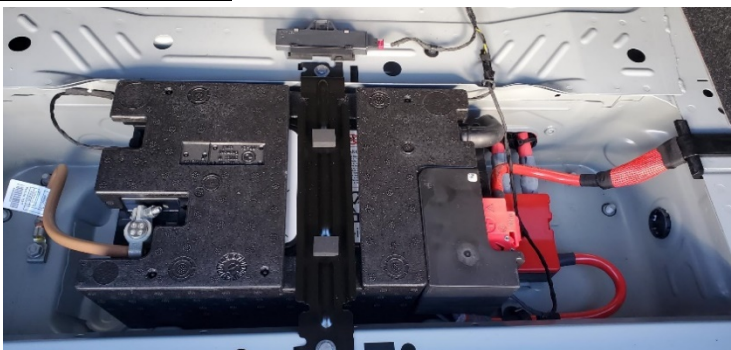
1. Raise the trunk luggage compartment floor and inspect if the EPP insert (arrows) is installed.

2. If the EPP insert is installed, **no further work is necessary.**

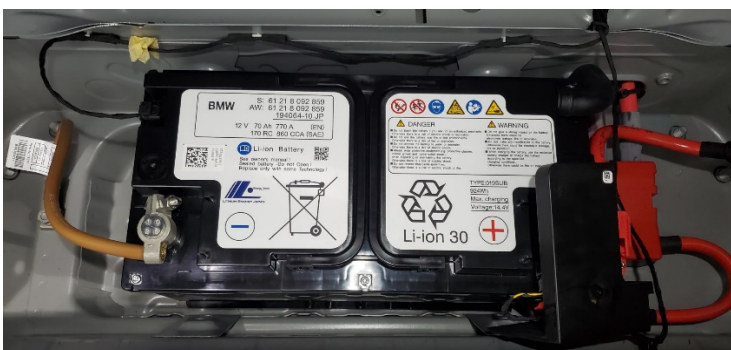
3. If the EPP insert is missing as shown, follow procedure in steps 4 to 7.
