SIB 11 14 21

SERVICE ACTION: CHECK ROCKER ARMS AND REPLACE WHERE NEEDED

2021-11-17

Model	Model Description
K63	S 1000 R
K69	S 1000 XR

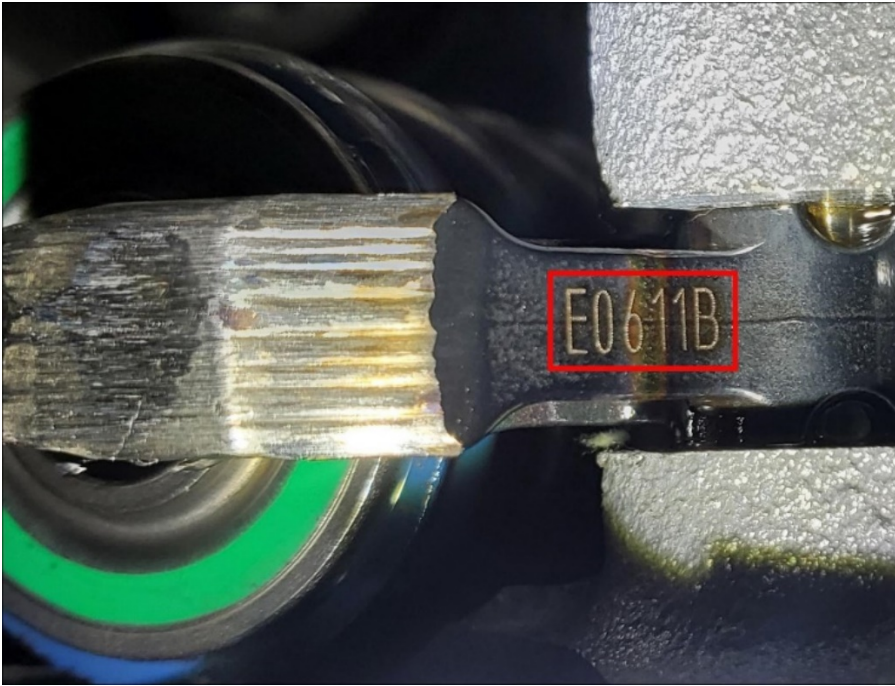
Due to a process deviation during production, the surface coating of the rocker arms may wear prematurely. Over time, increased wear on the rocker arms may also result in premature wear of the camshafts.

- Check for production batch E0611A or E0611B and for wear on all rocker arms, as shown in Figures 1 and 2, and plan out the next steps of action depending on what is found:

Figure 1: Worn rocker arm, shown with production batch number:

When at least one rocker arm with production batch E0611A or E0611B is found and black surface coating shows wear on at least one of these rocker arms, **all rocker arms and both camshafts must be replaced.**

- Replace all rocker arms or all rocker arms and camshafts according to Repair Instructions "11 12 116 – Remove/install cylinder head or replace cylinder head gasket" and "11 33 552 – Replace all rocker arms (cylinder head removed)".
- Refer to the part numbers and warranty information below.

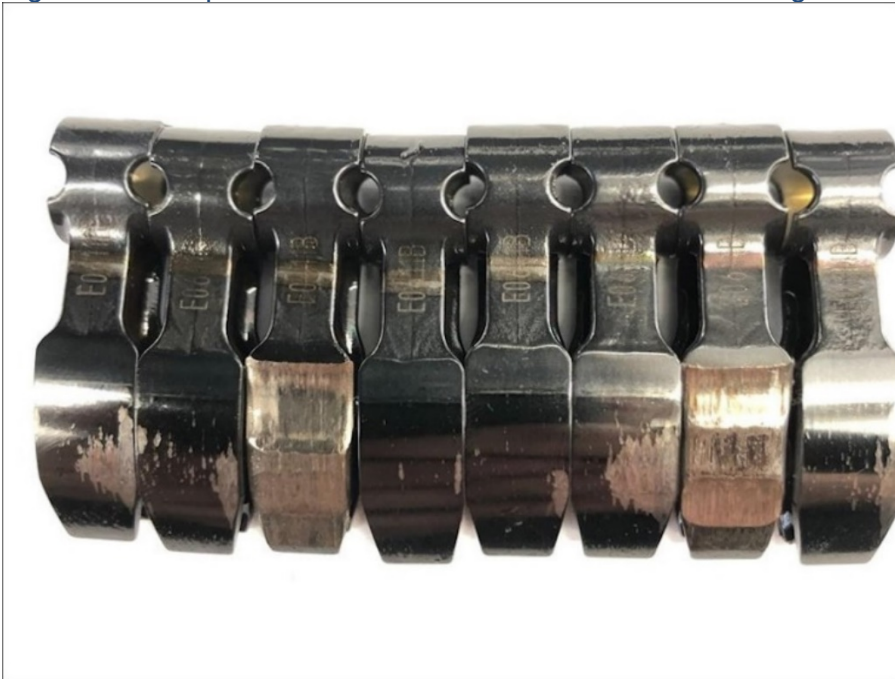
Figure 2: Examples of rocker arms with worn surface coating:

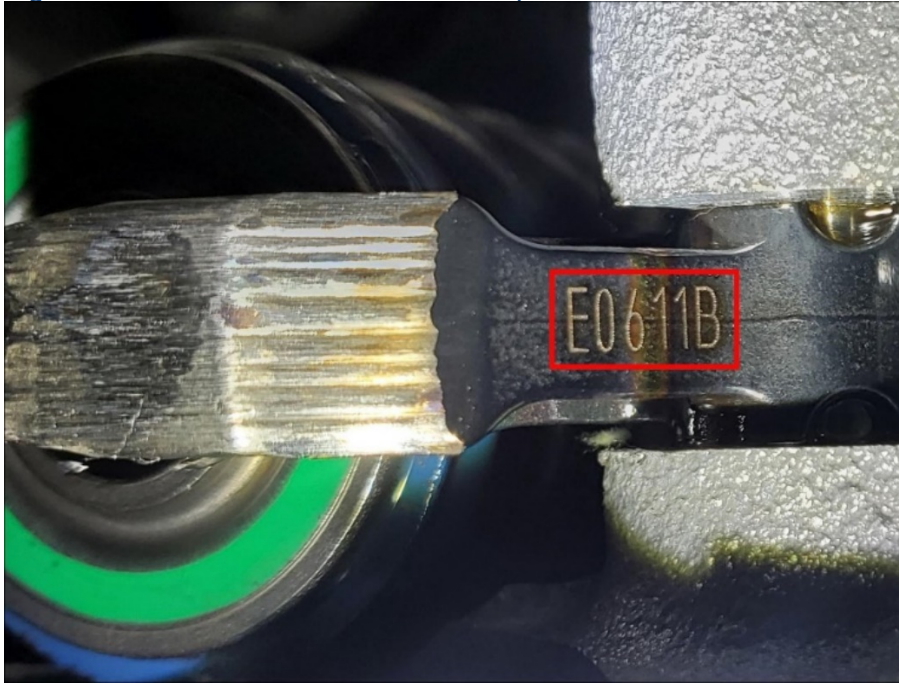
Due to a process deviation during production, the surface coating of the rocker arms may wear prematurely. Over time, increased wear on the rocker arms may also result in premature wear of the camshafts.

- Check for production batch E0611A or E0611B and for wear on all rocker arms, as shown in Figures 1 and 2, and plan out the next steps of action depending on what is found:

Figure 1: Worn rocker arm, shown with production batch number:

When at least one rocker arm with production batch E0611A or E0611B is found and black surface coating shows wear on at least one of these rocker arms, **all rocker arms and both camshafts must be replaced.**

- Replace all rocker arms or all rocker arms and camshafts according to Repair Instructions "11 12 116 – Remove/install cylinder head or replace cylinder head gasket" and "11 33 552 – Replace all rocker arms (cylinder head removed)".
- Refer to the part numbers and warranty information below.

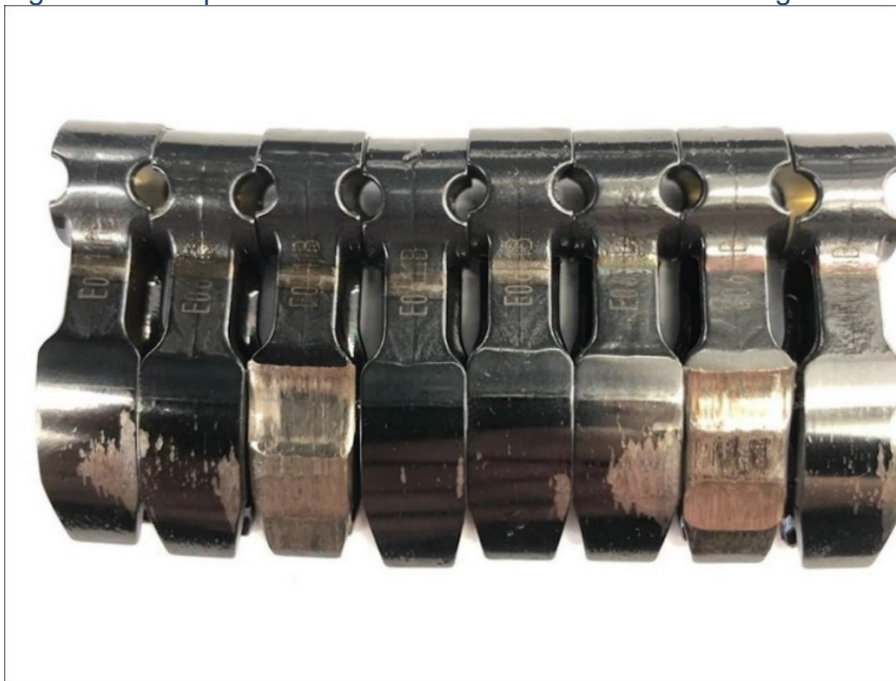
Figure 2: Examples of rocker arms with worn surface coating:
