**SIB 46 01 01**

**SERVICE ACTION: Removal of retaining plate - Bulletin 46 001 01 (013)**

Bulletin No: 46 001 01 (019)

### Topic: R 1150 R - Removal of retaining plate. Revised Information

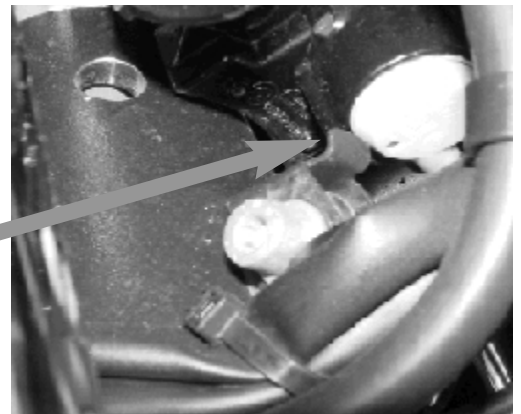
A new retaining bracket will be introduced into series production as of August 2001. The revised shape and geometry of this new bracket eliminates the possibility of the ignition switch wiring harness chaffing. As a result, this new retaining bracket will not have to be removed.during PDI.

**Topic:** On the R 1150 R there is a retaining bracket bolted, together with the horn bracket, to the front frame section. This bracket serves exclusively as a support point for the motorcycle while it is being transported in the crate (see bracket location right).

**Service Measures:** Remove the retaining bracket during the set up and pre-delivery procedures. Replace the retaining bracket with the washer described above. Fit the washer between the horn bracket and the front frame section. Upon reassembly tighten the M8x30 bolt to a torque of 21 Nm.

**Important Note:** In the case of motorcycles that have already been delivered, remove the retaining bracket during the 600 mile service.
