**SIB 46 03 07****SERVICE ACTION: Replacement Brackets for Fairing Side Panels - 46 003 07 (011)**

**Subject:** Replacement brackets for fairing side panels

**Model:** K 1200 R Sport (K43HV)

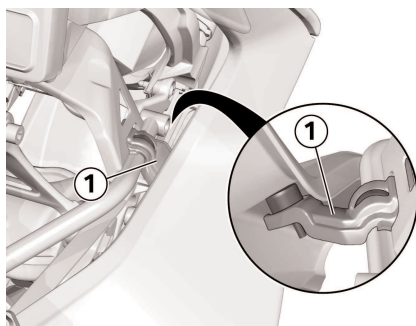
New version, plastic bracket

- \* Remove both side panels.
- \* Remove the screw securing the steel bracket on each side, remove the two steel brackets and scrap them.
- \* If necessary, use black paint to touch up minor damage to the paintwork of the instrument carrier.
- \* Install the rubber buffers in the plastic brackets (1).
- \* Install the plastic brackets (1) on left and right and secure them to the instrument carrier with cable ties.
- \* Install both side panels, paying particular attention to their alignment.

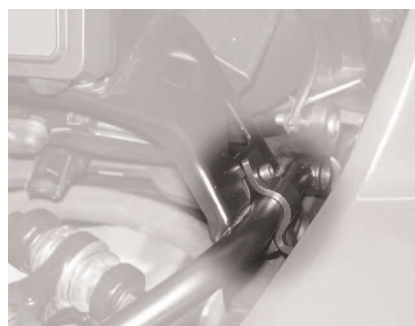
**Details:** The fairing brackets installed on the early K 1200 R Sport (K43HV) motorcycles were not sufficiently resistant to corrosion. These steel brackets are secured by screws and have to be replaced by the latest version (plastic brackets).

Old version, steel bracket
