**SIB 23 02 04**

Ball end joint loose on gear lever - Bulletin 23 002 04 (025)

Bulletin No: 23 002 04 (025)

**Topic:** Ball End Working Loose on Gearshift Lever.  
F 650 CS

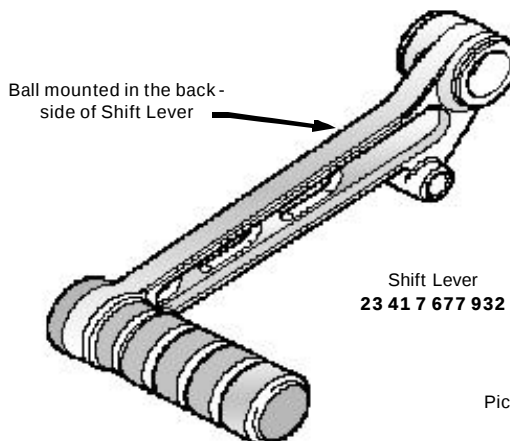
Picture 1

**Subject:** The ball end mounted on the inside of the gearshift lever can work loose. In the worse case this may cause the gearbox to shift with difficulty, or not at all.

**Service:** 1: Check the security of the ball end on the shift lever.  
2: If the threaded ball end is found to have worked loose on the shift lever, remove the entire shift lever and install the modified shift lever with reworked ball end.
