SIB 11 01 07

SERVICE ACTION: F800 Engine Cover Screw Torque - Bulletin 11 001 07 (022)

**Subject:** Checking security of threaded fasteners, engine-block covers

**Models:** F 800 S / ST (K71)

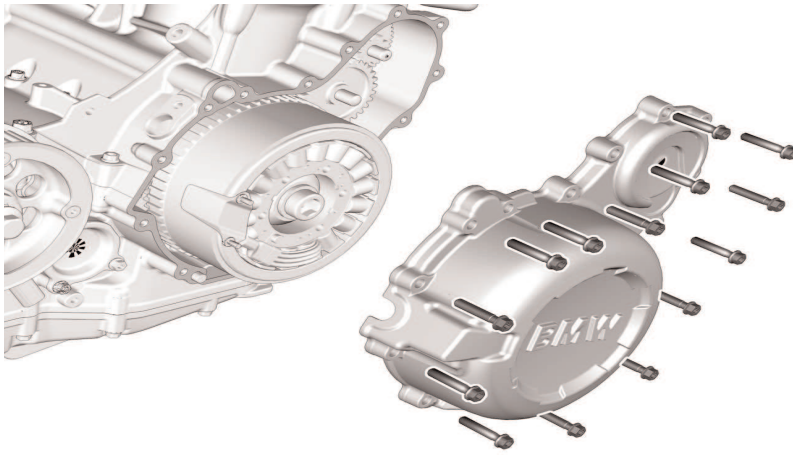
**Details:** During the first hours of engine operation, the pretension of the threaded fasteners securing the engine-block covers diminishes because the coating on the covers is expelled from the areas underneath the heads of the screws. This can result in two kinds of leaks:

Threaded fasteners of alternator-side cover

**After-sales Solution:** In a once-only check, the next time a motorcycle in the range affected is brought into the workshop, check the security of all engine-block cover screws (see photos) by application of a tightening torque of 12 Nm.  
If the oil pressure telltale light shows when the engine is running, always check first to ascertain whether the left engine-block cover gasket is cracked, and replace if necessary.

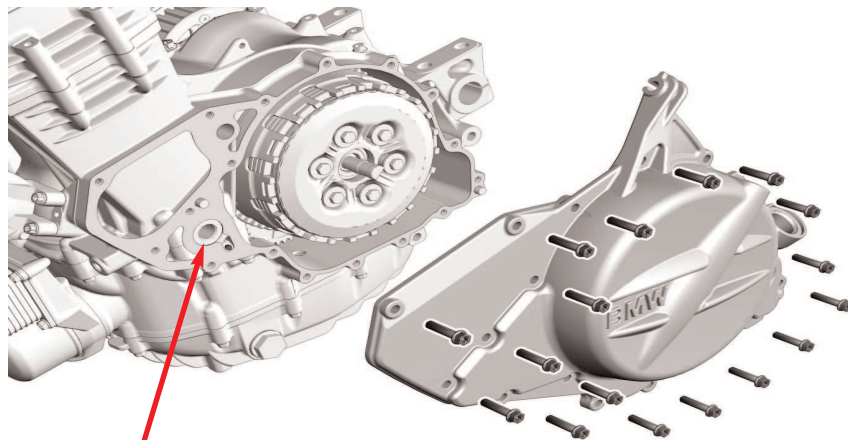
1. Oil weeping at the sealing face between cover and engine block; clearly visible, but generally not critical in terms of engine operation.
2. An "internal" leak at the clutch side cover gives rise to the risk of damage to the engine: the pressurised oil that lubricates the conrod bearings flows through the left engine block cover. A leak from the pressurised oil duct to the sump (see bottom photo, arrow) where the oil is not under pressure, is not visible from the outside, but it causes a drop in oil pressure.

Pressurised-oil duct

Threaded fasteners of clutch-side cover
