**SIB 61 01 07****SERVICE ACTION: Check of EWS Wiring Harness - Bulletin 61 001 07 (001)**

**Subject:** Check of cable routing to the EWS ring antenna

**Model:** K 1200 GT (K44)

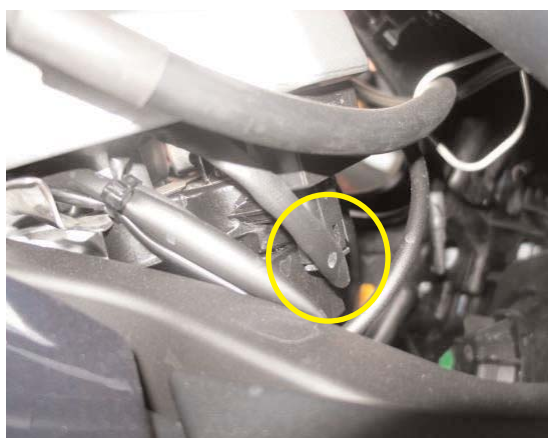
Photo 1

**Details:** There is a possibility of the "EWS" (electronic immobilizer) error message being displayed in the instrument cluster of the K 1200 GT (K44). If this occurs the engine will not start.

The problem can be caused by a broken wire at the plug connection of the ring antenna. If the wiring harness is not correctly routed, the wiring can chafe against the plug connection when the handlebars are turned from side to side, and eventually break. (Photo. 1)

**Solution:** As of VIN ZN45643 cable routing has been corrected.

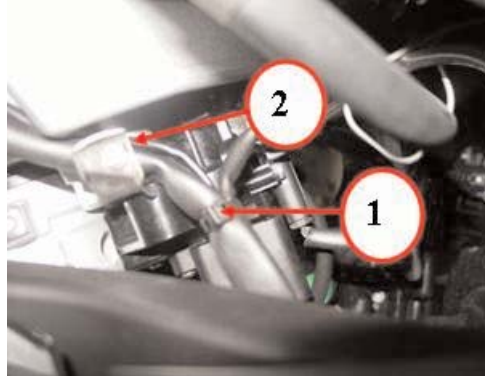
Photo 2

1. Make sure that the handlebars are set to the highest position of their range of adjustment.
2. Cable tie (1) must be positioned approx. 20 mm in front of metal retainer (2) (Photo 2).

- Correctly re-route the cable. (photo 2)
- reinstall all components.

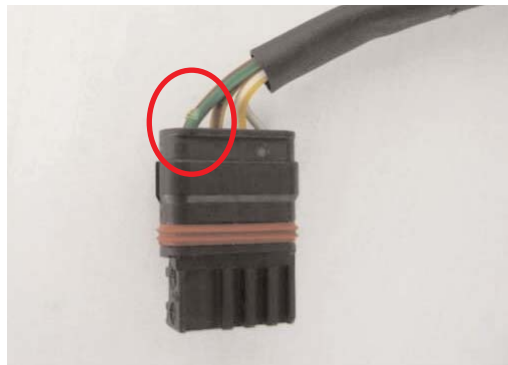
Photo 3

1. Turn the handlebars all the way to the left and right and make sure there is no strain on the wiring at the plug connection of the EWS ring antenna.
2. If the wiring is too short, disconnect the plug from the EWS ring antenna and check for signs of chafing (see photo 3)

3. If the wiring is free of chafing and is in good condition, proceed as follows. If the wiring has suffered damage from chafing go to step # 4.

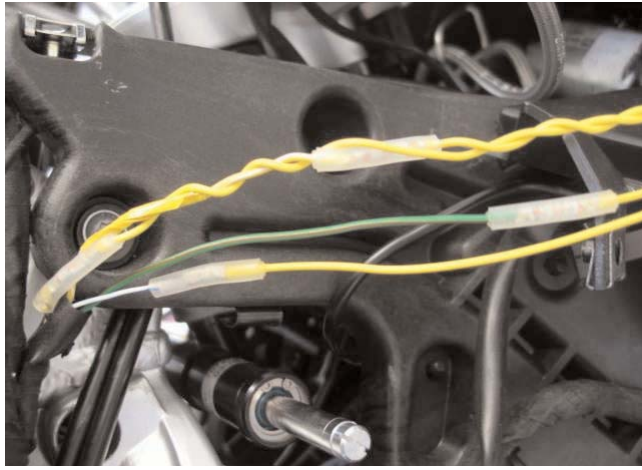
Photo 7

**Note:** Location of connectors are offset from each other.

- **Important:** Begin by pushing the shrink-on hose onto the wire. Make sure that the wires are correctly paired. Crimp the push-in connectors from the repair kit onto the two signal wires.
- Twist the two signal wires around each other.
- Crimp the connectors onto the remaining wires.
- The push-in connectors should all be located along the length of wire from the point of separation from the main wiring harness and the first cable clip. (photo 7)
